| <b>DOT Auto Safety Hotline</b><br><b>Vehicle Owner's Questionnaire</b><br><b>To Report Vehicle Safety Defects</b><br><b>1-888-DASH-2-DOT</b><br><b>(1-888-327-4236)</b><br><b>INTERNET: www.nhtsa.dot.gov/hotline</b> | | | | FOR AGENCY USE ONLY 100148 | |

Re: Insured: [REDACTED]  
Claim No: [REDACTED]  
RCG File No: [REDACTED]  
Subject: Report of Findings

Rimkus Consulting Group, Incorporated was retained to determine the origin and cause of a vehicle fire incident that occurred on January 17, 2015, approximately two miles [REDACTED] near Memphis, Tennessee. It was reported by the client that a fire occurred involving a 2014 Nissan Cube with Vehicle Identification Number (VIN) JN8AZ2KR4ET [REDACTED].

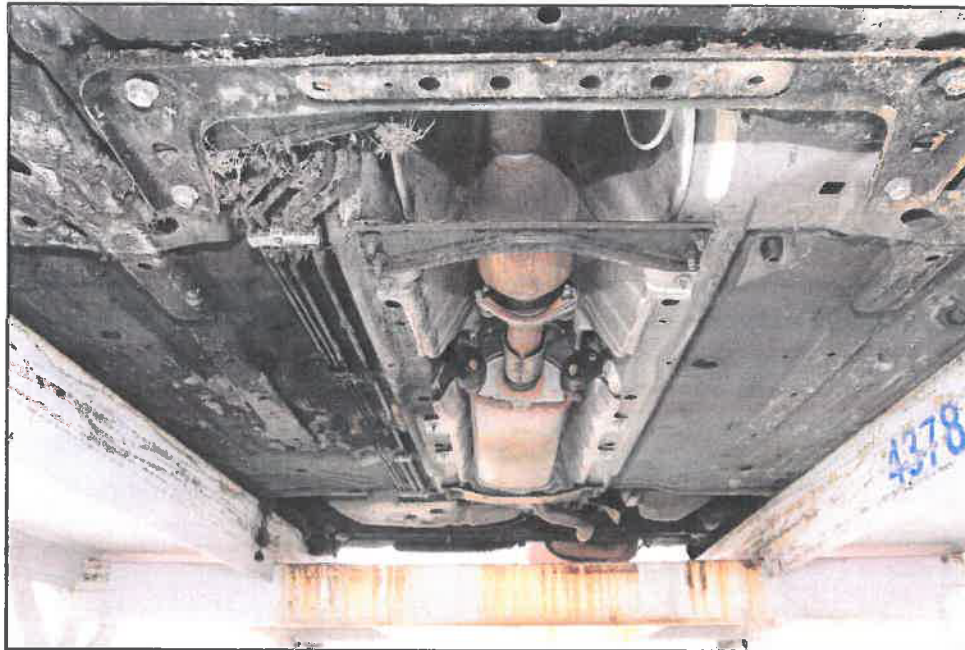
**Photograph 5**

A view of the underside of the vehicle where no fire damage or fire causes were observed.

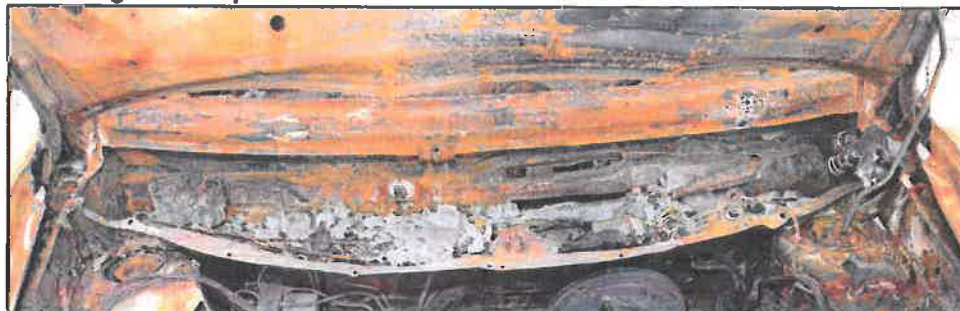
**Photograph 6**

A view of the engine compartment.

After gaining entry to the engine compartment, an analysis was made at which point it was observed that the majority of the various components were destroyed by the fire, including all belts and hoses. The oil dipstick was removed and the oil level evaluated. Based on the level on the dipstick it would appear that the oil level was within the manufacturers recommended range. The battery was observed in the engine compartment and had been destroyed by the fire. The battery terminal connections were evaluated and showed no evidence of abnormal electrical activity. The power distribution block had been destroyed by the fire preventing any analysis of the fuses. The remnants of the wiring harness was examined and found to have been destroyed by the fire.

Burn patterns observed within the engine compartment and the extensive damage to the engine compartment components indicated that the fire spread from within the engine compartment and through the manufactured openings in the bulkhead wall, separating it from the passenger compartment.

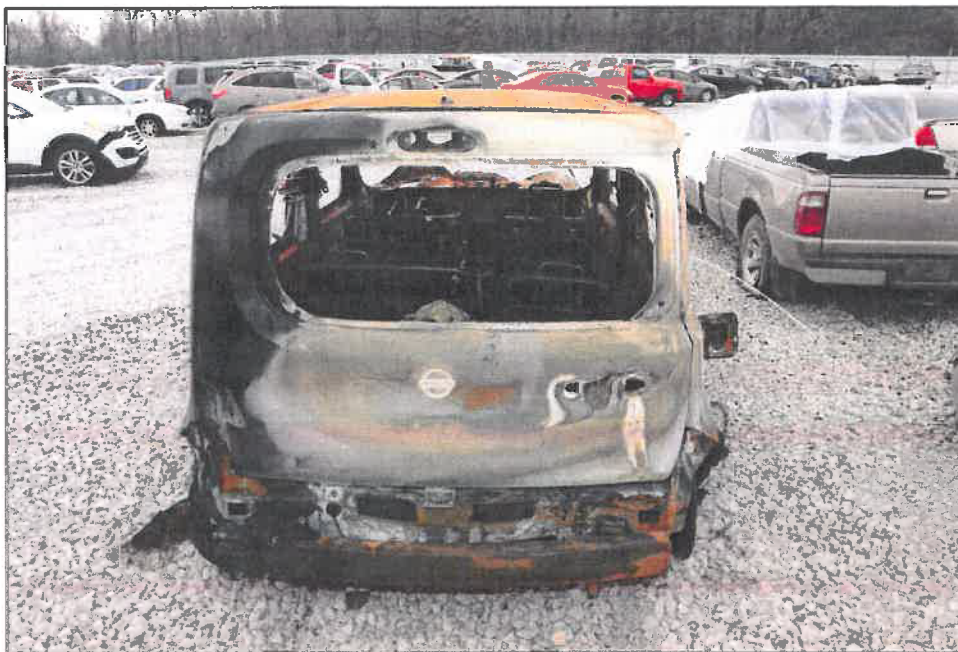
**Photograph 3**  
A view of the rear of the vehicle.

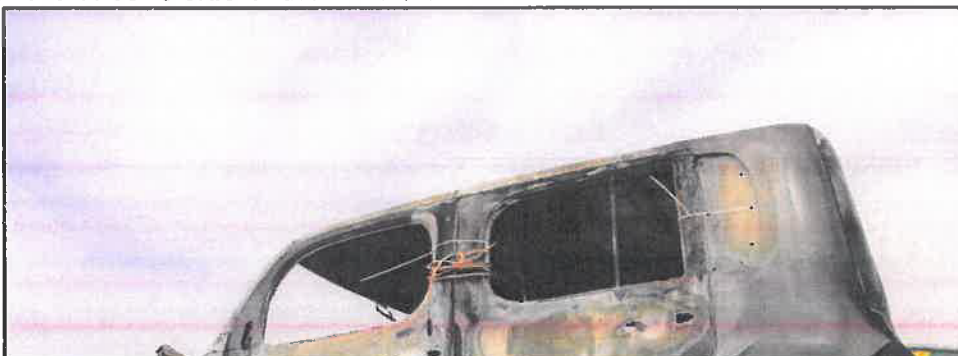
**Photograph 4**  
A view of the driver's side of the vehicle.

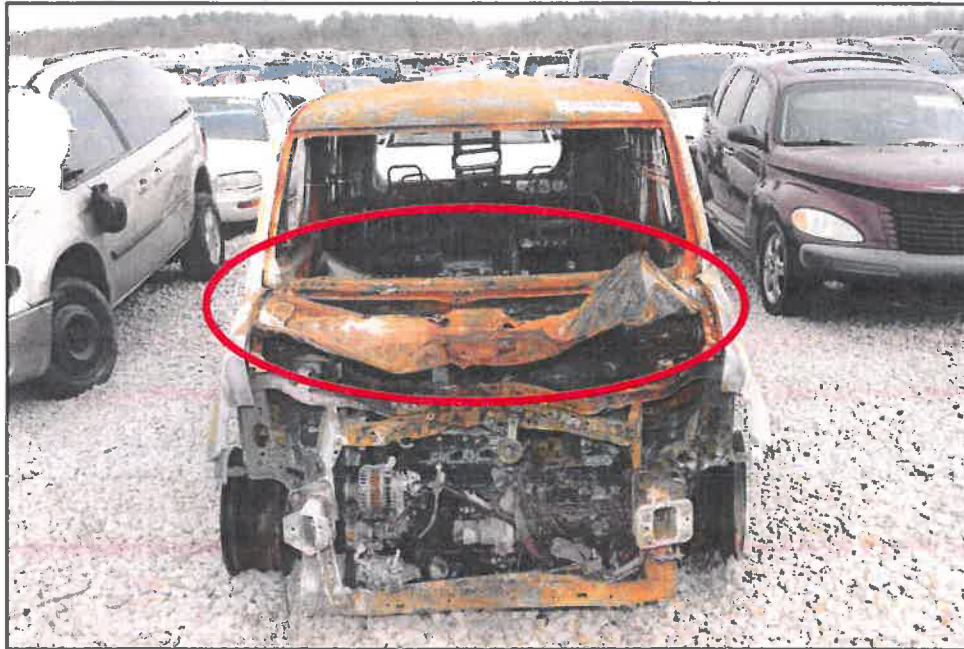
**Photograph 1**

Overall view of the front end of the vehicle. The circled area denotes the damage sustained during the fire suppression efforts.

Upon initial inspection of the vehicle, it was observed that there was no body damage that would immediately indicate that the vehicle had been involved in a recent collision. The damage observed to the front hood and core support was sustained during the fire suppression efforts conducted during the fire event. The license plate, typically located on the rear of the vehicle, was not observed in place.

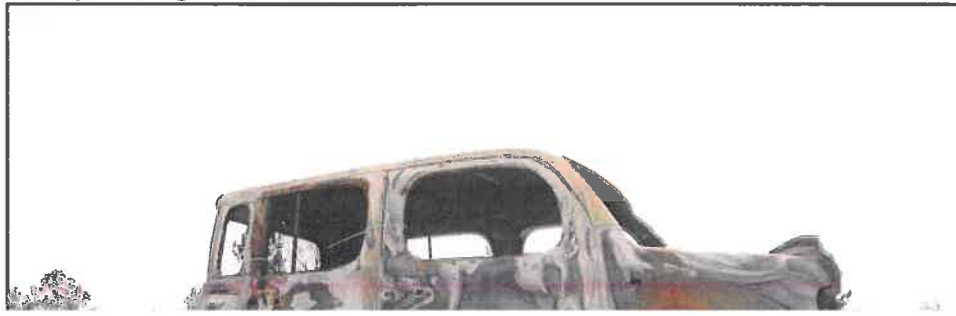
**Photograph 2**

A view of the passenger side of the vehicle
