I recently read the article involving Triumph motorcycles concerning safety defects in the steering of certain models. (NHTSA 42-15). I believe I have found one defect even much more serious as well as a cover up by the factory to hide this defect. In the data below, I will describe what I found and why I feel the factory not only knew about this defect, but covered it up.

I purchased a 2011 Triumph GT Sprint motorcycle in October of 2012 from Eldorado Springs Cycle in Eldorado Springs, Missouri. Ser# SMT601PK4BJ

### The Front Forks

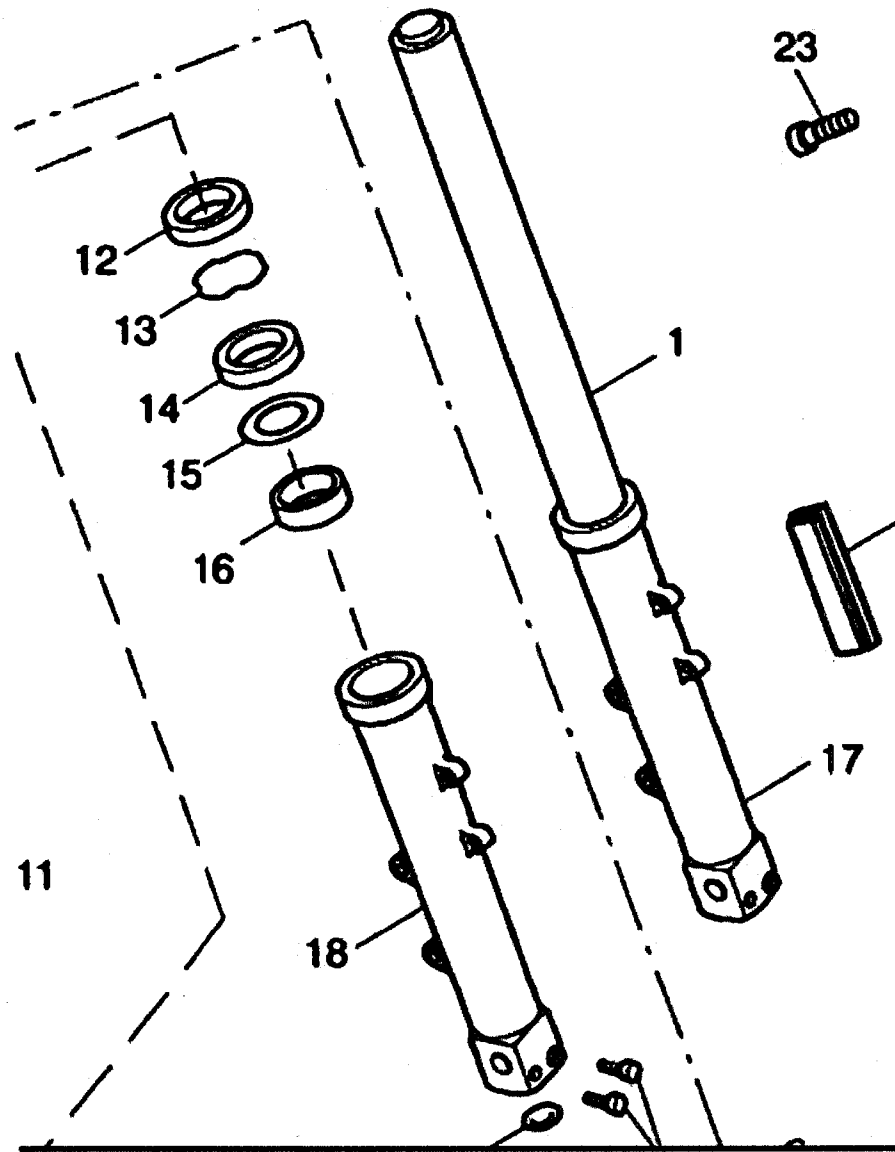
When I took the chrome tube (no. 1) it wobbled around inside the lower slider tube (no 17). On both front forks. These two components should be very solid. The upper chrome tube should NEVER wobble around inside of the lower tube. This was causing the vibrations in my braking system all this time!!

What I did was to reassemble everything with all the new parts. When I checked the wobble, it was exactly the same. Thru my own measuring, I found the upper guide bushing (#16) is within spec. But, the bore in the lower tube is too big!! On both my old tubes and these new tubes. I now have 4 different lower stanchion tubes all over-bored exactly the same!!

With the new parts coming in with the same over-bore as my 4 year old parts, I suspect that every single tube on every Triumph has this same problem. And, there is NO WAY to fix this!! Buying new parts will yield the exact same wobble.

It is impossible to fix this situation. For any normal person, that is. Because I am an engineer, I can make a part that will bring the upper tube into spec making the upper and lower tubes now SOLID. Like they SHOULD be!! I then MUST install my .060" wheel bushing or I will over-pinch the bottom of the front forks.

I feel Showa should supply a set of lower stanchion tubes with the correct bore to allow the bushing to tightly fit the forks. Then, a spacer shim must be installed (or a redesign of the existing spacers) or the forks will be severely pinched at the bottom.

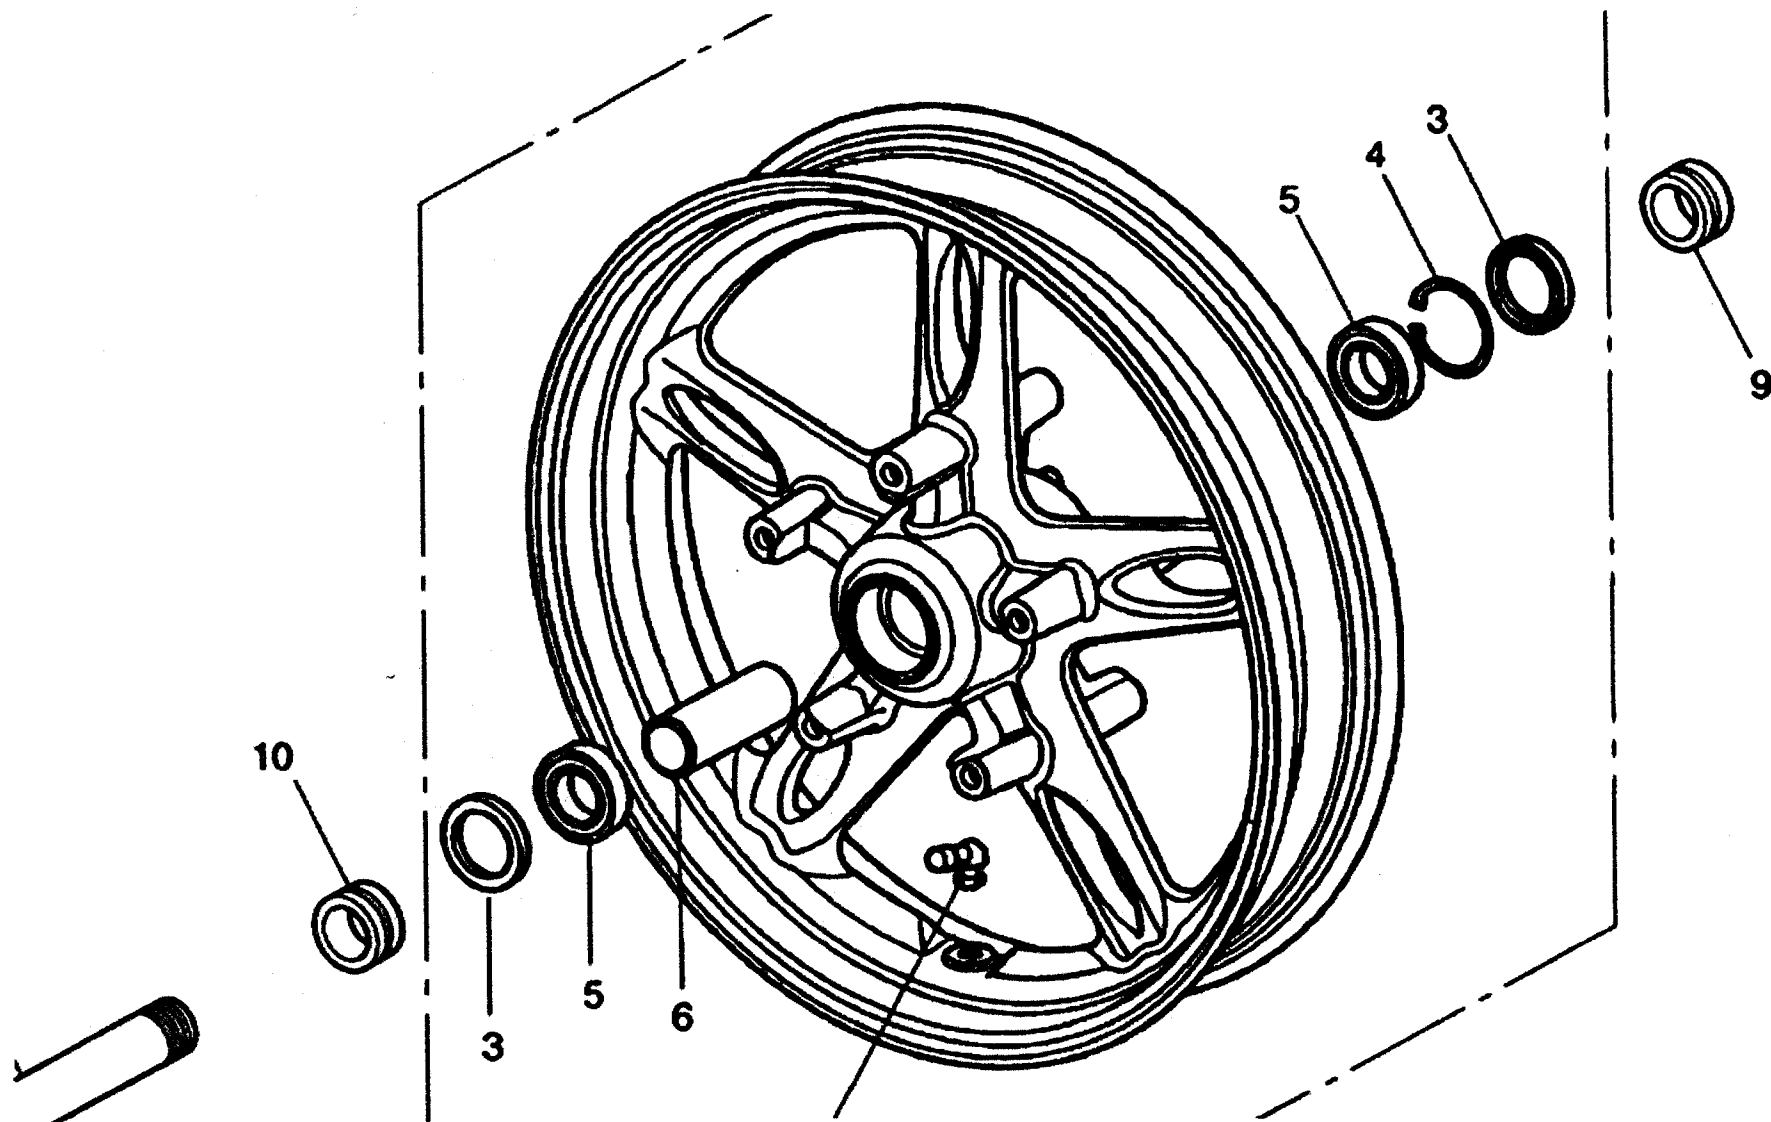
I believe that Triumph knew about this issue clear back to 2005. The reason I say this is the spacers in the front wheel. On any previous Triumph model, the total gap of the spacers and front wheel when installing this assembly between the two front forks is just a few thousandths of an inch. If this gap is greater, it will pinch the fork tubes at the bottom and cause distortion.

On my wheel diagram I supplied, you can see the two wheel spacers. Part # 9 and # 10. These spacers are used on every 1050 Triumph with ABS braking. The gap I measured is around .060" of an inch. This is just too much gap to close up. It will severely pinch the fork bottom stanchion tubes together.

I feel Triumph motorcycles knew about these bad front forks. They covered this up with an excessive amount of clearance on the front wheel spacers. When tightening the axle, this pinches the entire fork system together to try to reduce the wobble and vibrations caused by the incorrect tolerance of the front forks.
