**Vehicle Owner's Questionnaire**  
To Report Vehicle Safety Defects  
1-888-DASH-2-DOT  
(1-888-327-4236)  
INTERNET: www.nhtsa.dot.gov/hotline

# Trust's 2015 Salem Villa

## Another Problem

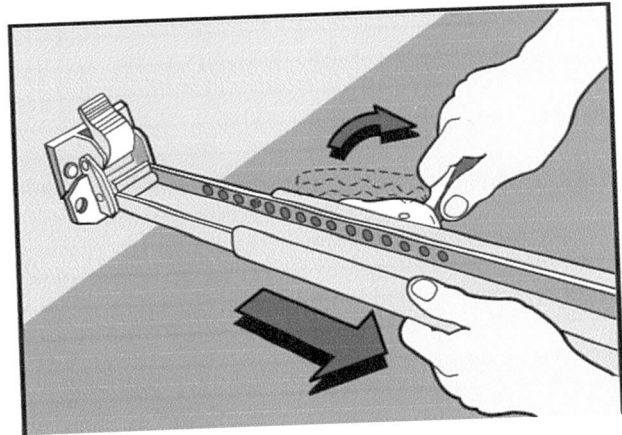
A...Lateral "play" in the fit between the main support arm and the adjustment arm varies the locking pin penetration into the adjustment arm when there is any mild release of tension from a light wind.

- A. Adjustable Arm (inside with holes)
- B. Main Support Arm (slides over "A")
- C. Self-locking Lift Handle
  1. 45 degree range
  2. Last 5 degrees engages pin into hole
  3. Handle does not stick/lock to frame
  4. Handle has no tension except locking

Note: Adjustable Arm has bottom stop bolt but no top stop bolt to prevent separation

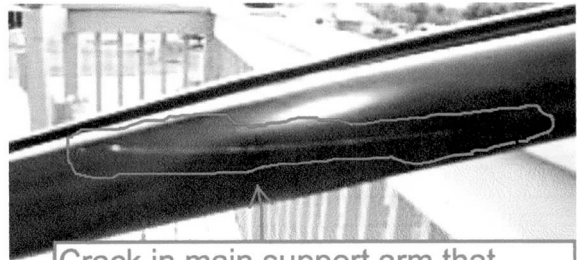
2. Discovered crack (see photo) in main support arm contributed to additional lateral play.
3. [redacted] at age [redacted] after 3 heart attacks, manually can separate adjustable arm from main arm.
4. Self-locking lift handle has a 45 degree arc from close (down) to open. About 5 degrees of this arc (open/activate) engage locking pin.
  - a. The handle does not lock in the down position & is free to swing up with the loss of tension with mild upward awning movement.
5. **If undesigned lateral play exists because of a poor fit or is enhanced by a crack, then the locking pin does not properly penetrate the hole in the adjustable arm, allowing arms separation.**

Crack in main support arm that came apart; crack contributes to lateral play which allowed lock pin to recess and subsequently support arms separation.

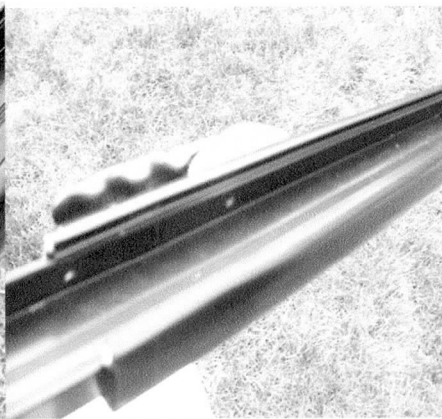
Lateral play recesses pin

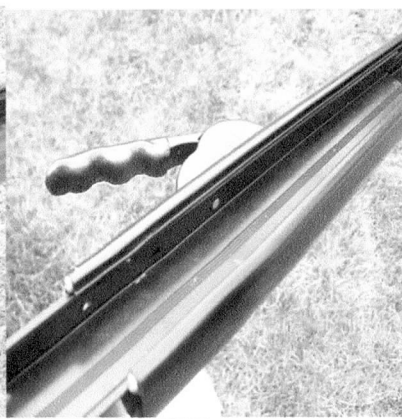
Slide movement opens handle

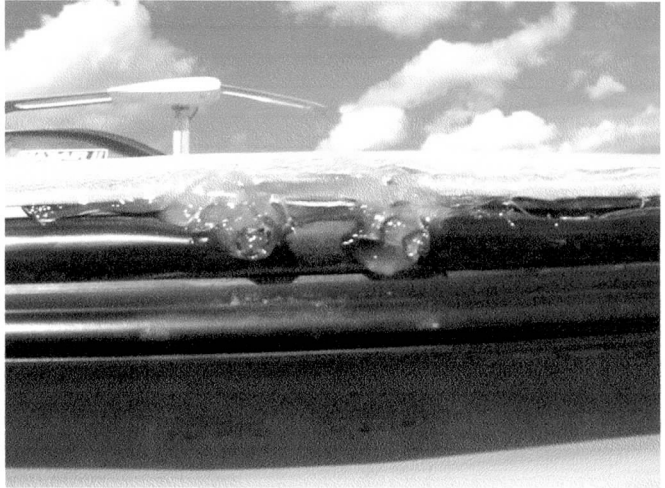
**A "grip rail" runs along the top of the trailer on the door side and holds the awning and canister via the mounting bracket shown below in picture 3. The end of the tarp (awning) is secured to it as well; the canister rolls out as extended.**

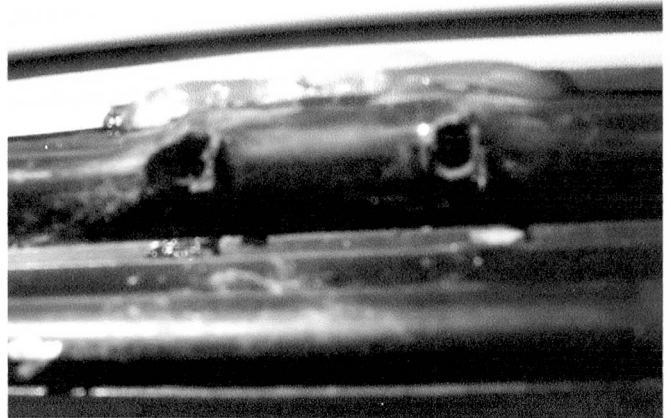
**The shown holes from where the lag screws were bolted depicts the rail as hollow and not reinforced.**

**Due to mechanical defect, related herein, TerryTown RV will repair the awning under the extended warranty by getting replacement parts, putting fill in existing holes and drilling new ones. While we are grateful for this, we do not feel safe using it or attaching a sun screen to block the afternoon sun.**

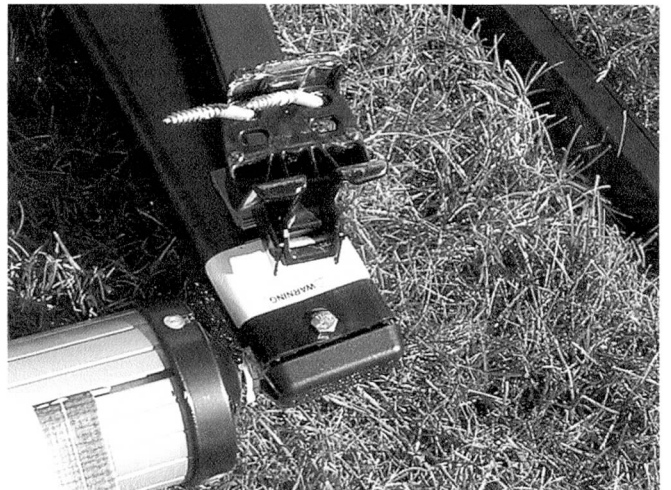
**The two securing lag screws (about 1.5" long) were bent when ripped out of the grip rail. The tarp and canister are heavy. The lag screws seem to only hold in 1/8" aluminum rail which is a danger in use or storage (still or moving).**
