**Vehicle Owner's Questionnaire**  
To Report Vehicle Safety Defects  
1-888-DASH-2-DOT  
(1-888-327-4236)  
INTERNET: www.nhtsa.dot.gov/hotline

Reference No.  
10911266

RE: NHTSA Campaign No. 13V617000; and, Reference No. 10911266.

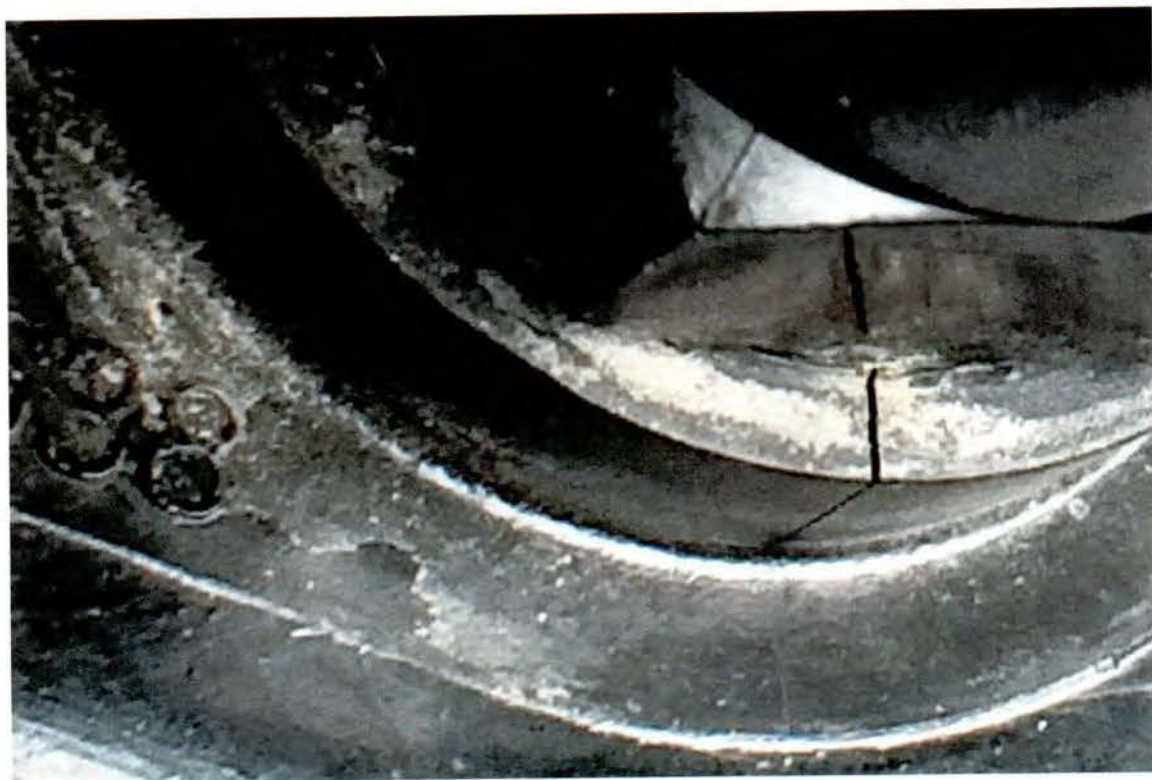
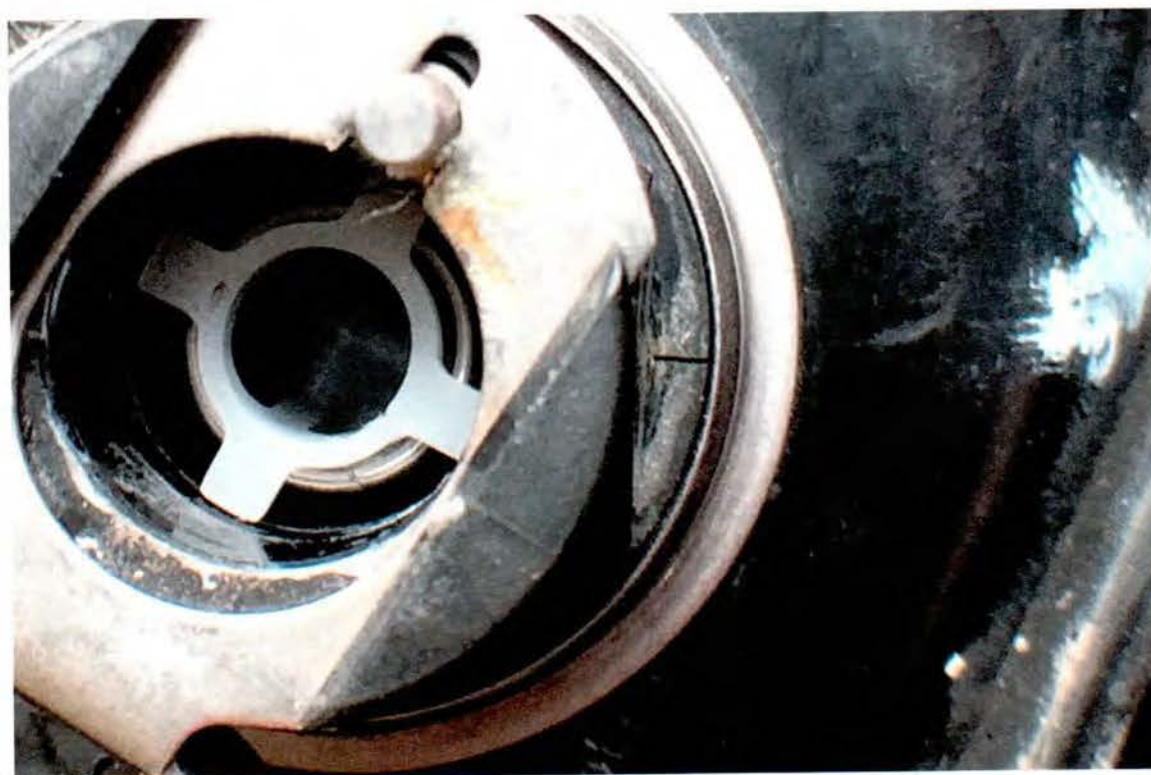
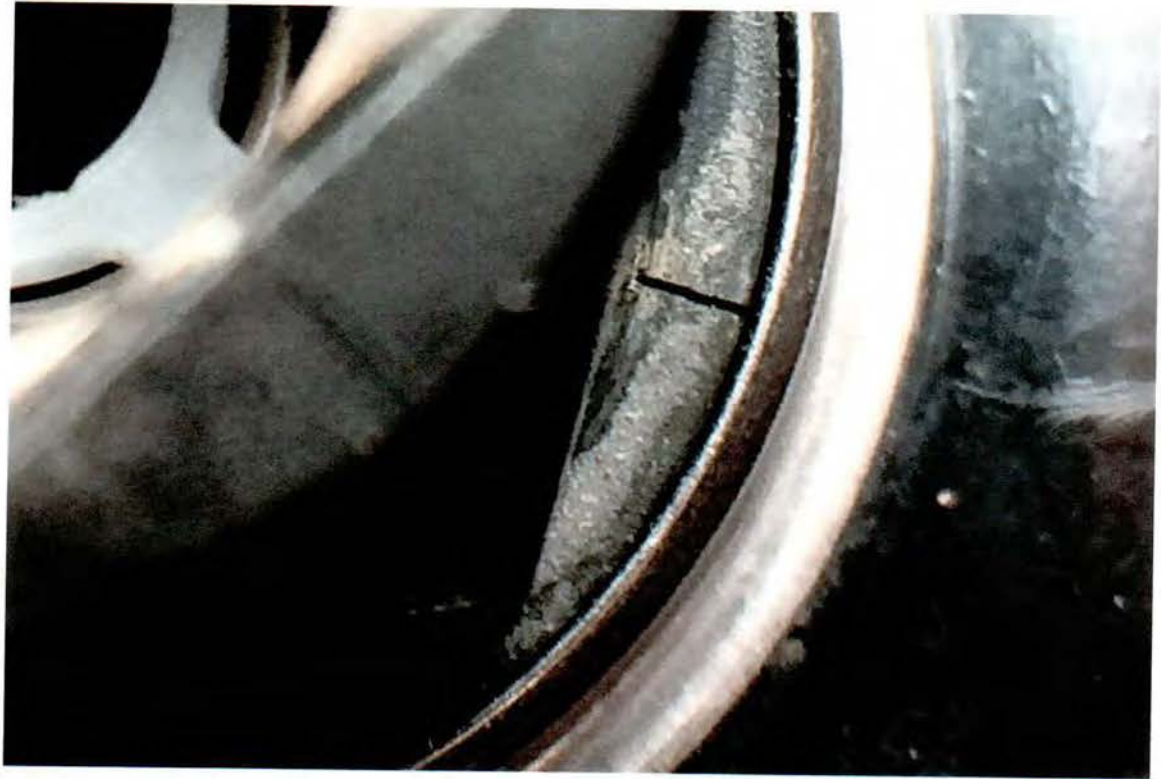
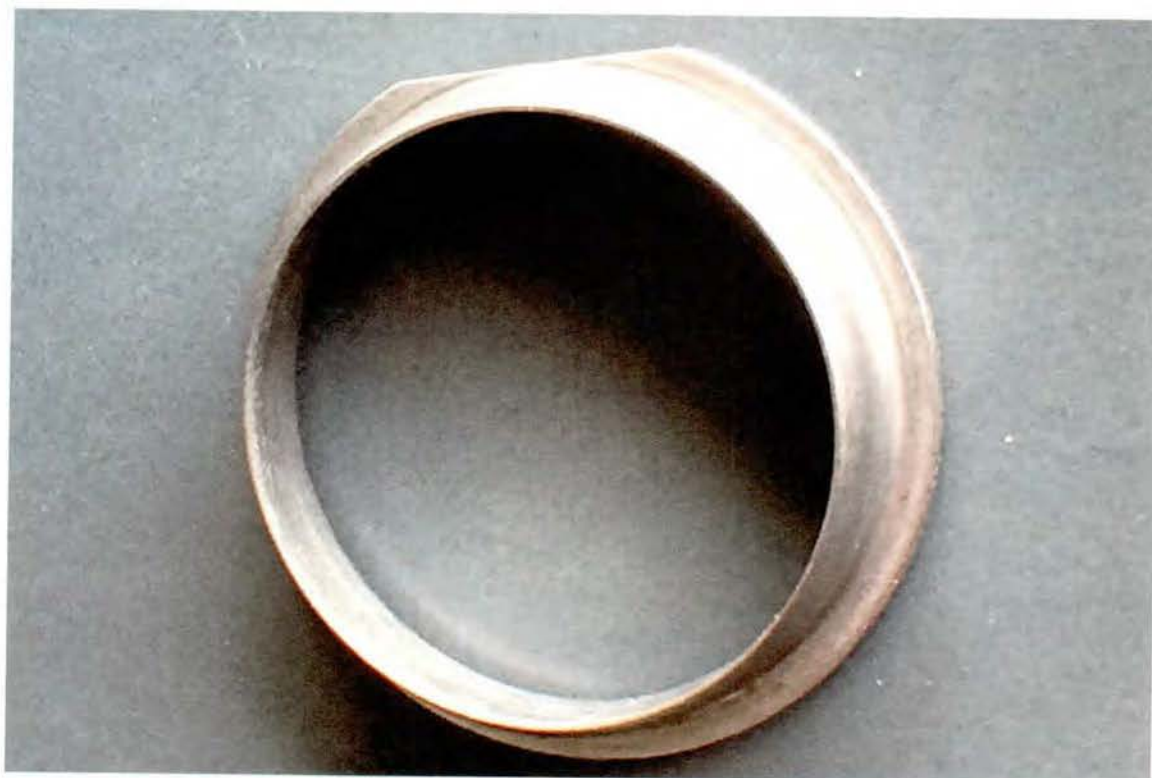
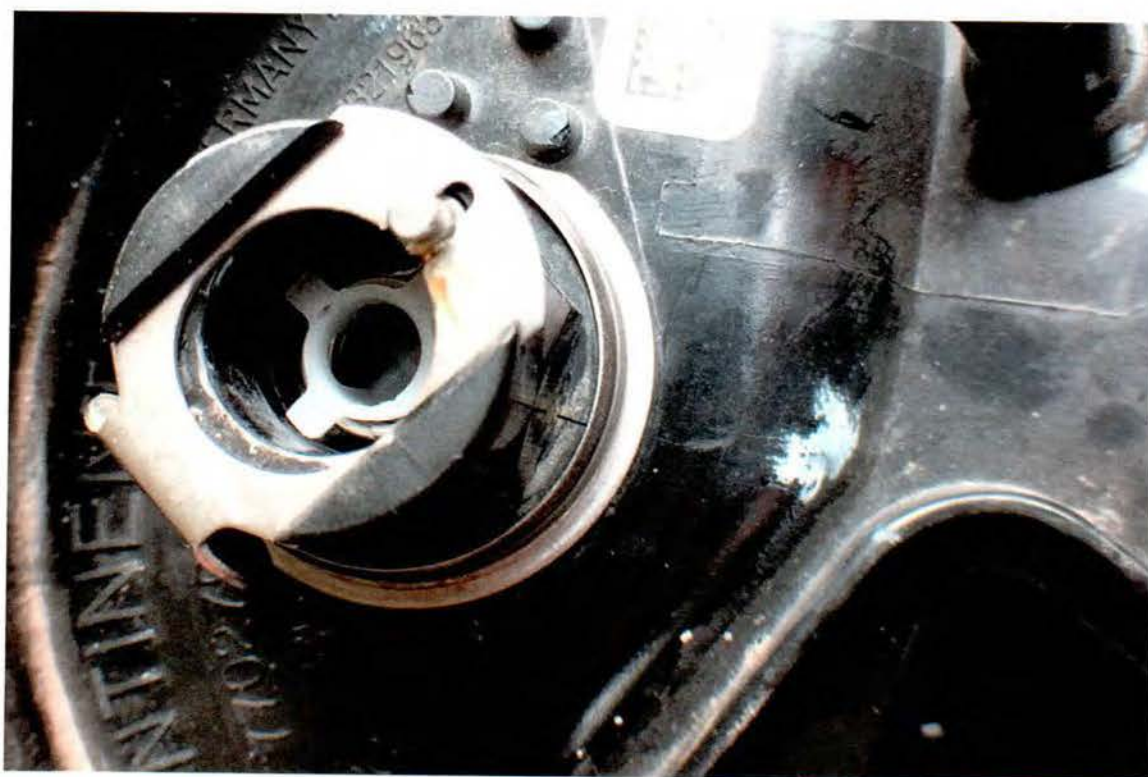
quick connect on the top of the fuel pump. This was not a "small" leak as had been described by BMW in the original NHTSA recall paperwork. Rather, it was a large "gusher". In fact, the spray was so large and powerful that it sprayed all the way from the gas tank compartment up past the handlebars and onto the windshield of the motorcycle, which is pretty clearly evidenced by the fact that the gasoline "etched" the windshield material, leaving a rather nasty cloudy patch on the windshield. Not insignificantly, this area between the top of the fuel pump and the windshield is exactly the area in which a riders' arms, upper torso and head would be situated while driving the bike. In addition to spraying gasoline up and onto the windshield, it pretty much sprayed gasoline in every direction from the top of the fuel pump, drenching the top of the gas tank, the engine block, the front part of the exhaust pipes where they exit from the engine block, the front fork/shocks, the front tire and all over the wiring and inside of the fairings in the gas tank/wiring compartment. Obviously, there are at least 20 ways that this type of a leak could have proved catastrophic/deadly if the leak had manifested while the motorcycle was moving.

Chris looked at the bike and after completing relevant diagnostics and physically inspecting the fuel pump, confirmed that, in fact, the source of the fuel leak was a large radial crack in the fuel pump quick connect underneath the supposed reinforcing collar. At my request, Chris saved the cracked, leaky fuel pump which I still have in my possession. To assist with your investigation, I have included several photos that illustrate (1) the location and size of the crack, (2) that the reinforcing collar simply slides on and off of the quick connect and doesn't clamp on or exert any force, (3) a gap between the outside edge of the quick connect nipple and the inside edge of the collar, demonstrating the lack of any "reinforcing" or "shielding" functionality of the collar, and (4) that a crack of exactly the type prompting the original recall formed in exactly the area of the supposed reinforcing collar.

Pick-up service Parnahoa Place  
Diagnose fuel leak at pressure side elbow base  
Order and replace 90° elbow end of quick couple  
Order fuel pump  
Remove + replace fuel pump + 2 gaskets (extensive accessories)  
Basic pre ride safety check  
Test ride - no leaks
