**Vehicle Owner's Questionnaire**  
To Report Vehicle Safety Defects  
1-888-DASH-2-DOT  
(1-888-327-4236)  
INTERNET: www.nhtsa.dot.gov/hotline

17 digit Vehicle Identification Number Located at bottom of windshield on driver's side 1HD1FF4177Y	Make HARLEY-DAVIDSON	Model FLHTC	Model Year 2007
Date Purchased 2/2/2009	Dealer's Name and Telephone Number Milwaukee Harley-Davidson 414-461-4444		Engine: No: Cylinders 2
Original Owner <input type="checkbox"/>	Dealer's City Milwaukee	State WI	Zip Code 53225
Transmission Type MAN.	<input type="checkbox"/> Antilock Brakes <input type="checkbox"/> Cruise Control	Powertrain	Multiple Failure: Incident Date(s) 13-AUG-2016

Vehicle Component Code: 100000 POWER TRAIN.	Failure Mileage 60000	Failure Speed 75
---	--------------------------	---------------------

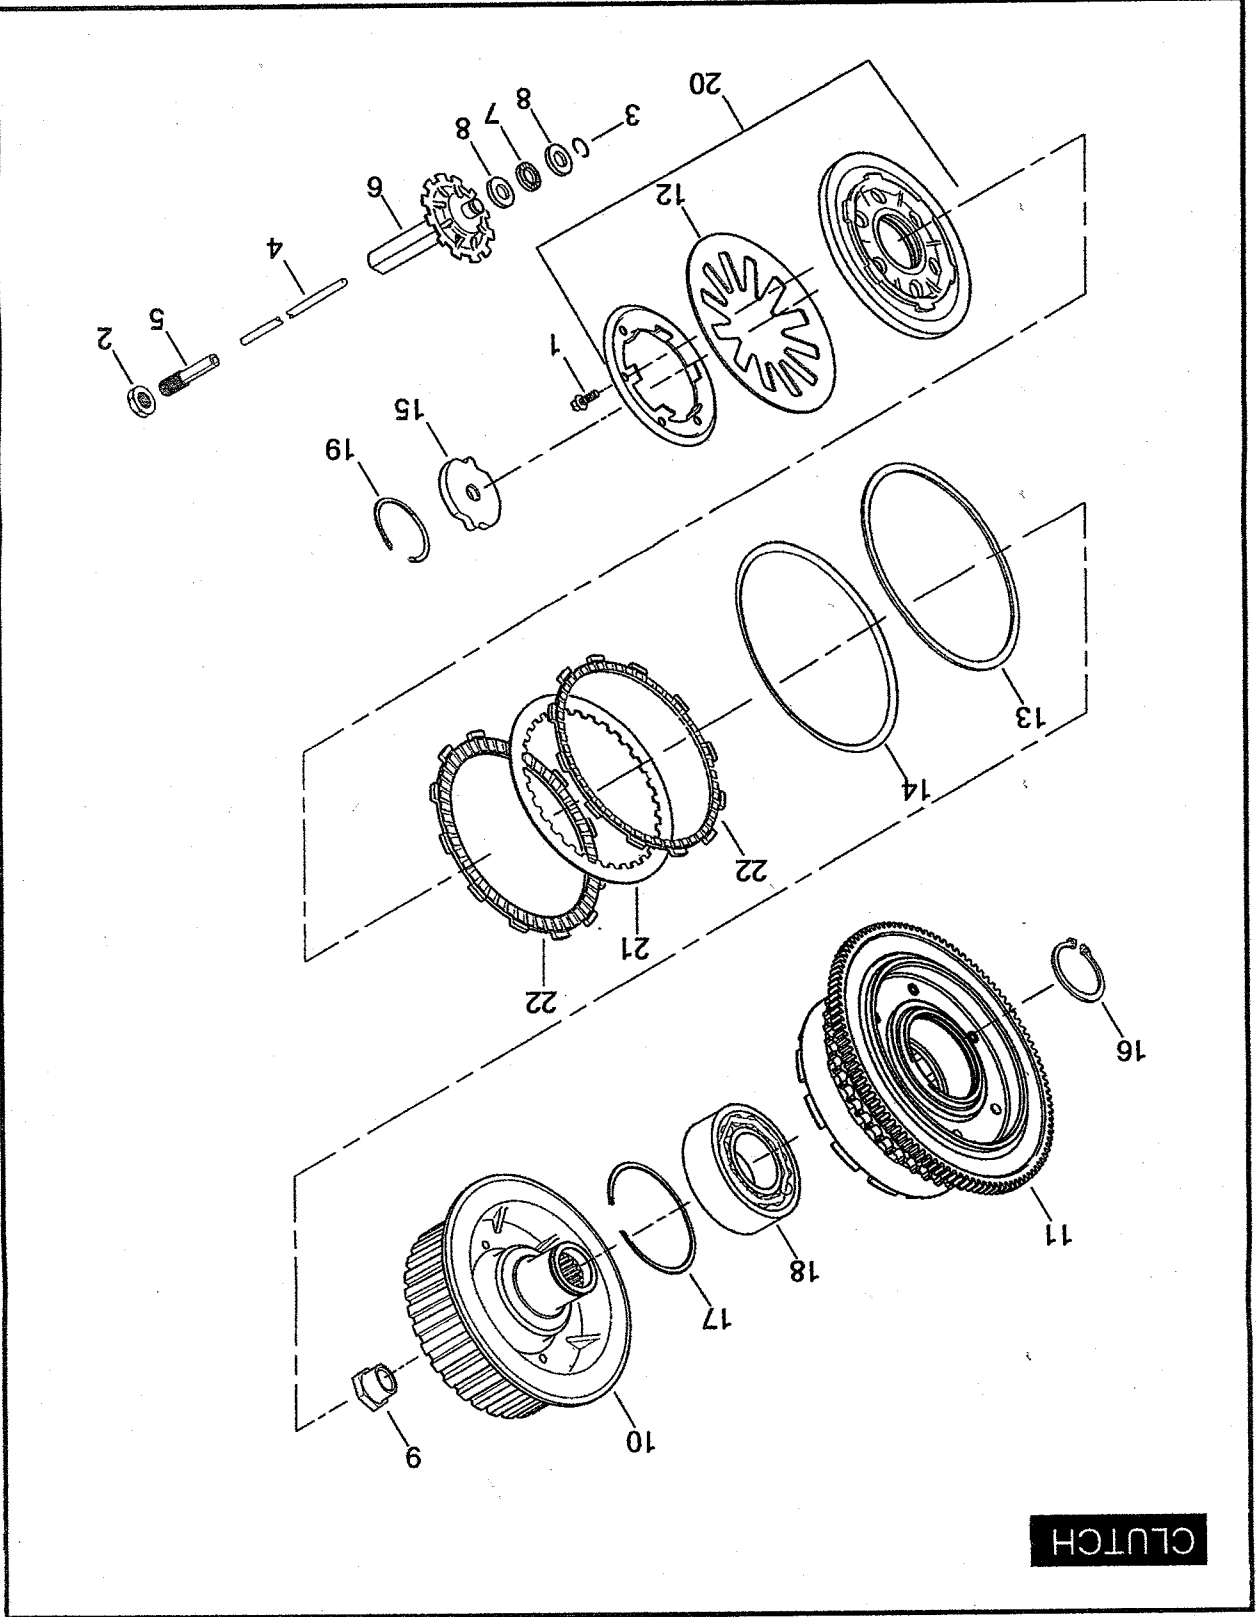
CLUTCH

Part # [redacted] Ref # 10 Hub Assembly Clutch was machined wrong by Harley-Davidson- AND cause my bearing and gears to fail causing loud noises at 75 mph. TRANS: was ready to lock up CAUSING a CRASH.

They one on my bike was machine wrong and they could not achieve the torque I have pictures of the part that is machined wrong causing trans to fail

Clutch Hub Part number 37554-06A should have a spacer (washer) as part of the Hub attached to it, this was missing and a new hub was installed. I believe this is a factory defect too.

Vegas Harley put a new Hub Assembly Clutch in and they could then achieve their torque they need

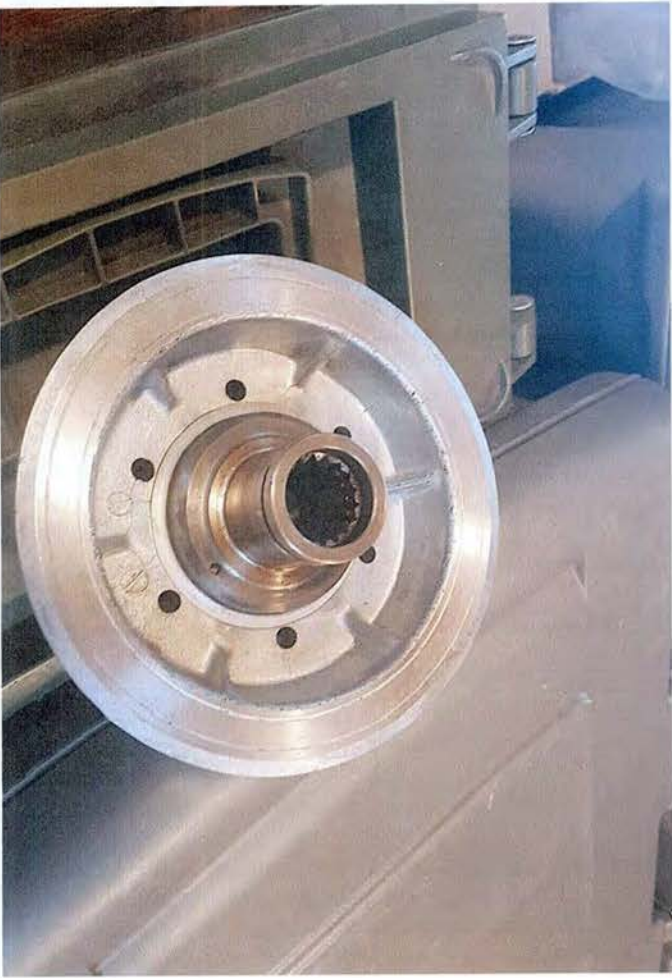
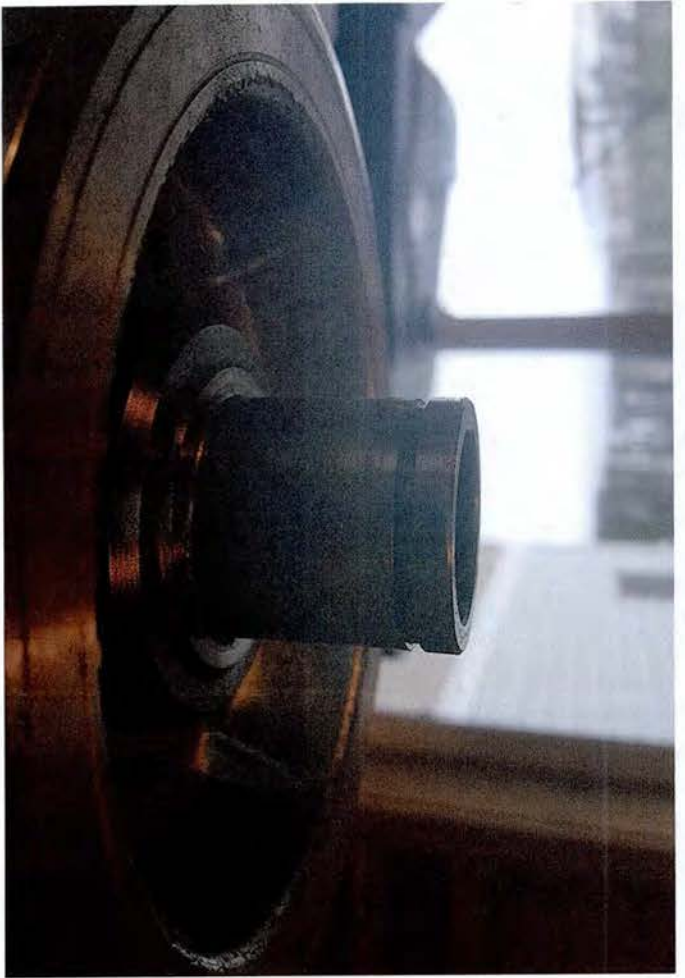
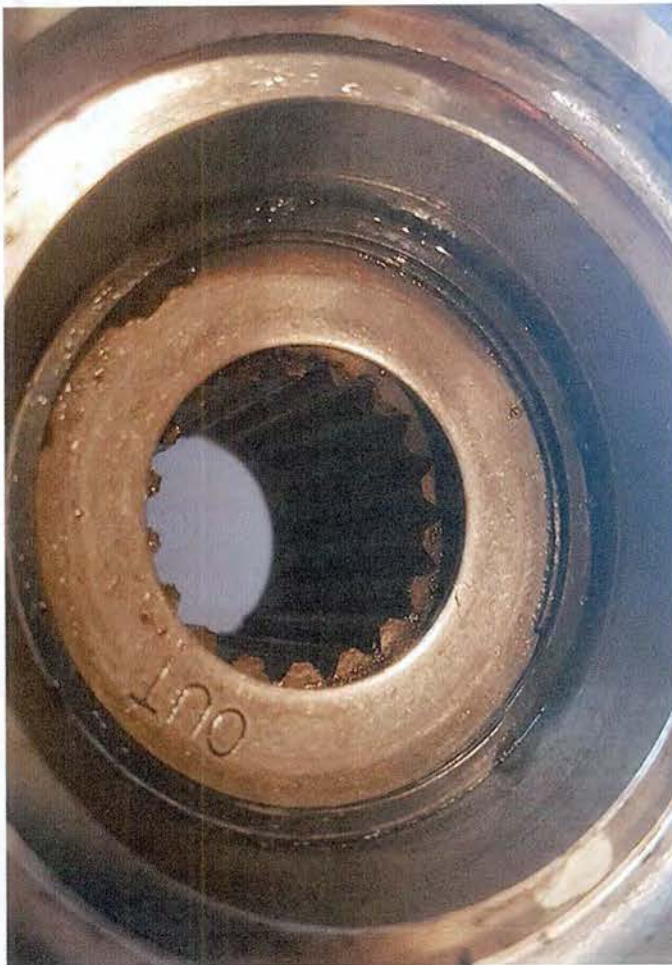
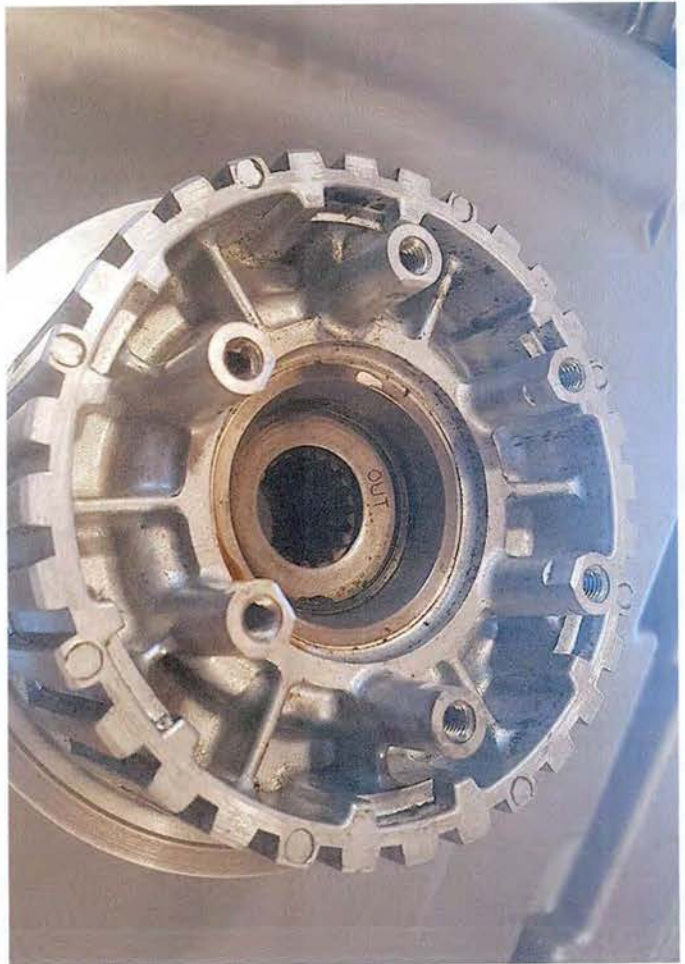
- 1.) 3 Dog could not torque the assembly to the right specs and had to add a washer.
- 2.) Vegas Harley-Davidson could not torque the assembly to the right specs without 3 Dogs washer.
- 3.) Vegas Harley-Davidson said I could just leave the washer in to obtain the right spec.
- 4.) Vegas Harley-Davidson said the out of spec hub is what caused my inner seal to fail.
- 5.) Per pictures of the original hub you can see original machining marks and stamp.
- 6.) The picture of my original hub does not look defective.
- 7.) The picture of my original hub shows no galling or mushrooming at each end.

That the cultch hub is missing an inner washer which looks like it has been missing from the factory defect. They told me they could put the same washer back for spacing Three Dogs installed. I told them to replace everything so it is right and back to factory spec.
