U.S. Department of Transportation National Highway Traffic Safety Administration		DOT Auto Safety Hotline Vehicle Owner's Questionnaire To Report Vehicle Safety Defects 1-888-DASH-2-DOT (1-888-327-4236) INTERNET: www.nhtsa.dot.gov/hotline		FOR AGENCY USE ONLY 100148 Date Received 17-MAR-2017 SEP 27 2017		Repository <input type="checkbox"/> Reference No. 10966456	
OWNER INFORMATION (Type or Print)							
Name		Address		Daytime Telephone Number		E-mail Address	
City		State		Zip Code		Evening Telephone Number	
HINESVILLE		GA		[REDACTED]		[REDACTED]	
The information you provide will be used to identify potential safety-related defects. We may share your information with the applicable vehicle manufacturer during an investigation or recall in accordance with the routine uses described in the agency's Privacy Act notice. See 49 FR 53971 (Sep. 3, 2004).							
VEHICLE INFORMATION							
17 digit Vehicle Identification Number Located at bottom of windshield on driver's side				Make		Model	Model Year

WBAXG5C56DD [REDACTED]				BMW		528I	2013
Date Purchased		Dealer's Name and Telephone Number				Engine:	Fuel Type:
6-1-15		Woody Edson Automotive (912) 375-0503				No: Cylinders	
Original Owner

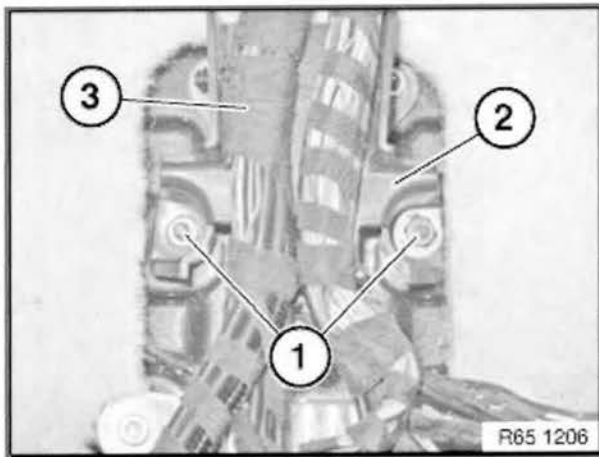
Unscrew nuts (1).

Remove holder (2) from centre console wiring harness (3).

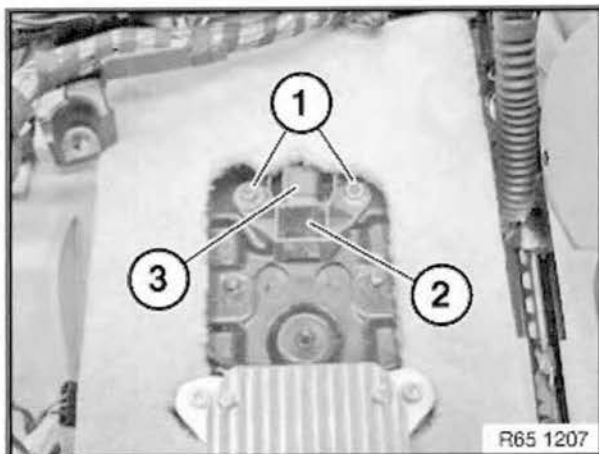
Unscrew nuts (1).

Tightening torque 65 77 5AZ.

Make sure sensor is mounted without play.
