**Re: status of NHTSA Safety Issue 11012912**

Manufacturer: Forest River, Coachmen

Model: Clipper 9.0 Express. Serial No. 2344

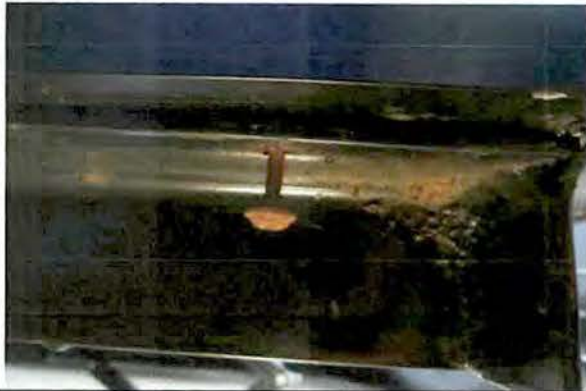
Following a 5-mile drive to our home along major highways it was noted that a small gauge wood screw at the front right corner, used to attach the upper body to the angle iron chassis, was only partially fastened. Further back two more screws were also not fully in place but to a lesser extent. It was also found that there were no screws across the front of the trailer although a series of holes had been provided for some in the chassis. By hand, the body could easily be lifted clearway from the chassis. **This hazardous condition of vibration so easily loosening from the body from the chassis during operation was promptly reported to the dealer.**

**Original Defect**

Early May, following contact with the manufacturer, the dealer replaced each small gauge Robertson screw with more substantial hex head stainless steel wood screws and also installed the same where fasteners had been omitted across the front. This seemed to be a logical fix. However, after several miles of travel over rough road works along North Dakota Highway 1804 east of Williston, the replacement chassis-to-body fastening screws also worked loose. In order to maintain adequate road worthiness needed to continue our journey, I removed all loose fasteners – the entire front row and behind these 3 down each side in front of the axle – then replaced them securely after jamming several hard wood slivers into each hole. The screws have since remained in place, but I consider this to be a band-aid solution and not one that all owners can be expected to be aware of or know how to perform during their own travels.

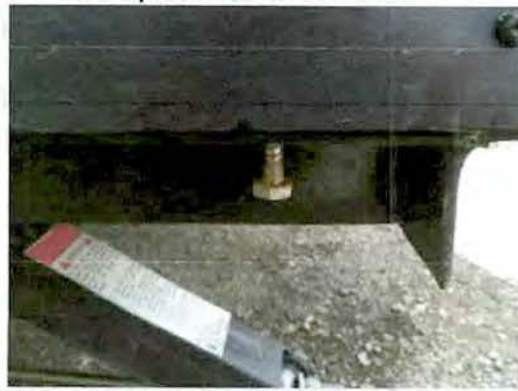
**Loose replacement screws**

This condition and temporary fix was reported to the dealer June 25, 2017 with the following recommendation: **these trailers need to be recalled and corrected sufficiently to satisfy highway safety codes.**
