| <b>DOT Auto Safety Hotline</b><br><b>Vehicle Owner's Questionnaire</b><br><b>To Report Vehicle Safety Defects</b><br><b>1-888-DASH-2-DOT</b><br><b>(1-888-327-4236)</b><br><b>INTERNET:www.nhtsa.dot.gov/hotline</b> | | | | FOR AGENCY USE ONLY 100148 | |
| 17 digit Vehicle Identification Number Located at bottom of windshield on driver's side<br>WB1053906A2 <b>[REDACTED]</b> | | Make<br>BMW | Model<br>K1300 GT | Model Year<br>2010 | |

I am in receipt of your questionnaire asking that I supply additional details regarding the unsafe and defective motor vehicle component I reported (Ref 11046596).

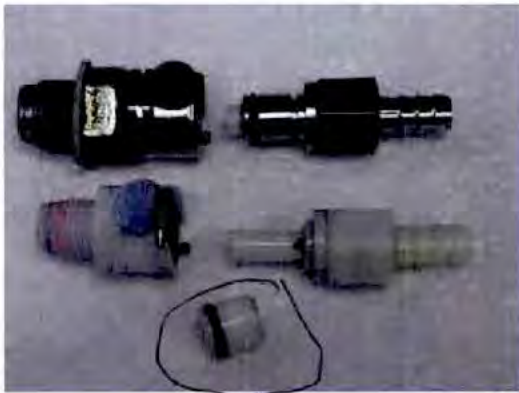
Upon analysis of the failure I learned that the plastic quick release connector that BMW uses to connect the fuel tank to the fuel line had broken and thus allowed fuel to pour from the gasoline tank. This is a problem that had previously happened to me on my 2003 BMW K1200GT motorcycle and I later learned that it is a problem that occurs to virtually every BMW motorcycle after they get to be a few years old and the plastic connectors get brittle and break off.

I am attaching a picture that shows a broken plastic fuel disconnect (see figure 1 of attached photos). Also shown is a metal aftermarket fuel disconnect sold by one of the dozens of firms that produce metal fuel disconnects made to replace the defective plastic connectors.

← Example of a new Metal  
AFTERMARKET Fuel  
Disconnect.

Broken  
piece

Picture of a Failed old  
plastic Fuel Disconnect (Figure 1)

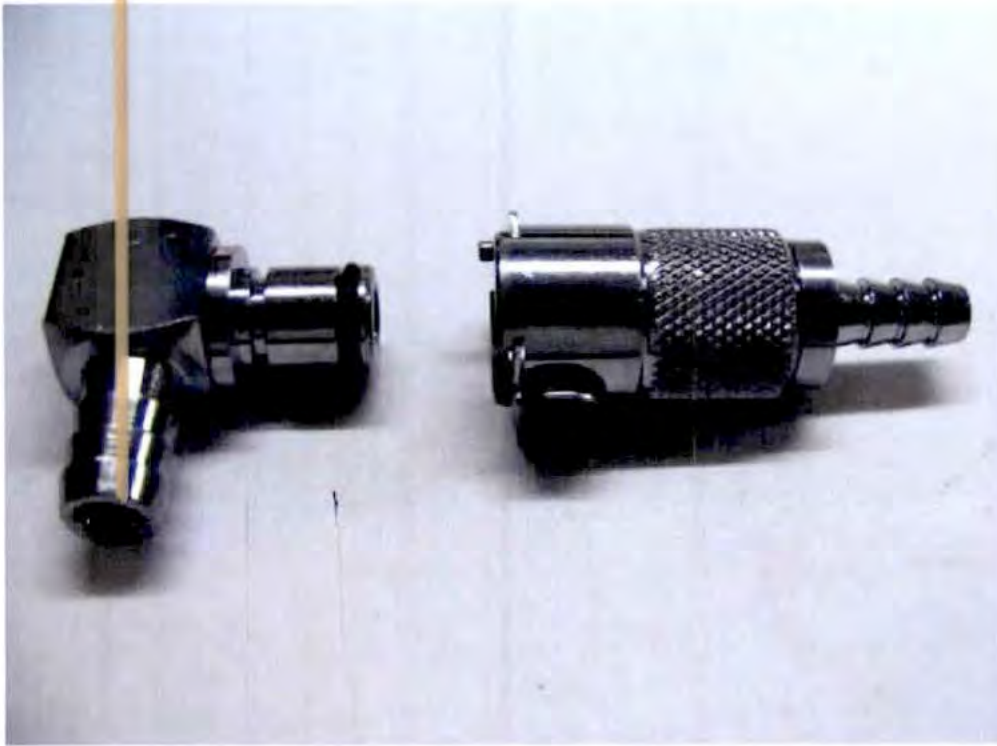
Example of AFTERMARKET METAL Fuel  
Disconnect Sold to Replace  
The hazardous, Defective, plastic  
OEM BMW Fuel Disconnects.

There are many aftermarket companies who make metal quick disconnect couplings so that people can replace the dangerous and defective OEM BMW plastic couplings. I spoke with my local BMW dealer and he told me that whenever someone brings their BMW into his shop for service he tries to convince them to have their deadly plastic fuel quick disconnects removed and replaced with after market metal connectors. It is clear that the BMW corporation has been aware that they are placing the lives of hundreds of thousands of their customers at risk yet BMW has made no effort to recall and replace the defective plastic disconnects.
