DOT Auto Safety Hotline
Vehicle Owner's Questionnaire
To Report Vehicle Safety Defects
1-888-DASH-2-DOT
(1-888-327-4236)
INTERNET: www.nhtsa.dot.gov/hotline

17 digit Vehicle Identification Number Located at bottom of windshield on driver's side: SUXFE435X8[REDACTED]
Make: BMW Model: X5 Model Year: 2008
Date Purchased: 8/23/16 Dealer's Name and Telephone Number: Excellence Auto Direct 214-584-6969 Engine: No: Cylinders: 6 Fuel Type: Premium
Original Owner: Dealer's City: Addison State: TX Zip Code: 75001
Transmission Type: Auto Antilock Brakes Cruise Control Powertrain: V6 3.0L AWD Multiple Failure: Failed engine Incident Date(s): 02-DEC-2017

Vehicle Component Code: 060000 ENGINE (PWS) Failure Mileage: 111778 Failure Speed: 60

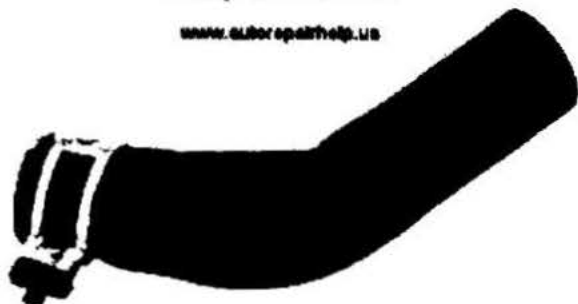
Collapsed PCV hose

Even original equipment hoses sometimes give problems. This is common on Ford and some Mazda vehicles. The hose chosen is not adequate for the task, and after miles of use, it will collapse.

When this occurs, flow to PCV valve system stops, and the hole in the supply hose may create a vacuum leak. Inspect all hoses in the PCV system and replace any that appear soft, swollen or collapsed.
