ISUZU

RODEO

2004

The centerpiece of this complaint is the repair that I had to incur for a severe safety matter. My mechanic completed repairs on July 6, 2017 to my **2004 Isuzu Rodeo**. My vehicle's problem was metal bracket-straps, bolts and a 1.5 x 3.5 foot horizontal jacket that together support the car's fuel tank. Much of it had rusted away, causing the tank to drop precariously below the car frame and at a particularly unsafe *acute angle*; this condition was very close to complete detachment which could have resulted in the fuel tank dragging along pavement if the car was in motion. Being undrivable as of early July 2017 it required immediate and careful correction which took two days and that cost me just over \$610. See Document A overleaf.

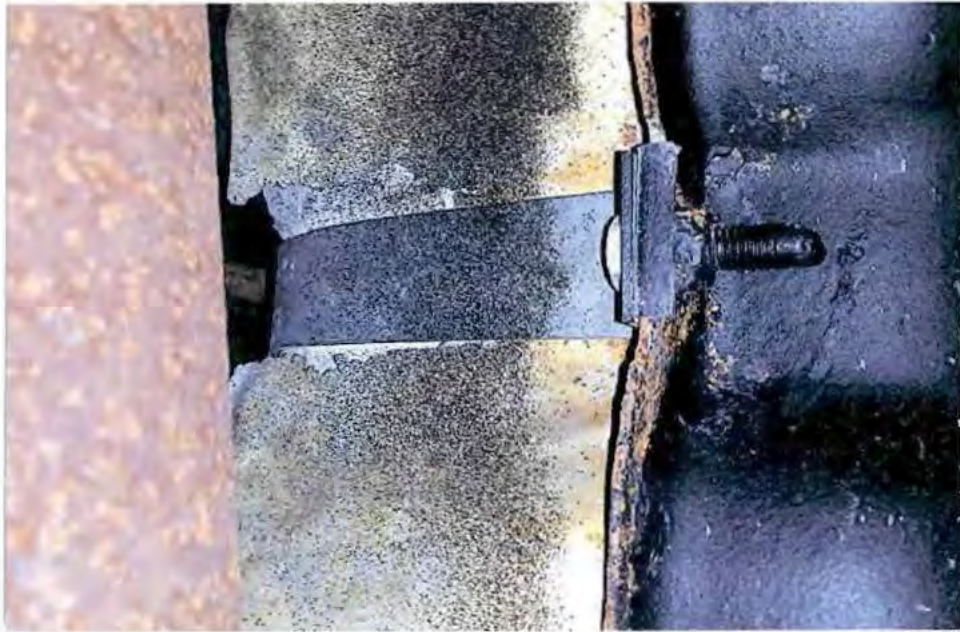
PHOTO II

\*Note that the mechanic's photos are included in order to clarify the actual locations of the *current* fuel tank metal jacket or saddle (photo 1) and its metal support strap with bolt (photo 2) to make all this understandable. The condition last July was the parts "rust-out" as described by the mechanic in his explanation letter but no photos of that were kept.

| Part Description / Number | Qty | Sale | Ext | Labor Description | Extended |
|---|---|---|---|---|---|
| Shop Supplies | | | 1.00 | KEVIN BYRNE BROUGHT HIS ISUZU RODEO IN TO CHECK A GAS TANK PROBLEM [FALLING OUT DUE TO RUST THAT ANOTHER SHOP HAD POINTED OUT]. WE FOUND THE SADDLE [PHOTO 1] SEVERELY RUSTED ALONG WITH THE FRONT STRAP DETACHED [PHOTO 2]. REAR STRAP BARELY HOLDING ON.<br>THE FRONT OF THE TANK HAD DROPPED ABOUT 5 TO 6 INCHES. THEY WERE NO NEW PARTS AVAILABLE THROUGH ISUZU OR ANY ONE ELSE. SO WE FOUND USED THROUGH LKQ [FOUND IN THE SOUTH WEST PART OF THE COUNTRY]. NOTE TANK WAS READY TO FALL COMPLETELY OUT AT ANY TIME. THE FRAME STILL IS IN GOOD CONDITION | 0.00 |
