CL-11103268-6552

I am writing to report a potential safety defect affecting my 2012 Triumph Tiger 800 motorcycle, VIN SMTE05BFXCJ [REDACTED] which I discovered on May 13, 2018, and diagnosed on June 2, 2018. This is a motorcycle with about 34,000 miles service time, with all maintenance done substantially according to the manufacturer's schedule and with no history of serious mechanical difficulty.

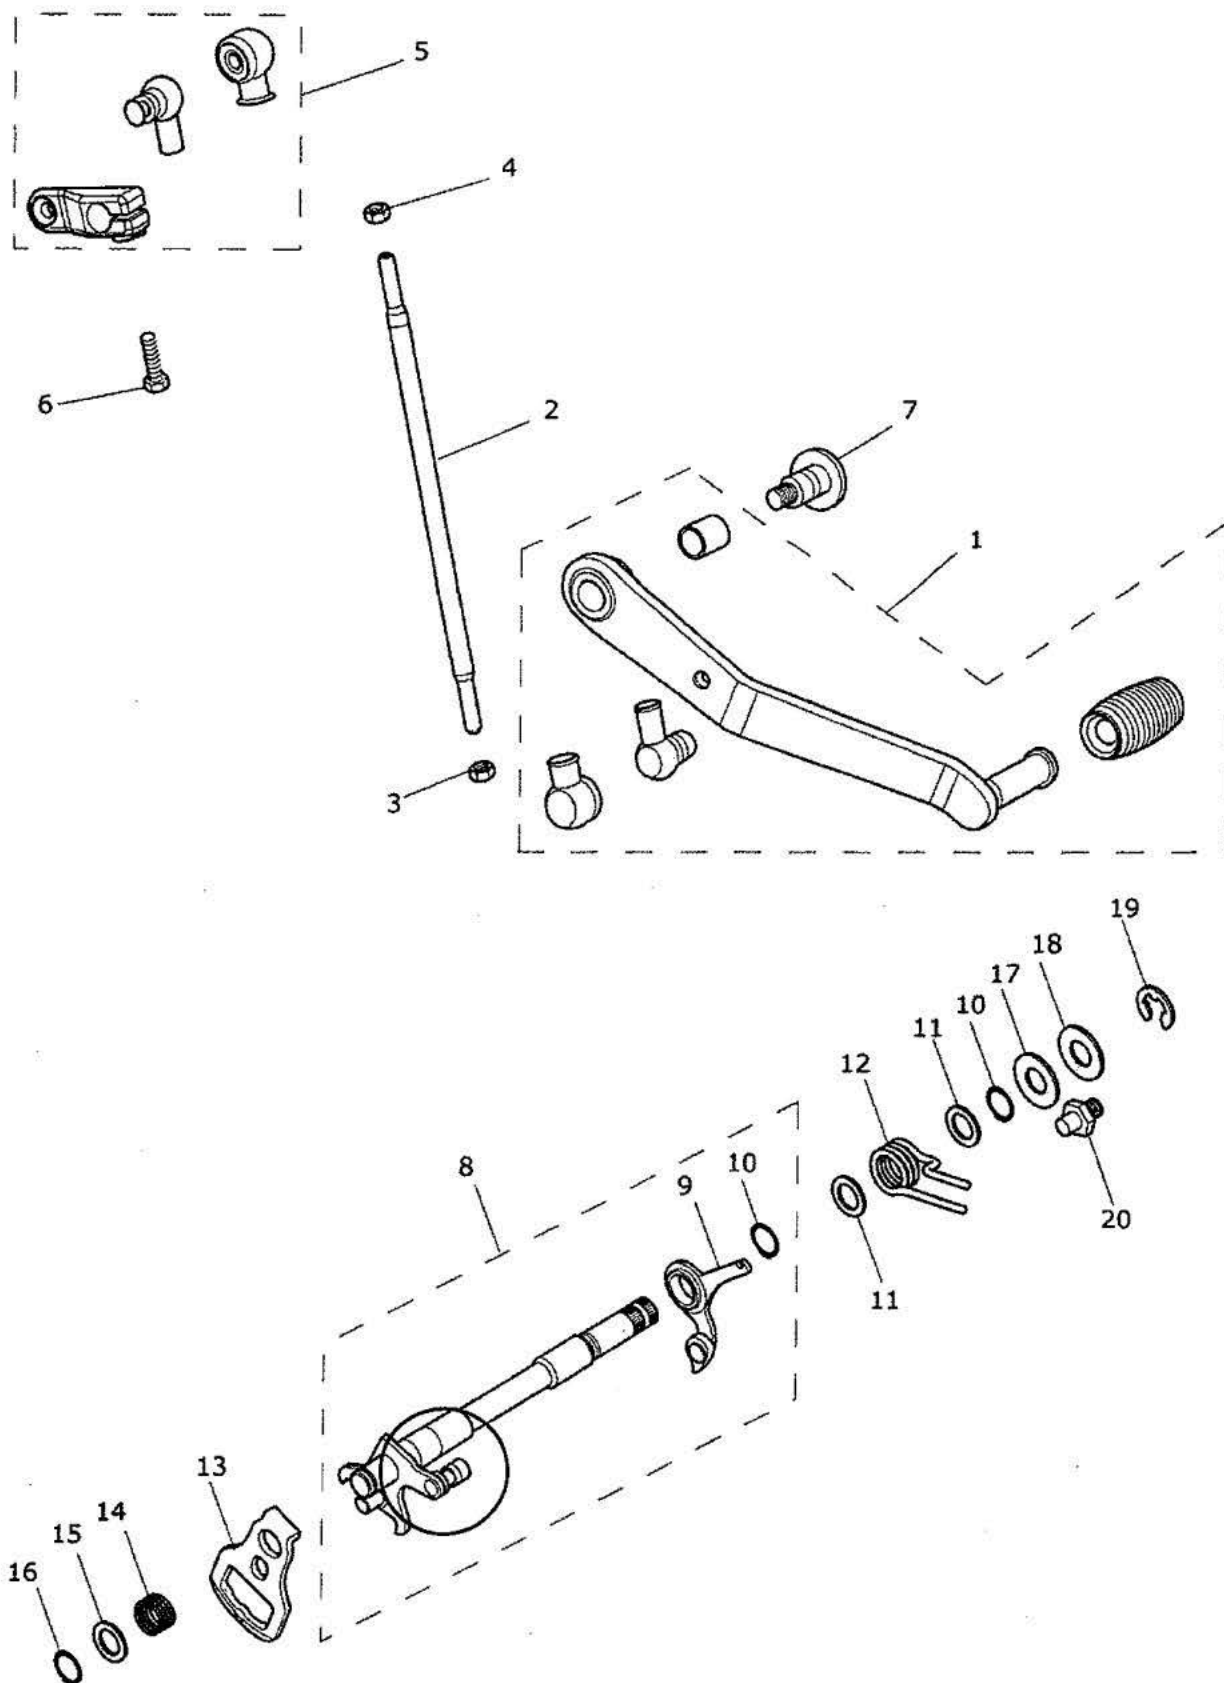
This defect concerns the transmission's gear change mechanism. I had been riding this motorcycle normally when the gearshift pedal dropped out of its normal resting position and to the bottom of its stroke. On inspection, I found that the lever moved freely between the downshift and upshift positions, rather than centering itself mid-stroke as normal. Disassembly of the mechanism revealed that the pin that normally connects the gear shifting shaft to its return spring had sheared at its attachment point to the crank, and was trapped between the ends of the return spring. This released the shaft from the return spring, allowing the pedal to fall to the bottom of its travel. The affected parts are circled on the enclosed copy of Triumph's assembly diagram.

The surface of the fracture is generally flat and level with the surface of the pin's crank, with a single raised ridge along its center. This ridge is radial to the shaft. There are no obvious signs of fatigue on the fracture surface, although I'm not able to do a very detailed inspection, nor to take useful photographs of the parts. However, under hand magnification, there appears to be a fine crack originating from inside the crank and extending irregularly out to the fracture. This crack is on the side of the pin that would bear on the return spring in the counterclockwise direction, looking from the clutch side of the engine.

I suspect that the way in which this part is assembled by the factory is responsible for its failure. It appears that the pin is put into its hole in the crank and then flared with a cone-shaped tool to secure it, in much the same way as the master link in the drive chain is riveted during installation. My suspicion is that the pin was flared too far for its diameter and the thickness of the crank, weakening the joint and making it prone to cracking. If this is the case, then I would expect the problem to repeat. In fact, there have been a number of anecdotes online about this very problem; see, for example, <https://www.tiger800.co.uk/index.php/topic.9167.70.html>.
