I am writing to create an awareness of possible safety defects in design and/or construction of a MOTORHOME (also called an "RV" for brevity).

2017 Fleetwood Pace Arrow  
Model 33D  
VIN 4UZAAJDT9HC [REDACTED]  
Purchased NEW, April 2017 from a local authorized dealer

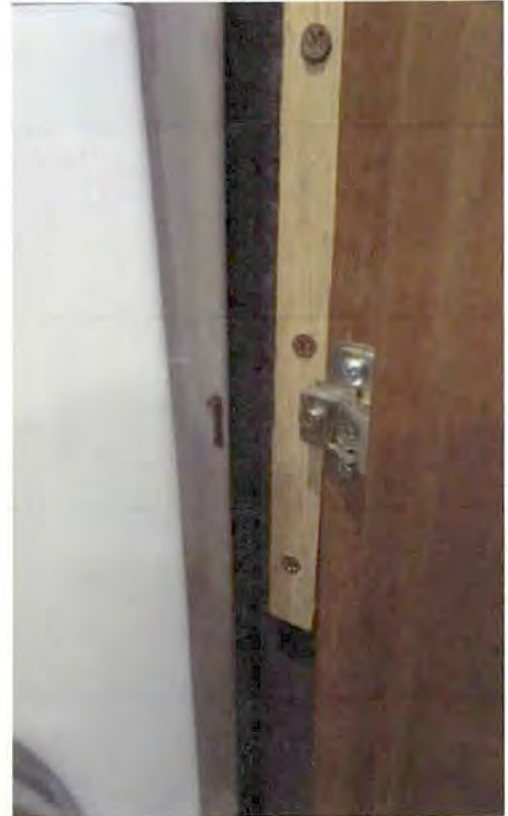
WD-1

After a short (100 mile) shake-down "cruise" I observed the WD had shifted in this closet and was scraping against one of the hinges of the louvered door of the wardrobe closet. Please see photo WD-1. Not being as aware as I am now of the possible implications, I simply shoved it

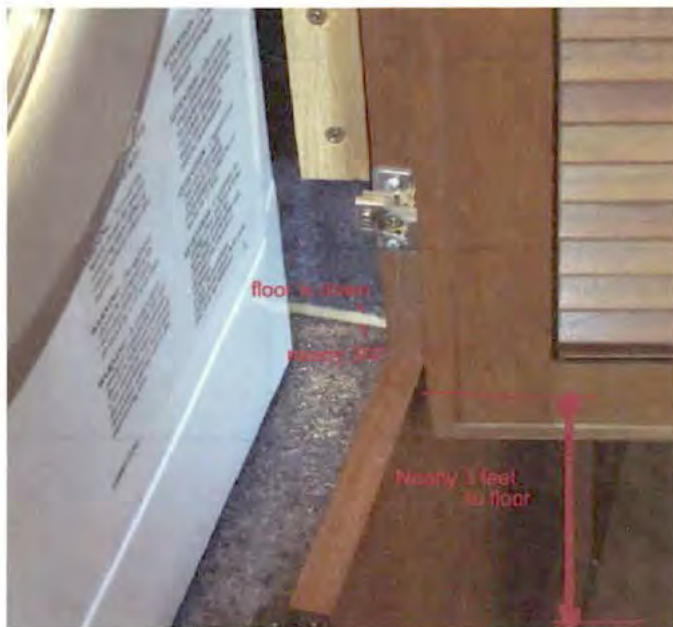
back and installed 3 small blocker boards to prevent the WD from striking the door hinge and further cracking the door frame. See photo WD-2

Further driving resulted in the WD resting firmly against the block-boards I had installed. This caused me to look for the restraint straps and determine why they were not doing their job. **RESTRAINT STRAPS COULD NOT BE FOUND. THERE ARE NO RESTRAINT STRAPS.** We have a situation of a heavy (145#), tall, WD unit sitting on the floor of a wardrobe cabinet (designed for clothing), free to roam around.

Later investigation showed that the floor of the wardrobe was collapsing under the moveable weight of the WD. Please see photo WD-2 again. The right front corner of the floor is down ½ - ¾ inch from where it should be. Pushing lightly toward the top of the WD caused the floor to drop more and less. After several e-mail discussions with Mr. David Matzenger, Dispute Resolution Administrator, REV Group (parent of Fleetwood), I was able to convince Fleetwood to authorize the dealer to remove the WD. I was compensated for the cost of the WD. We never used the WD. Fortunately, we never ran water into the unit.

It is my belief that in the event of a sudden stop (worse yet, an accident) the WD could depart the wardrobe cabinet (over 2 feet above the floor of the RV), tumble down the center aisle causing significant property damage and possibly injuring an occupant.

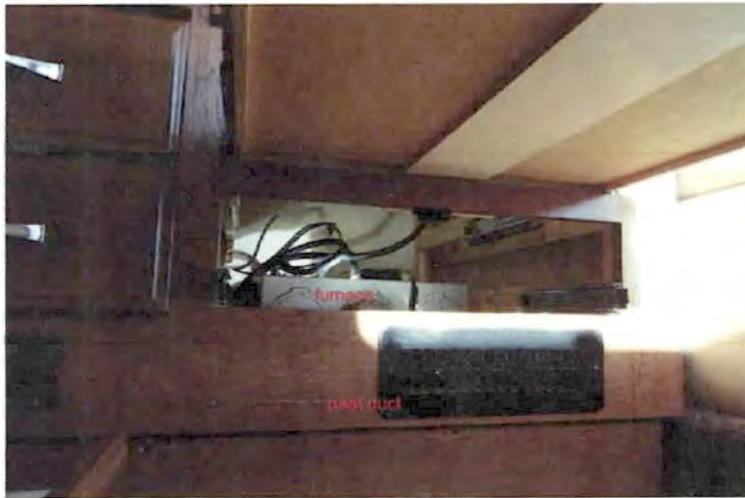
GL-1

I removed one of the kitchen drawers in an attempt to locate the entry point for the mice we were finding (or indications that mice had been there) in the RV. At the back of the drawer I observed the 2 LP gas lines – one going to the kitchen furnace, the other to the stove. I was a little surprised at the mess behind this drawer. Please see photo GL-1. A wide-view is shown here to give a sense of location.

I was able to convince Mr. Matzenger to authorize the dealer service department to fasten the gas lines to structure at the back of the drawer.

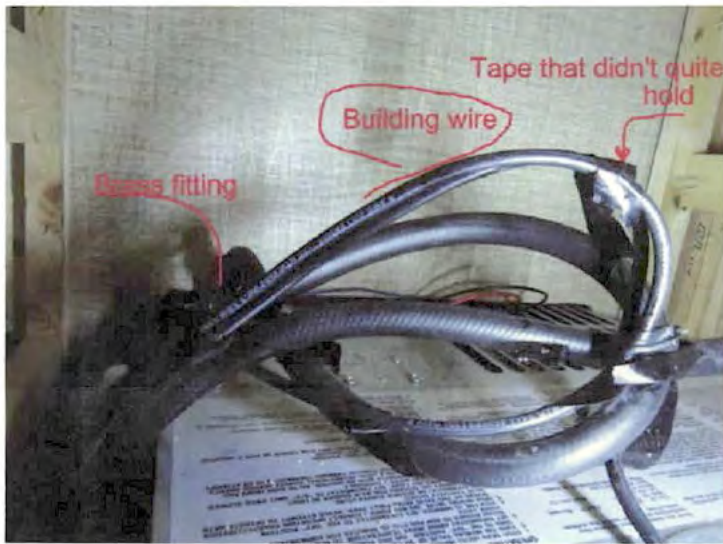
Photo GL-2 gives a closer look at the routing of the LP gas lines just above the furnace and the associated bundle of spare gas line and building wire. Photo GL-3 gives a view of the gas line bundle resting on the gas line and brass compression fitting as it enters the furnace. My first concern is for the line terminating at the brass compression fitting of the furnace. The "bundle" of surplus gas line bounces up and down perhaps hundreds of times per mile. **THE BUNDLE IS NOT SUPPORTED IN ANY WAY** (other than by resting on the portion of gas

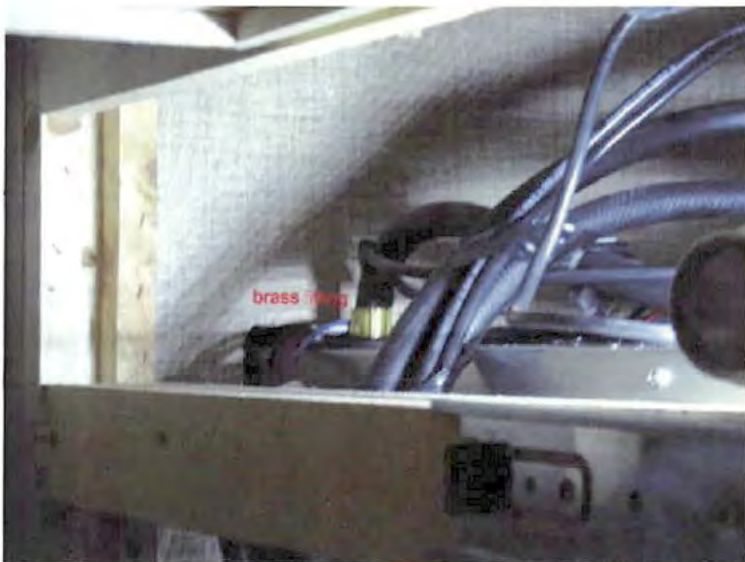
GL-3

line at the brass fitting). While the rubber gas line may be flexible, it may be fairly vulnerable at the edge of the sharp brass compression fitting.

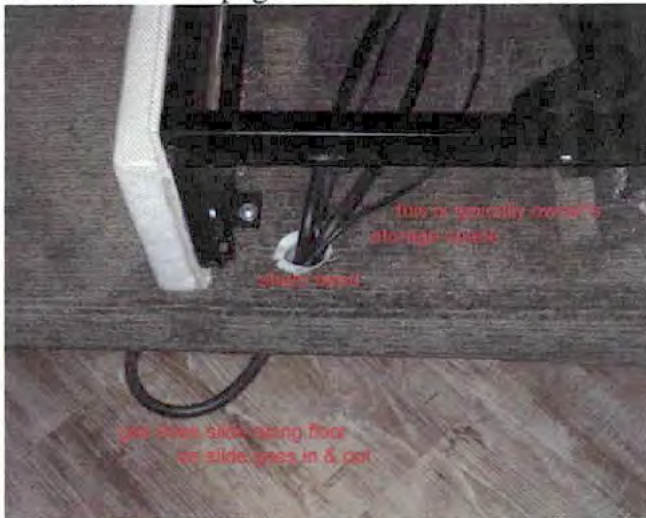
My feelings are that LP gas lines should not pass through an owner's storage space, especially when the gas lines make sharp bends at entry and exit. I also question allowing the LP gas lines to drag across the fixed floor of the RV as the slide is moved in and out. Again, photos GL-4 and GL-6.

My concern is these lines could be vulnerable to pinching and chafing. As with the WD, there is some reason to believe there may be many other Fleetwood Pace Arrow RVs with a similar routing of LP gas lines.

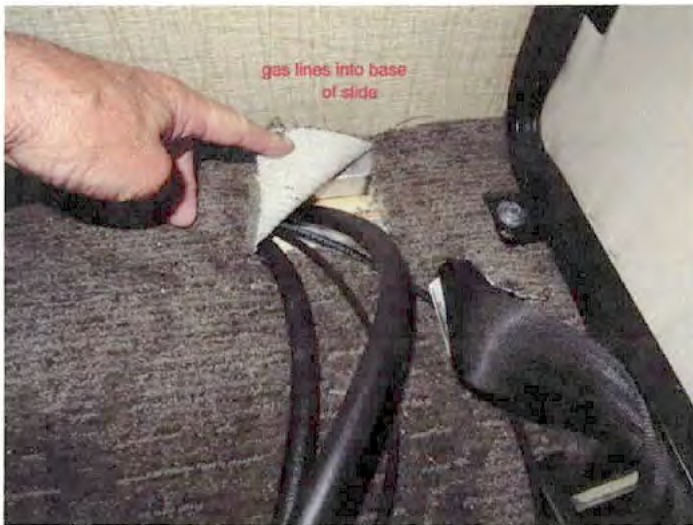
GL-5

The LP gas lines then travel the width of the storage compartment (owner's space) and exit where they appear to pass within the base of the slide to finally terminate at the kitchen furnace and stove. At the exit point, the LP gas lines make a 90 degree bend and head to the back. See photo GL-5. A wide-view photo is shown in GL-6.

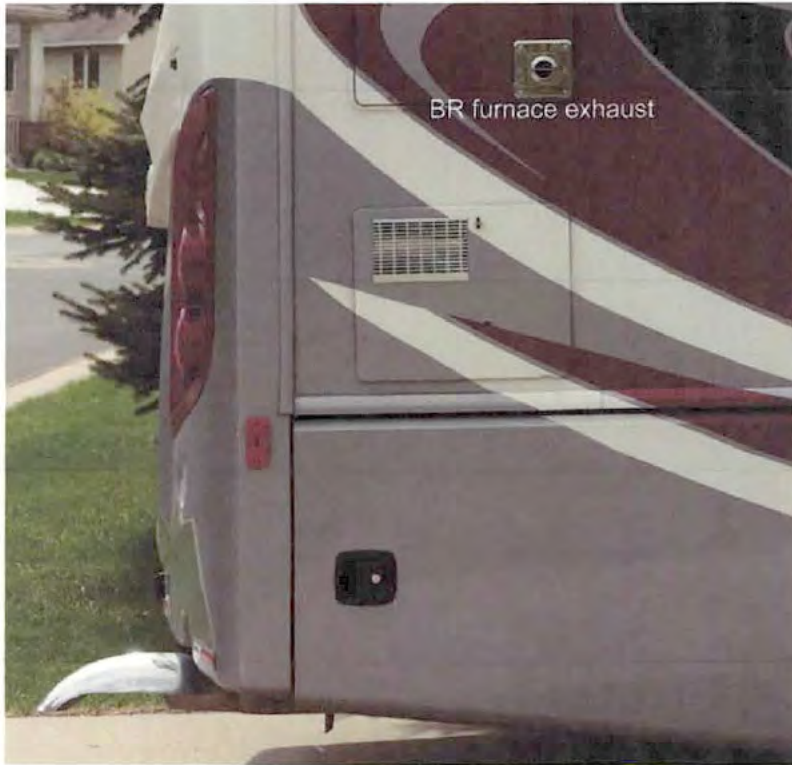
The furnace exhaust for the bedroom furnace on the 33D is located toward the rear and on the passenger side. The diesel exhaust is located at the back of the RV on the same passenger side.

I believe a valid analysis is as follows. The engine exhaust pipe is fairly close to the exhaust exit (entry) port of the bedroom furnace. Unless the RV is moving forward, or unless there is a breeze from the direction of the front, or unless the furnace is operating (unlikely during prep for departing), exhaust gas can be present near the furnace outside port. With roof vents open, there can be a chimney effect allowing exhaust gas to be pulled into the bedroom. Remember, the airflow for the combustion chamber of this simple furnace is bi-directional when the furnace isn't running. I was later able to prove this using a Halloween smoke generator. Photo E-1 shows the relative positions of the engine and furnace exhaust stacks. I have added lettering. The original untouched digital photo is available.
