From: [Wells, T. Cynthia CTR \(NHTSA\)](#)
To: [Fogle, Brenda CTR \(NHTSA\)](#)
Subject: FW: A Consumer's Question/VOQ #11113666 G6
Date: Monday, September 17, 2018 7:50:20 AM
Attachments: [SB477_EN_Indicator_stems_Tiger_800.pdf](#)
[image003.png](#)
[image004.png](#)

Service Bulletin 477
Strictly Confidential
February 2013

Affected Models **Tiger 800, Tiger 800 ABS, Tiger 800XC and Tiger 800XC ABS**

Subject **Indicator Stems (all except models fitted with LED indicators)**

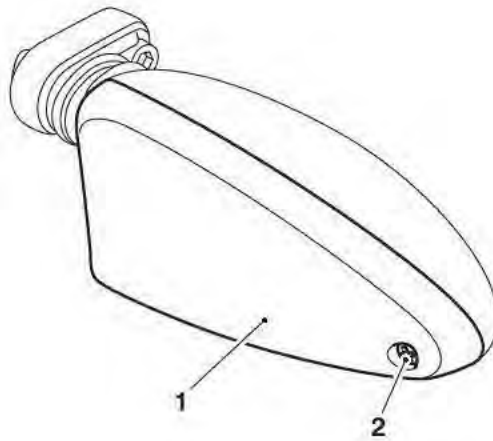
- **To access the fixing for the rear indicator stems it is necessary to remove the rear rack.**
3. Remove the rear rack as described in the service manual.
 4. Release the indicator lens cover fixing and detach the indicator lens from the indicator housing.

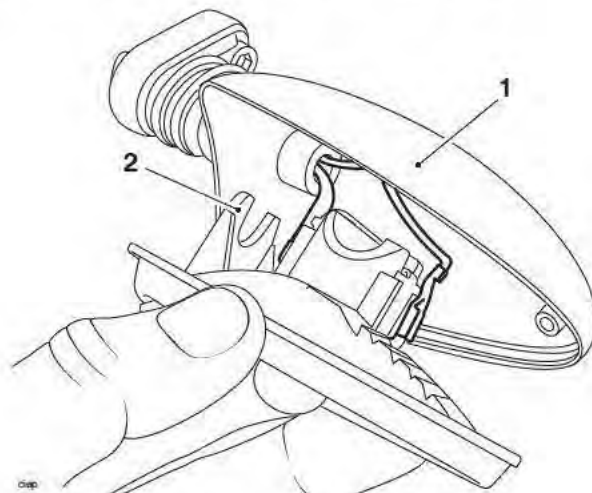
5. Pull the reflector away from the indicator housing to release the clip.

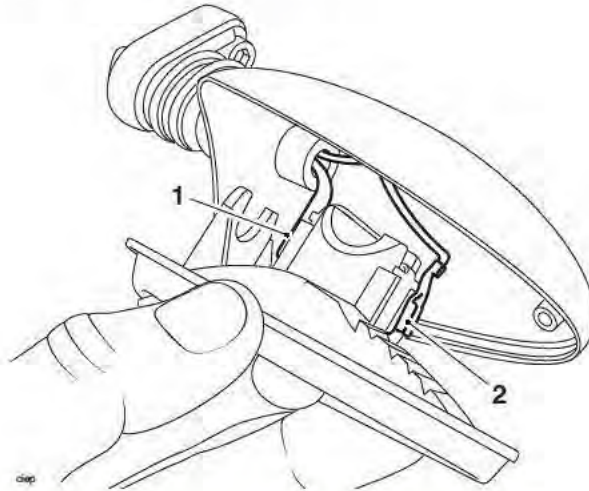
6. Release the wires making a note of their orientation.

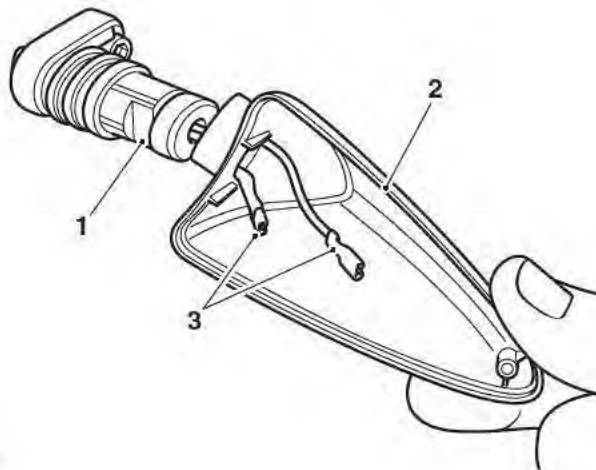
7. Release the indicator housing from the indicator stem, taking care not to damage the electrical connectors.

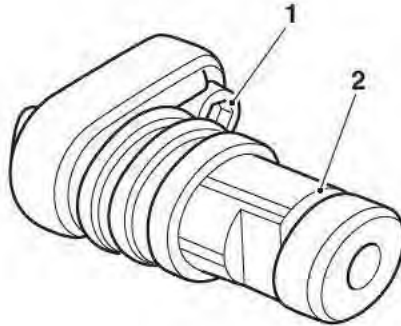
- Undo and remove the fixing and remove the indicator stem from the motorcycle.
