Reference #: 11206504.

2014-mercedes-benz C350W - Column Mounted - Controls

PHOTOGRAPHS - SERIES 3:

INTERIOR OF MERCEDES-BENZ C300W - 2019-MODEL-YEAR.

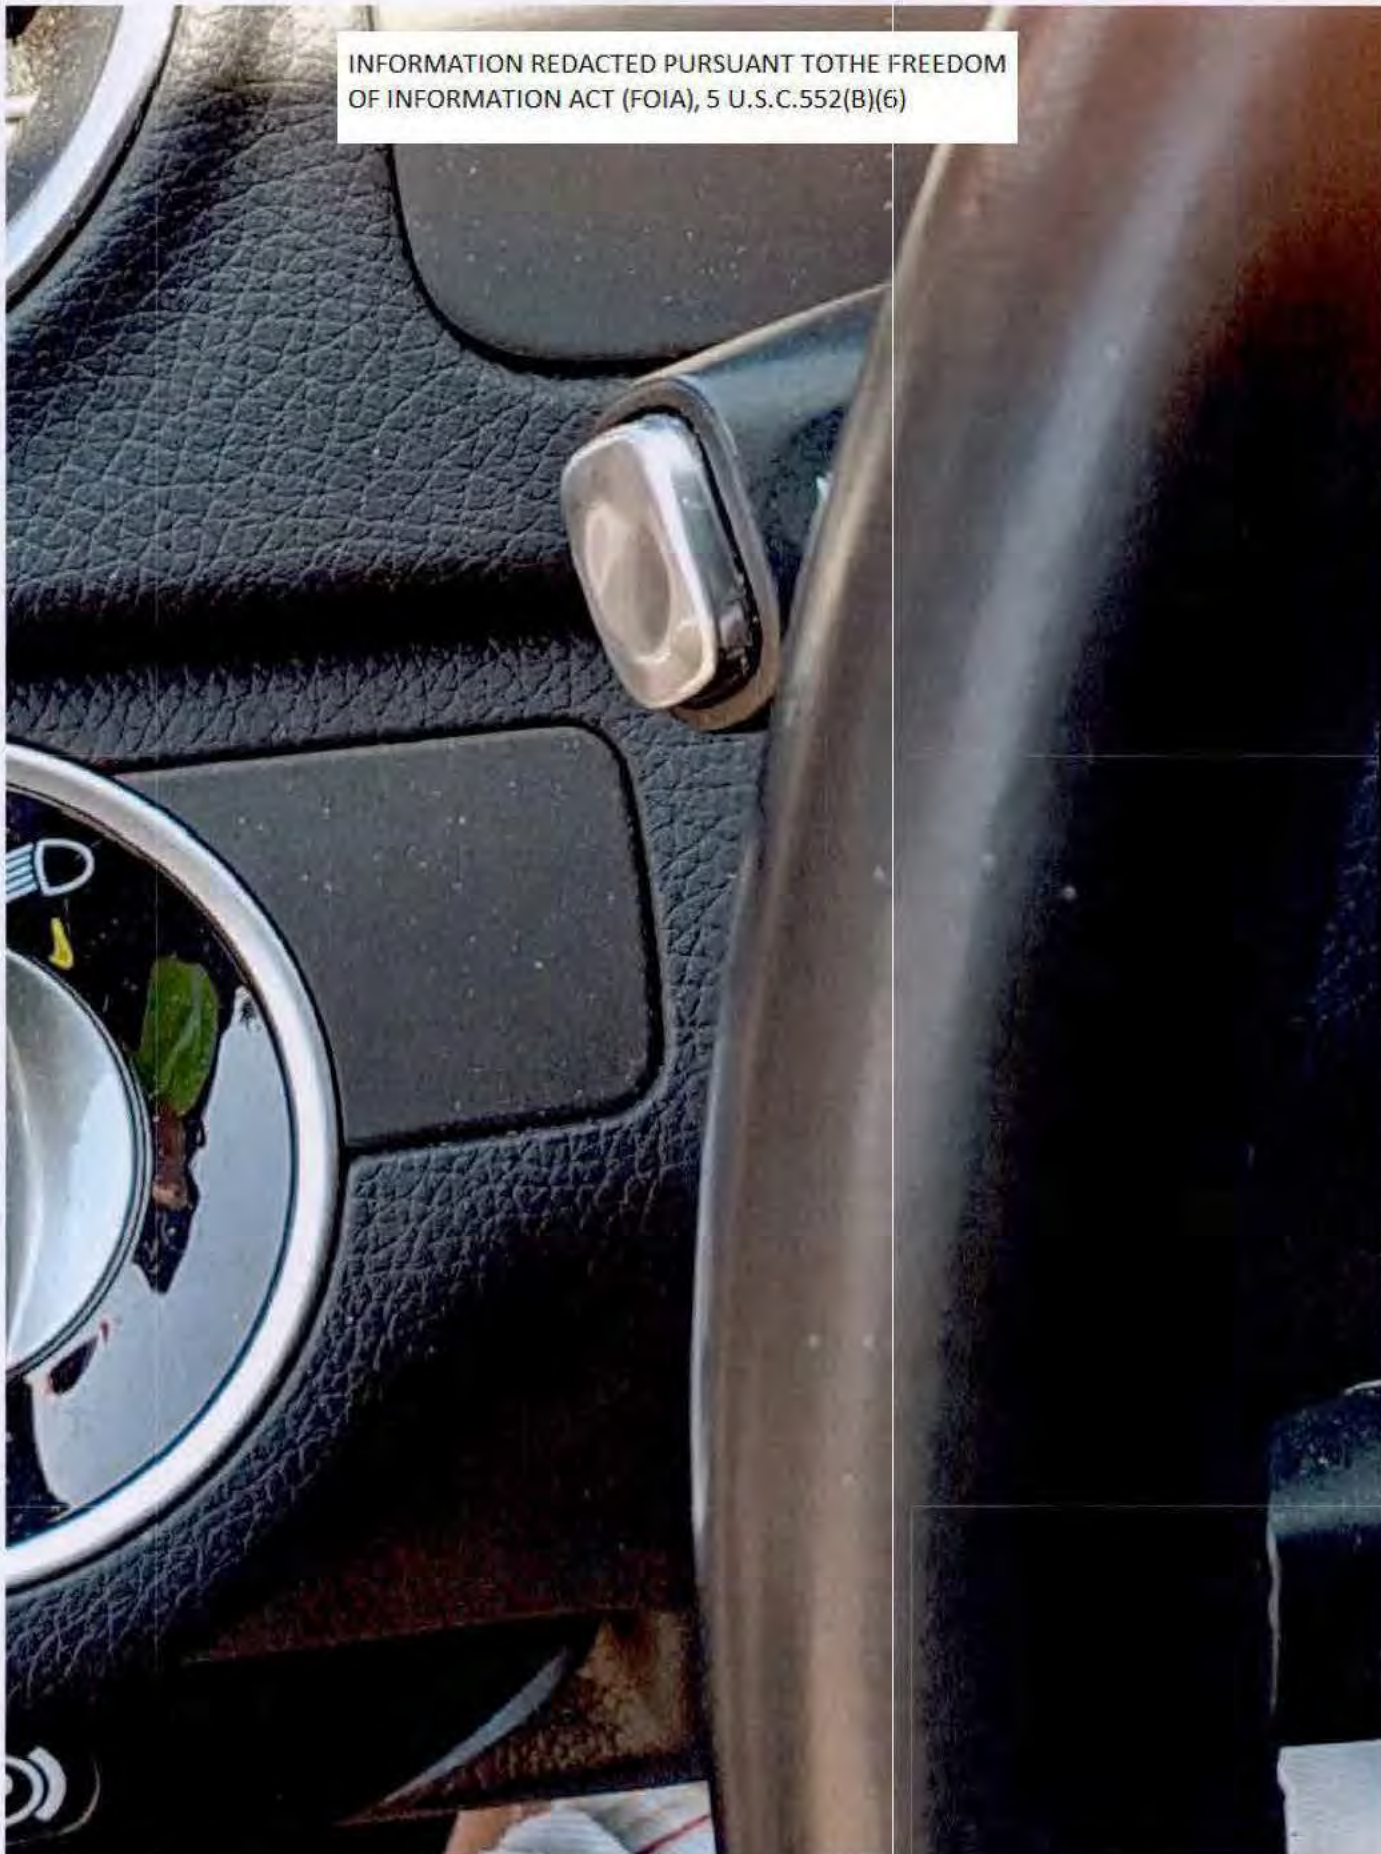
close-up - steering wheel, & Directional Signal.

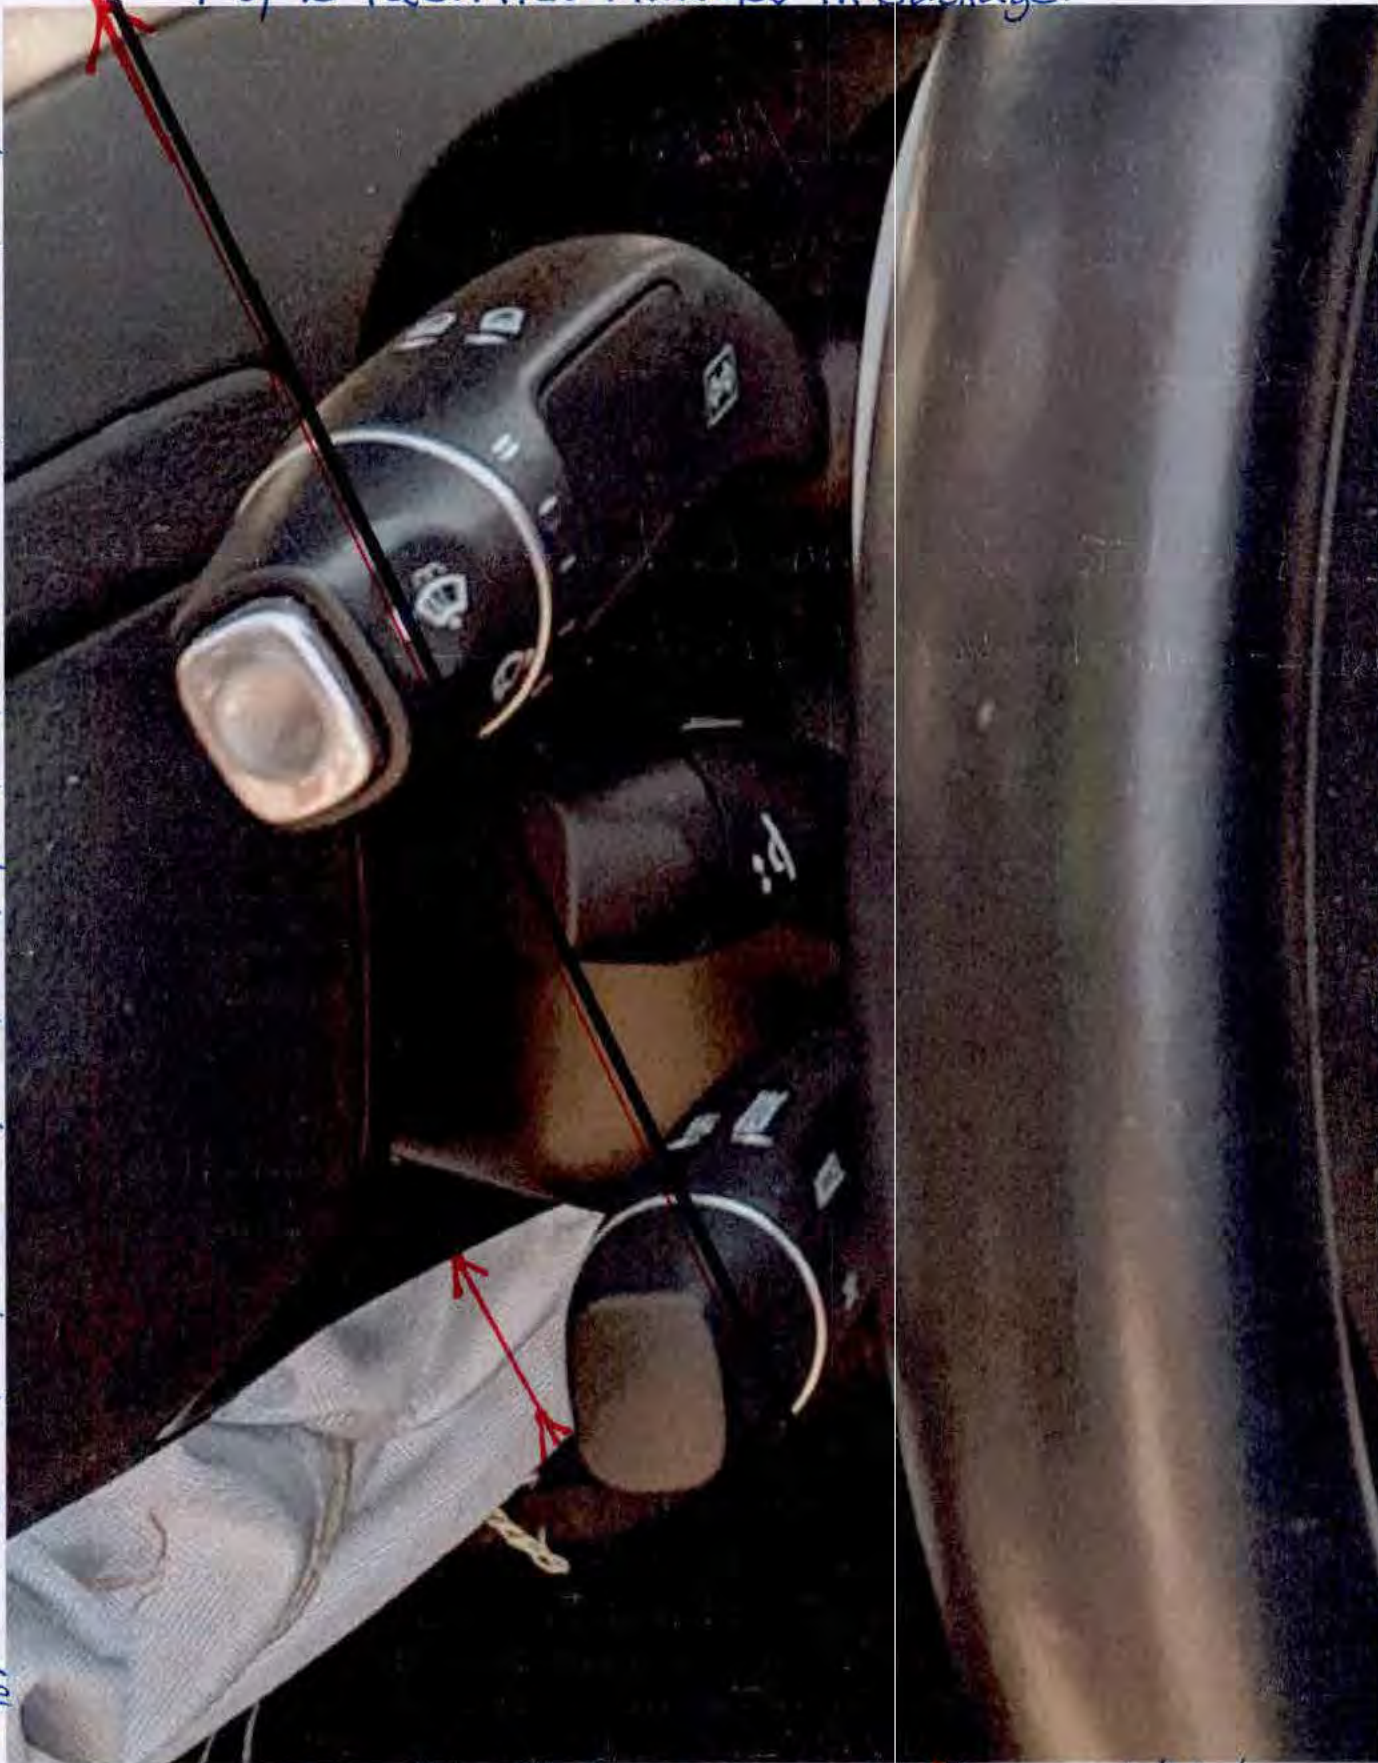
POST-CRASH Photo - Actual vector is a partial ellipse, a short arc, which must be carefully selected to avoid accidental activation

A straight vector line showing 1-potential travel-vector to activate controls: 1st Cruise- Control, and 2nd Directional Signals. #

Actual Direction of Left-hand travel

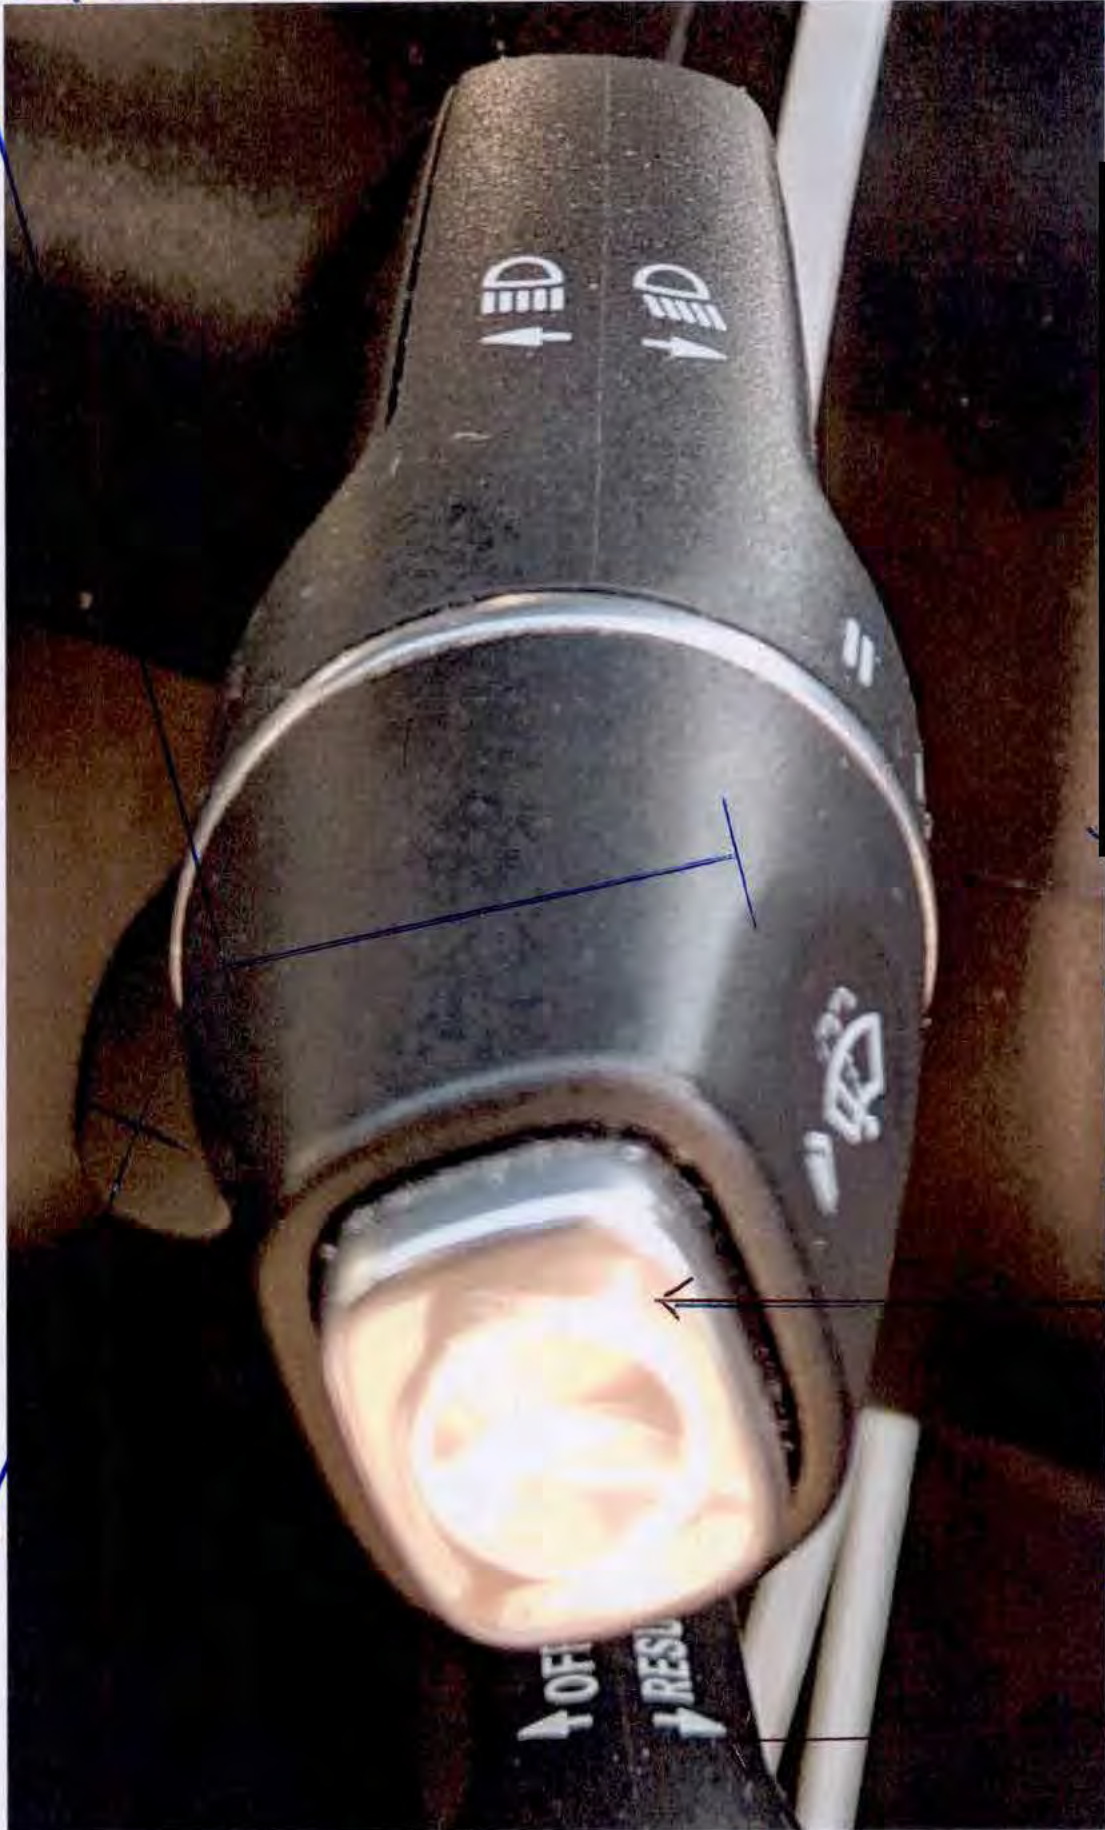
SHOWS 2 LEVERS, ONE AT TOP THE OTHER.

Activation Direction for -

Both Cruise Control and Directional signals  
"Accel" position and "right-turn, respectively.

Cruise Control lever

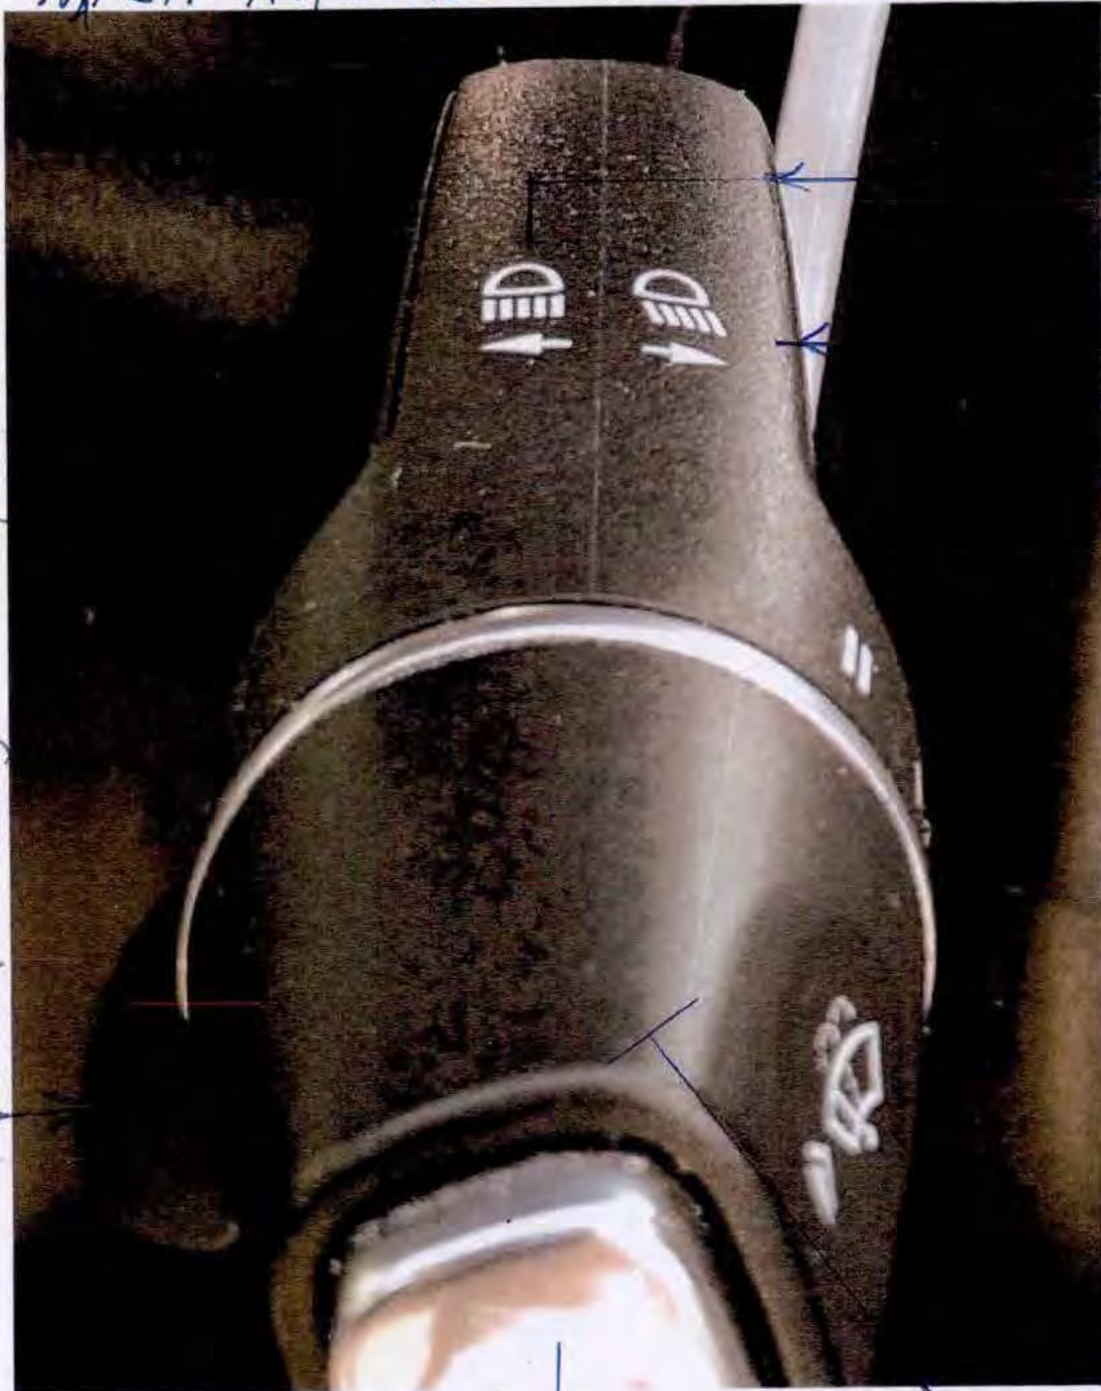
Marked as an in and out motion, instead activated in an up and down motion for apparently, high & low beams. This lever also activates windshield squirter by pushing inwards on the chrome button; also the wiper blades for the windshield, with a twisting motion of the end of the black plastic Knob. It can have 3 different positions of wiper speeds, plus intermittent speeds, and, "off."

Blow-up) Cruise-Control lever: Mostly Hidden, in this mostly-above-the-levers spot.

Pushing this button is required for deployment. TWISTING This Knob is required for deployment.

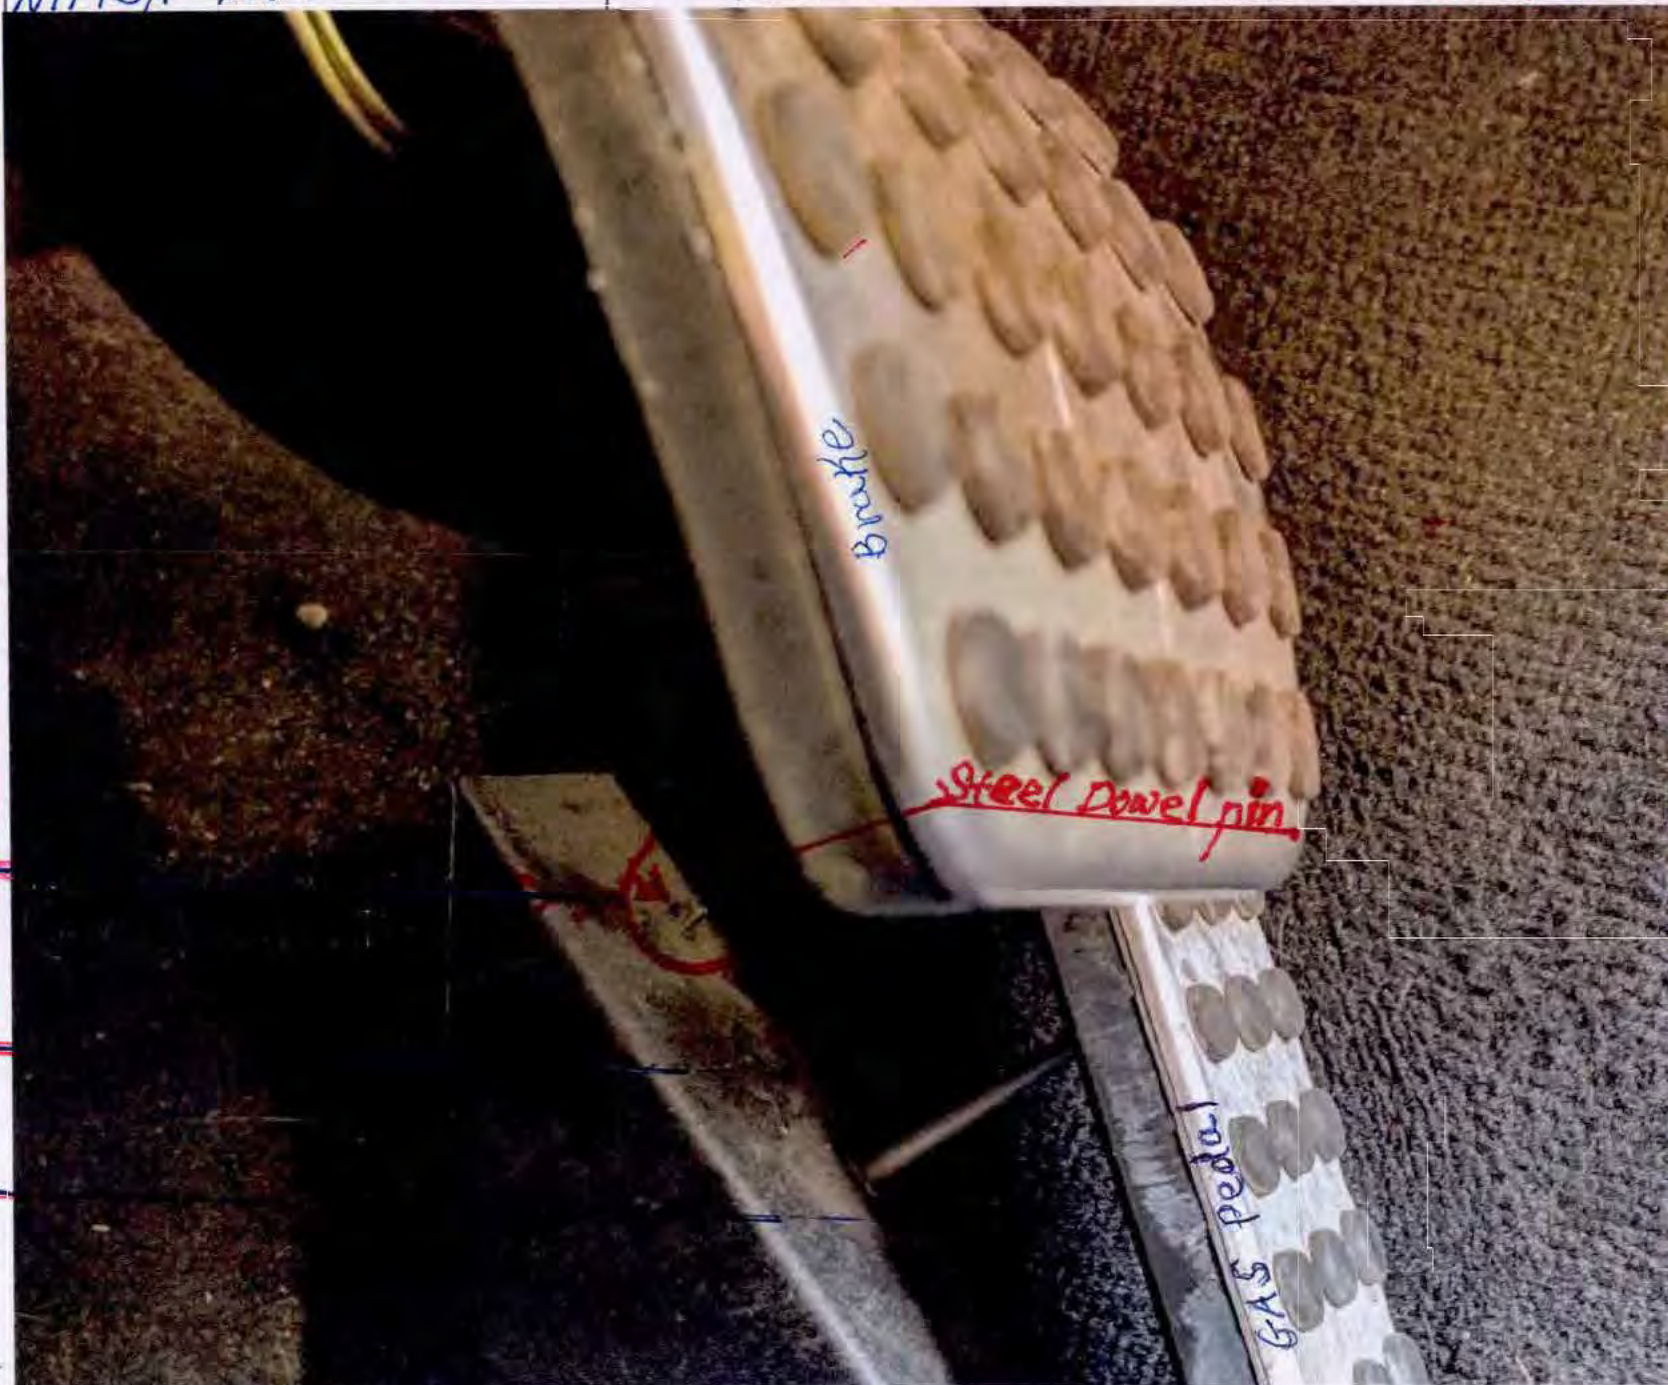
Recent Disturbance of Accumulated dust !! (Page 1 of 4)

DISTURBANCE OF ACCUMULATION OF DUST

that foot pinned by accelerator pedal.

DUST -> Demonstrates

"Red" is actually called, "steel - Dowel-pin."

Blow-Up of E350W Brake and Pedal Assembly; Note 2 small rods visible.

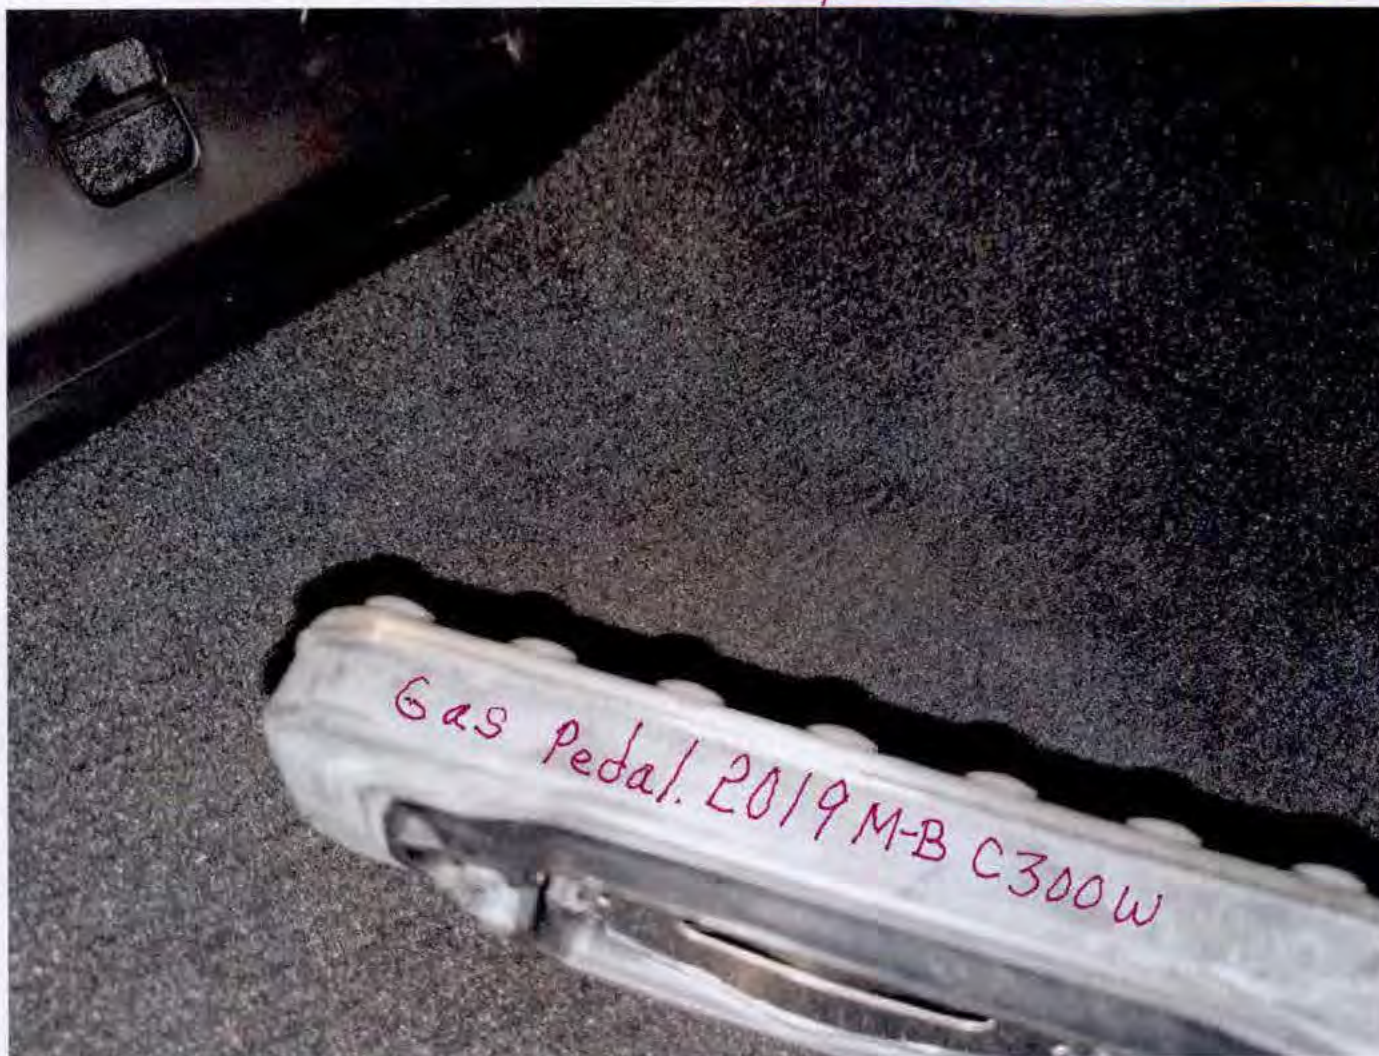
Depicts Spring Plate, bottom of gas pedal.  
Contrast with 2014 M-B C350W w/steel dowel pin  
on bottom of gas pedal. (Single image, this package.)

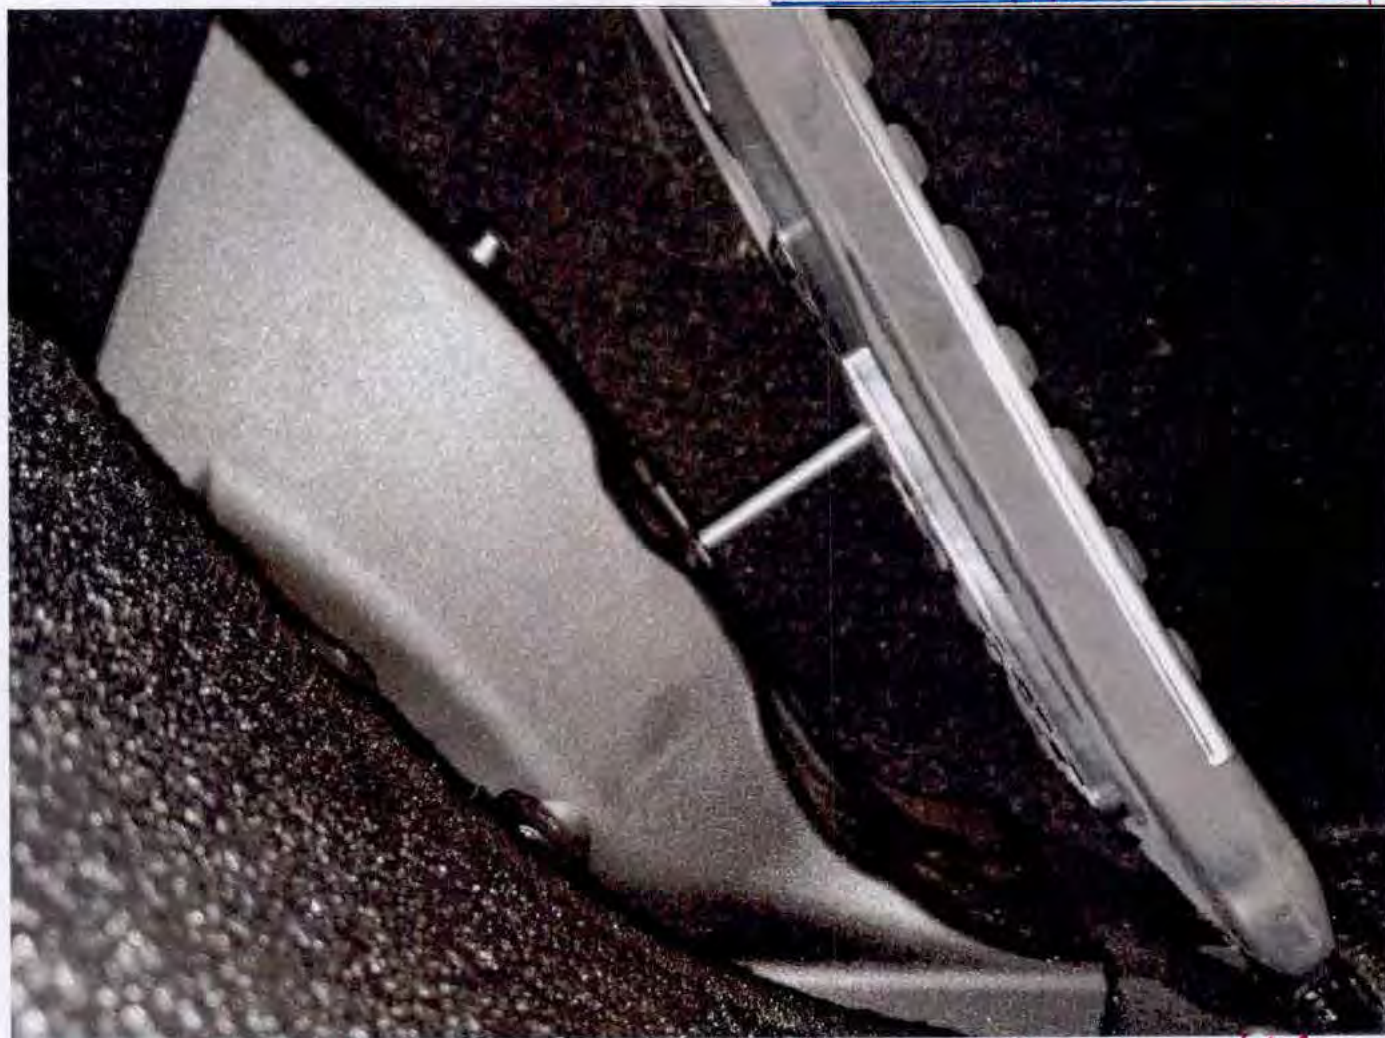
Description: Blow-Up of profile of Accelerator-Pedal-  
Assembly including plunger-rod passing through bottom-  
Attachment-Plate into throttle-unit. Also, pedal-spring-plate-  
stop, seen in profile (bright mark). Also, on bottom-plate surface,  
barely discernable, is a steel dowel-pin which is shorter than  
is the "gas-pedal-stop-pin." This design (2019-Model), appears to  
be much safer than is the design of the 2014 Model C-Series M-B.  
Note: "Actuator-Rod," and, "Plunger Rod" (or, "Pin") are same part.

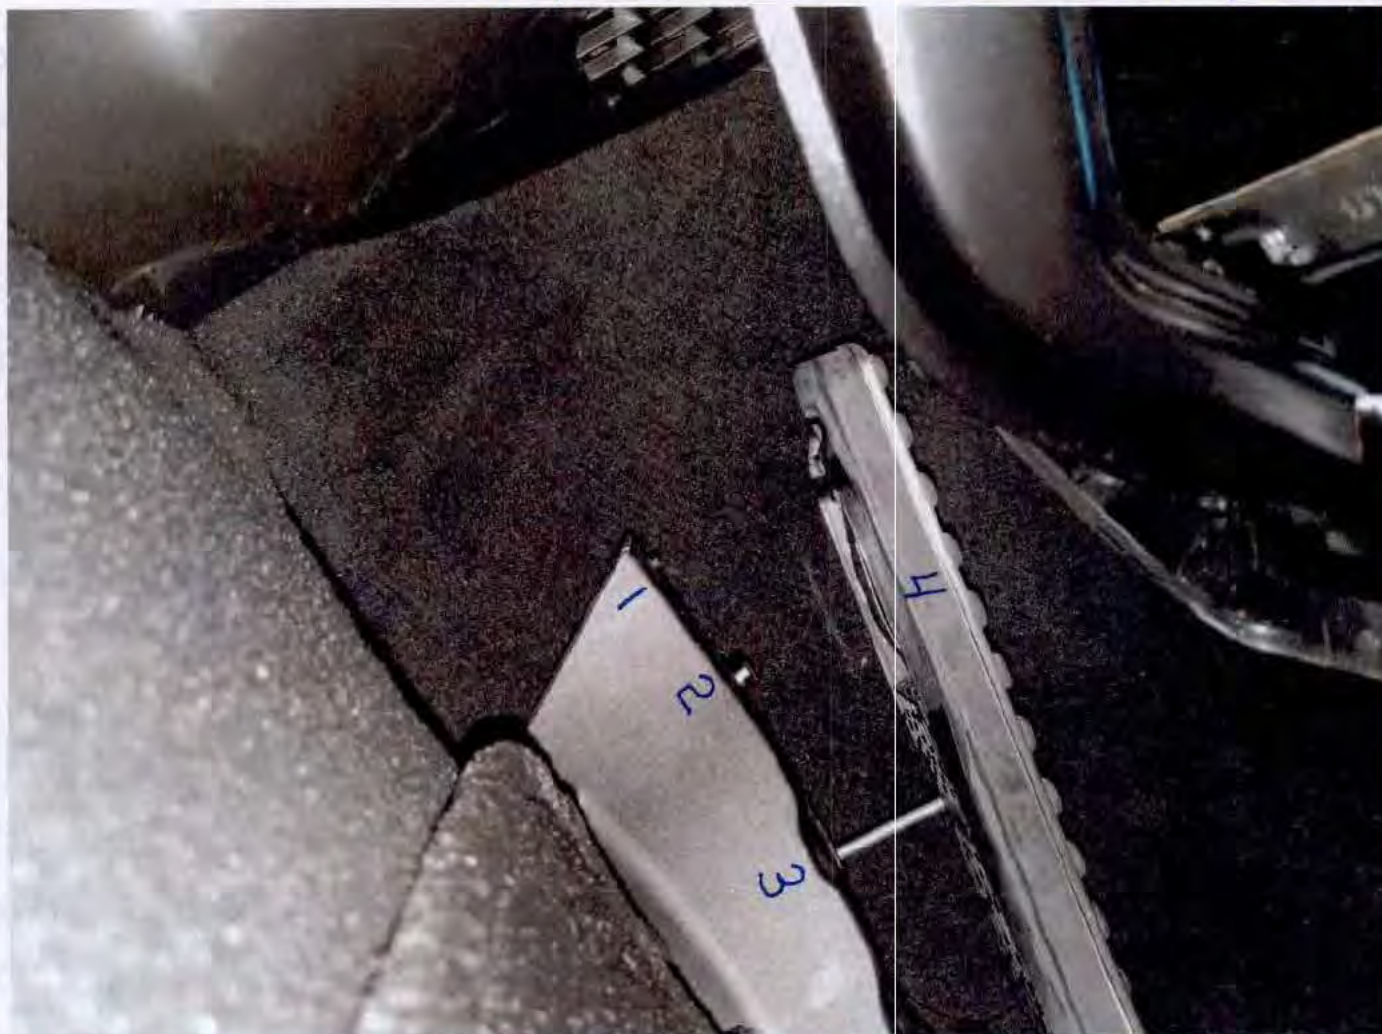
Wider-angle shot of footwell containing accelerator-pedal assembly in profile. Arm of footbrake and brake backing-plate show in upper-right quadrant of photo. 4 features are as follows: 1-Steel dowel pin; 2-Accelerator-pedal-bottom-stop and spring-plate-contact; 3-Accelerator-pedal-plunger-actuator pin (connects throttle-assembly and cruise-control unit. The pin (or rod) is pushed by the accelerator-pedal during normal operation. During cruise-control operation, (in the 2019 model), the accelerator pedal is not pulled to the floor or, "stop-pin," during my personal testing (over)

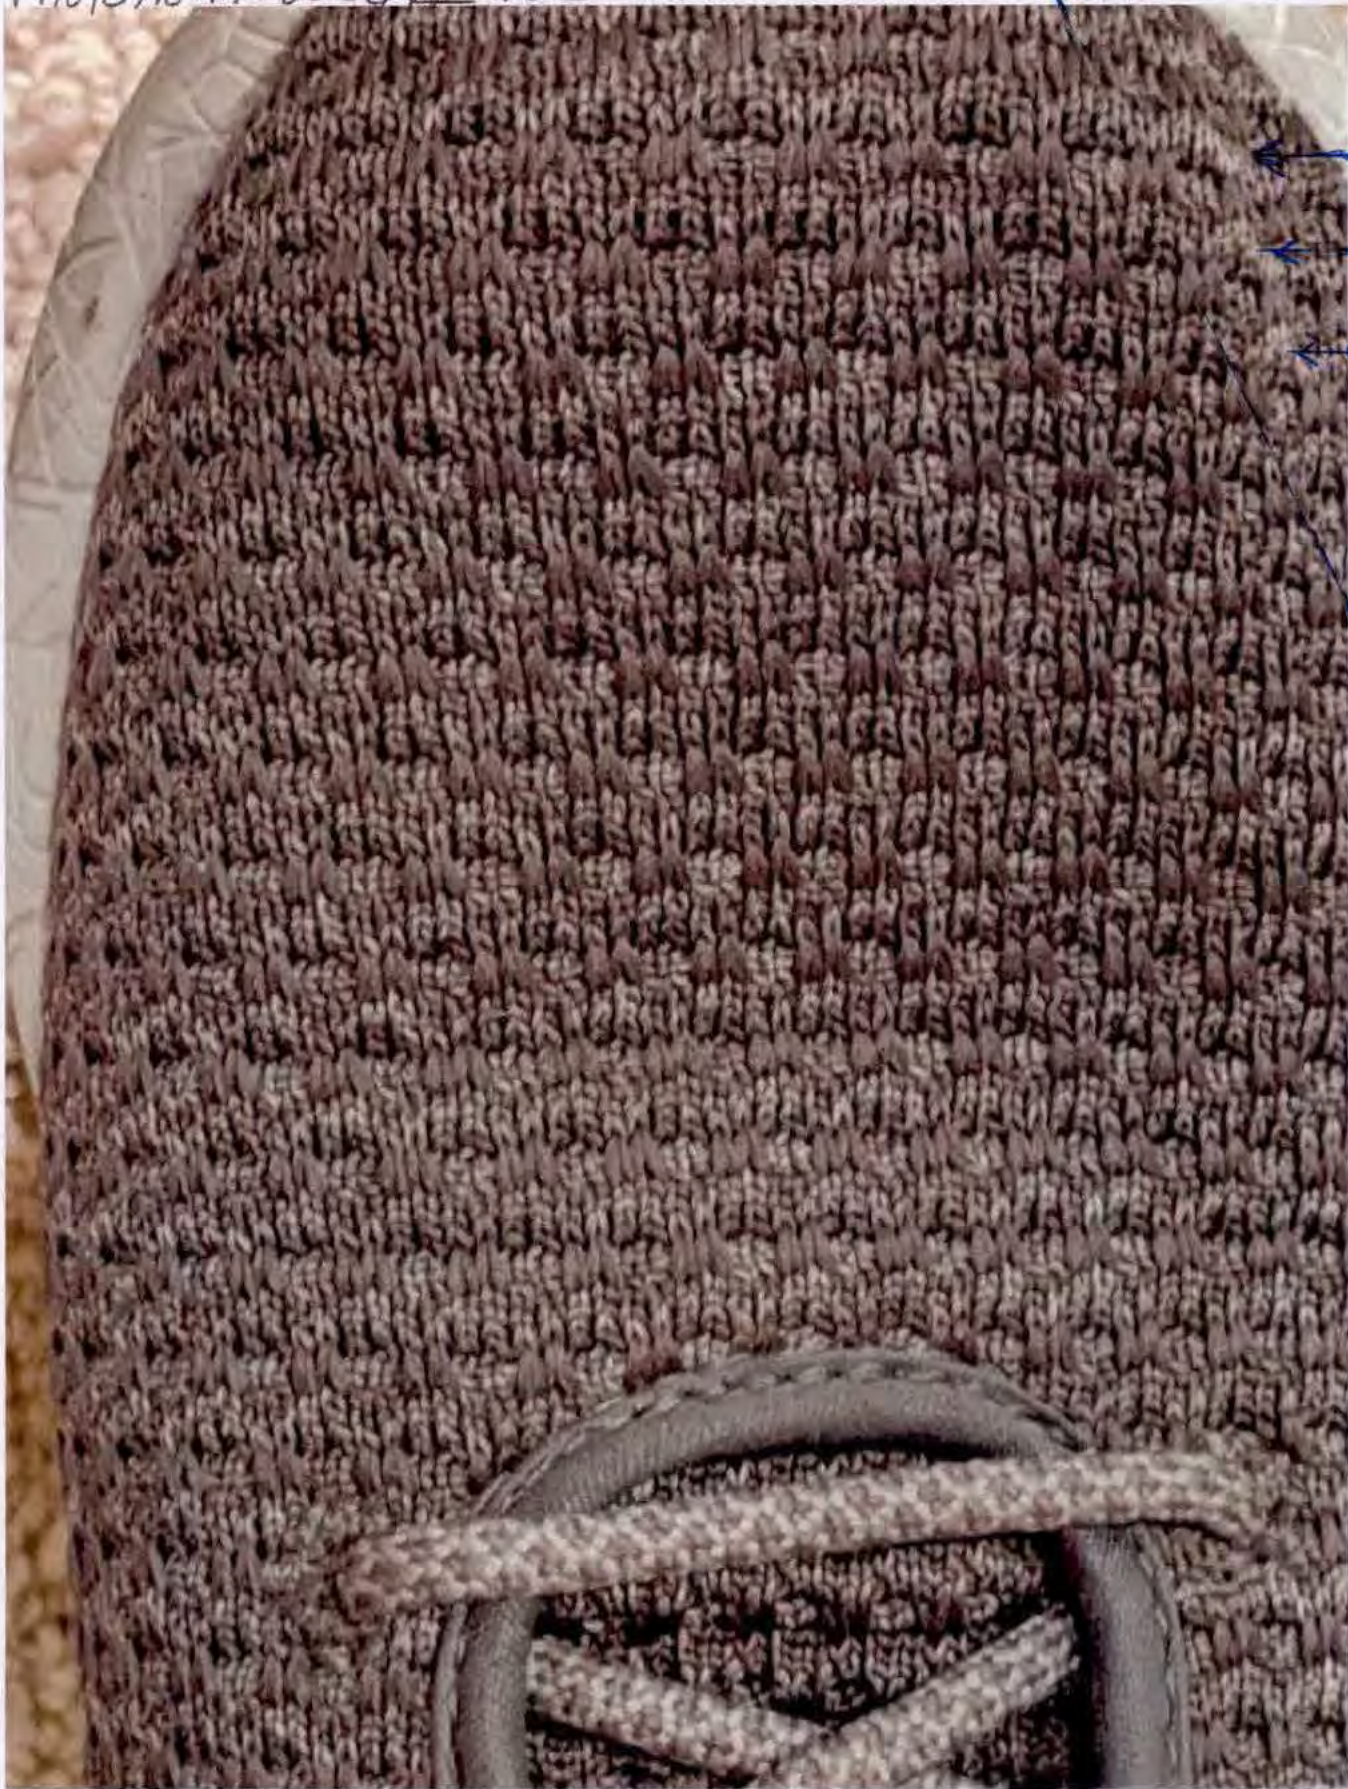
Disruptions of the fabric that may have been caused (over)

(Continued from other side) by a M-B factory pin<sup>↑</sup> affixed to the accelerator pedal (bottom) which may have contributed to Driver's foot being pinned under the accelerator pedal during the accident of 2/23/19. The discovery of two(2) factory-installed steel

pins, (one [1] on the bottom of the accelerator pedal; and one [1] affixed to the top of the accelerator-fastening-plate (plate appears to be made of a grade of automotive steel and is bolted to the floorboard of the M-B C350W via at least two(2) bolts [high grade] passing through two(2) holes in a shoulder-piece (L-shape) which is part of the fixing-piece of the accelerator-pedal-assembly. (This could potentially be another design-flaw which could endanger drivers in some unusual circumstances, and also therefore endanger other drivers on the road). To elucidate the new findings (7/3/19 - 7/5/19) and what this they mean and what it meant for Driver on 2/23/2019, (the possible design flaw) is that the [redacted] look like they are designed to contact one another, if and when the accelerator pedal is completely [redacted] depressed (pushed or pulled downward) (towards the floorboard). With [redacted] the type of shoes worn (see other side), and with the right foot having slipped approximately one [1] inch under the accelerator pedal, when the accelerator was pulled (or pushed) to the bottom of its travel, the upper pin is or was pushed into the upper mesh of the shoe, while simultaneously, the sole of the shoe was pushed into the lower pin (which is fixed). (See photo on reverse side for a view of the actual shoe upper mesh that was pinned during the accident. Also, please see: IMG\_20190325\_120506.jpg (included in packet) for a visual of the pins and their actual and relative locations. # (The reverse photo is part of the [redacted] pinned-foot-series of photos.) #

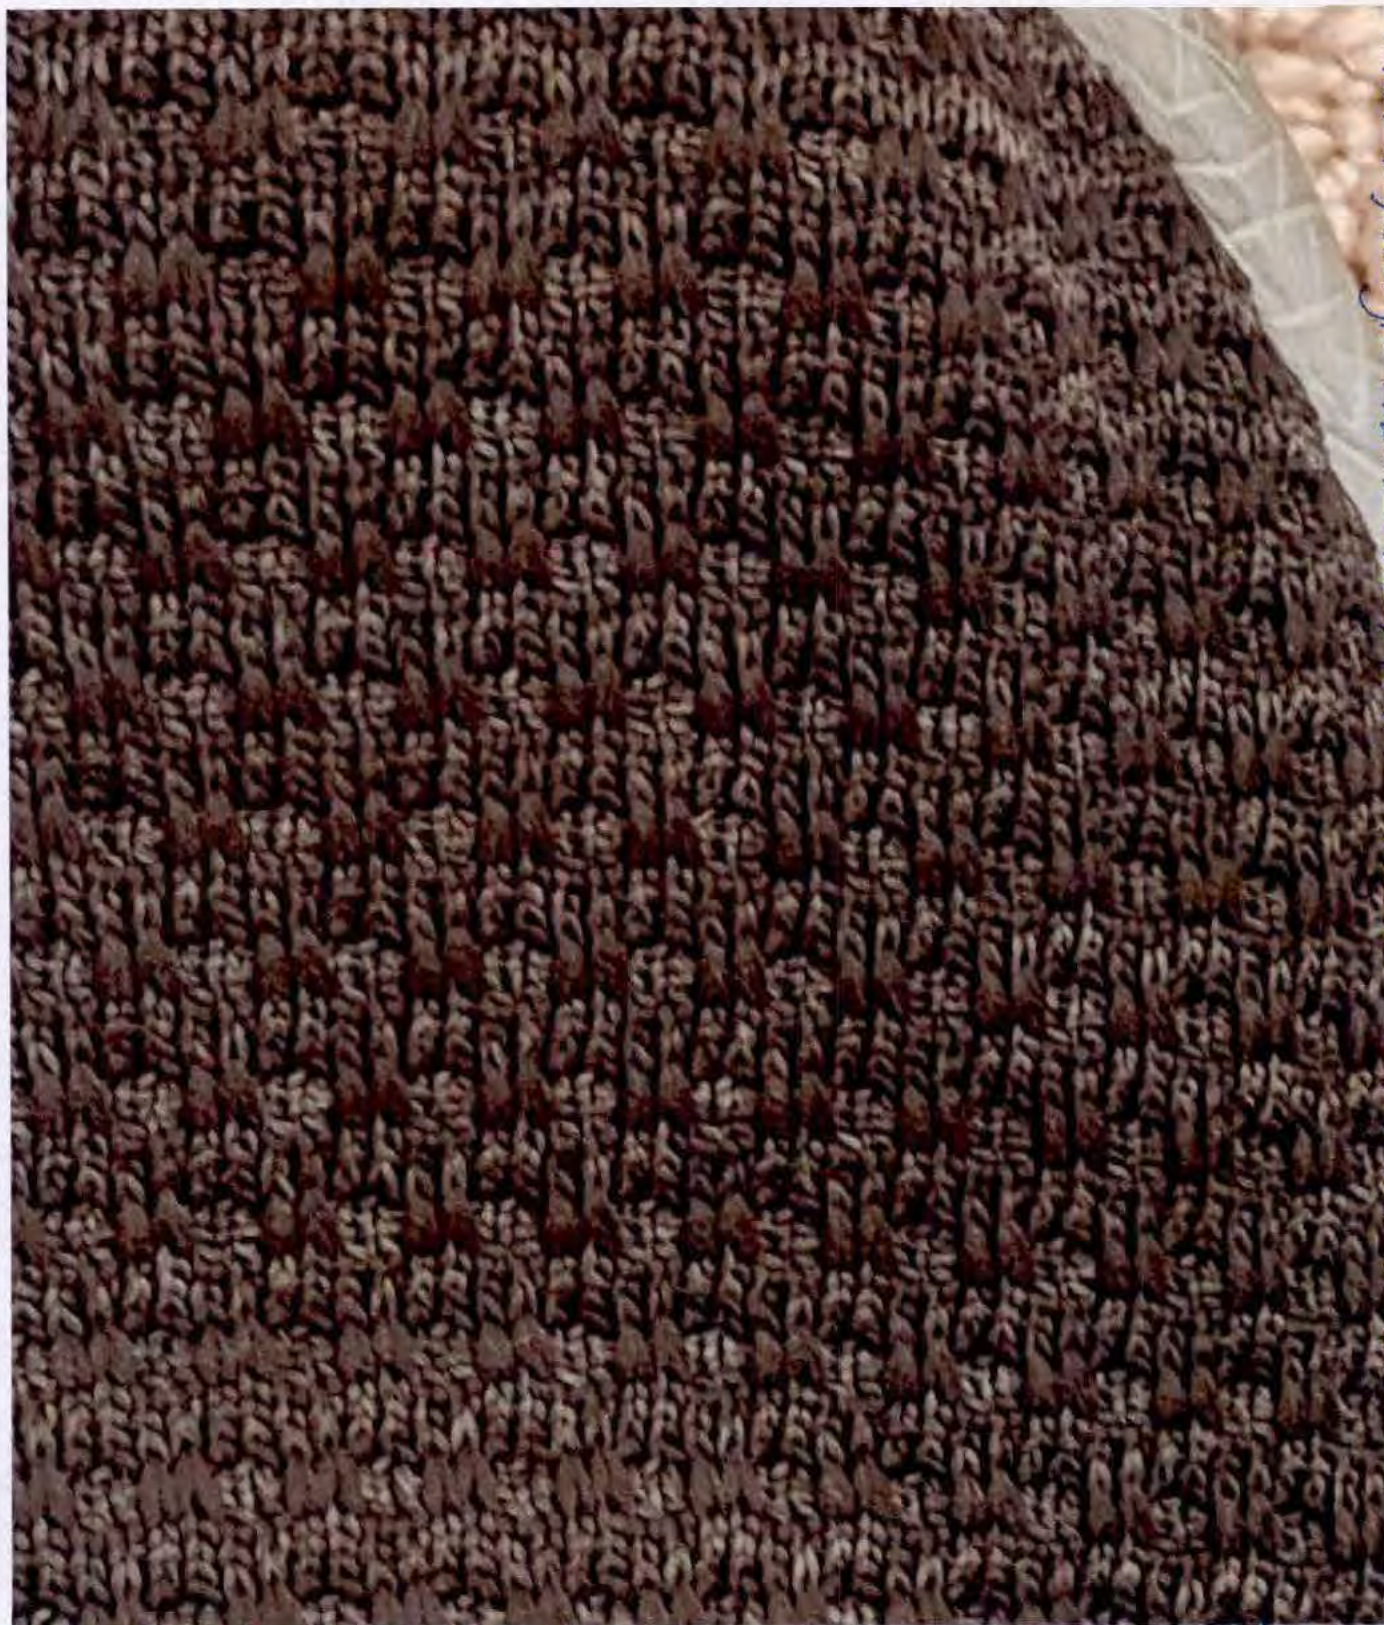
Right toe of SKECHERS right shoe worn by Driver during 4-car injury collision of 2/23/2019. Attempt to find irregularities in fabric that may have been caused by a pin affixed by M-B factory to bottom of accelerator pedal.  
1 of 2 identical photos.
