NHTSA REFERENCE  
NO. 11206504

PHOTOGRAPHS - SERIES 8:

Pinned-Foot-Photo-Series: (2) photos of brake-gas pedal assembly,  
All photos of Driver's Accident-worn shoes, all picture of Driver's  
right foot.

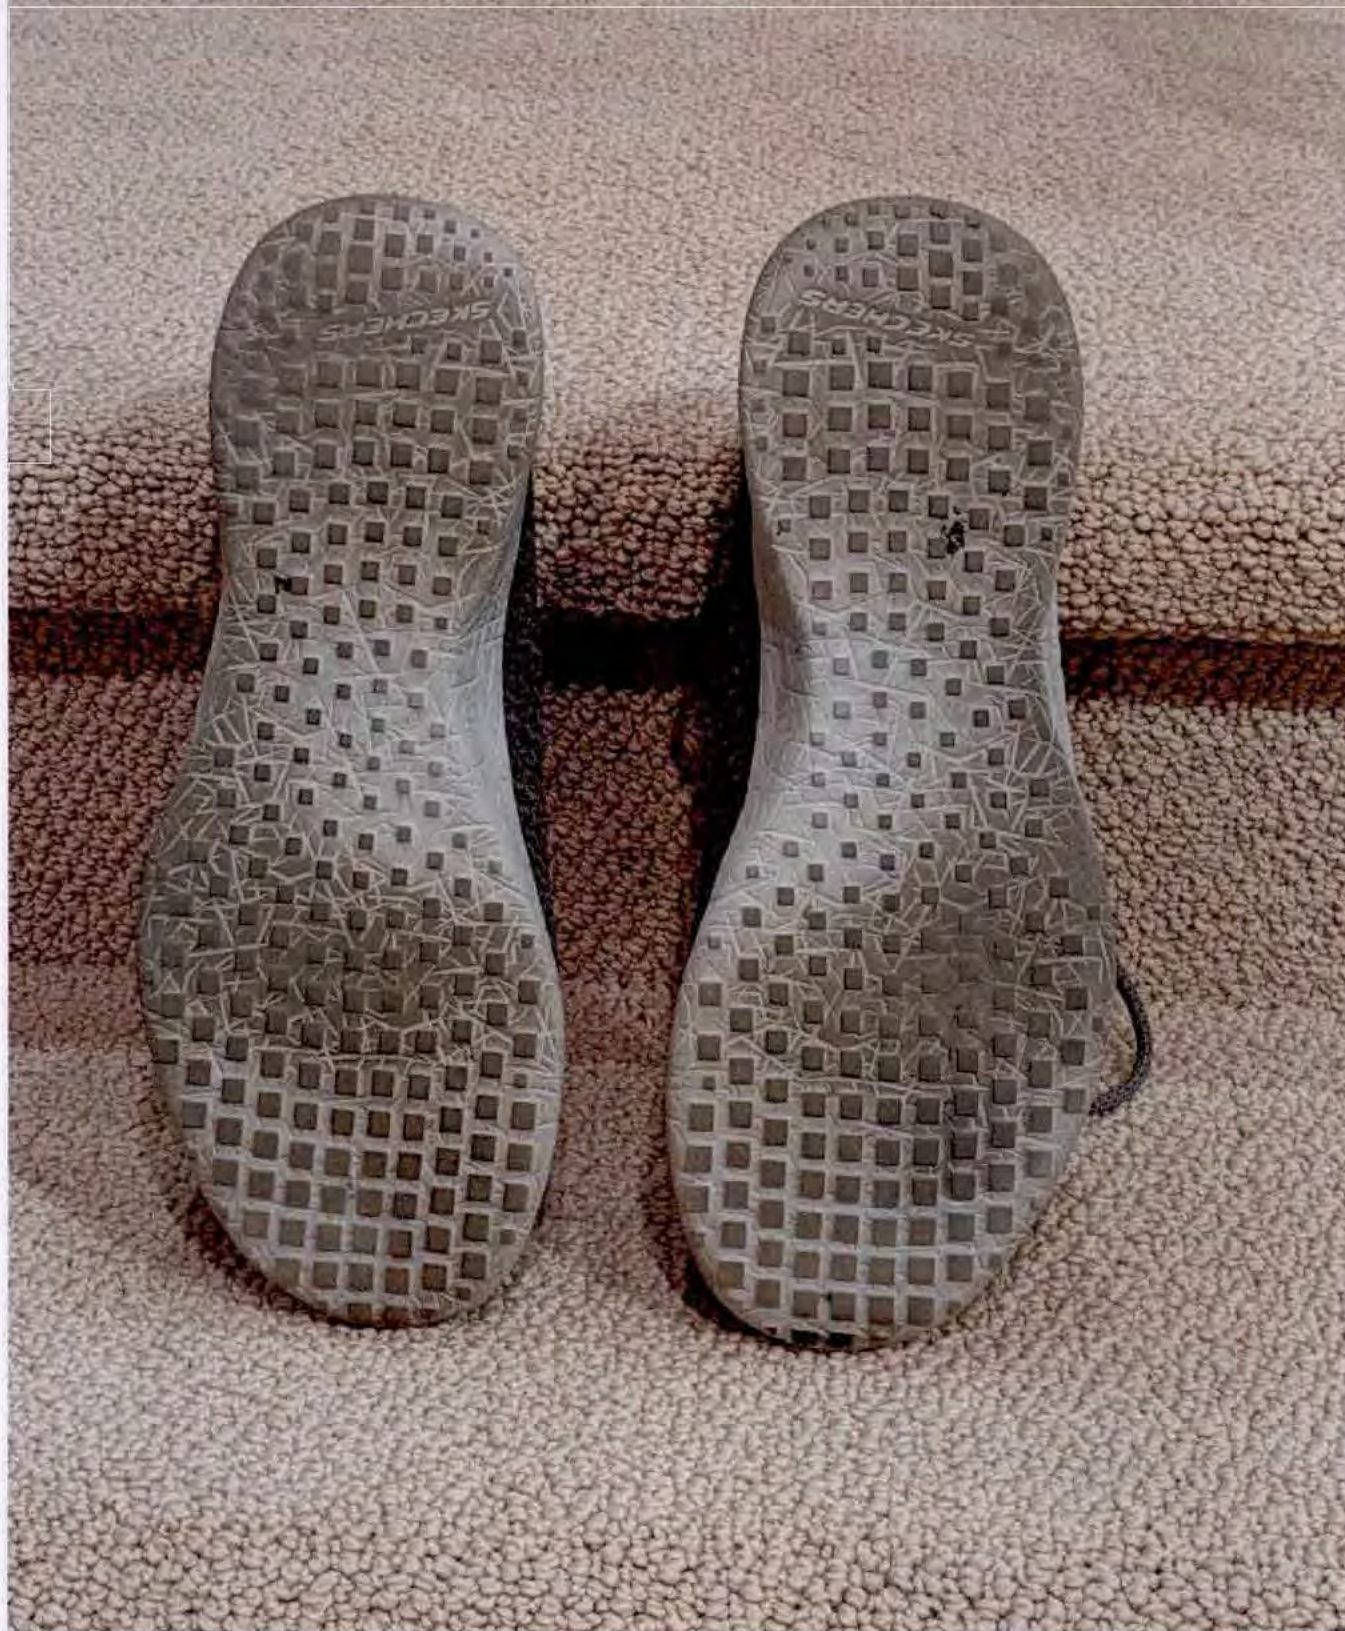
Worn while driving - Soles made of soft rubber.

Worn by Driver on date of accident, 2/23/19

Pair of SKECHERS  
SIZE: 10 (USA)

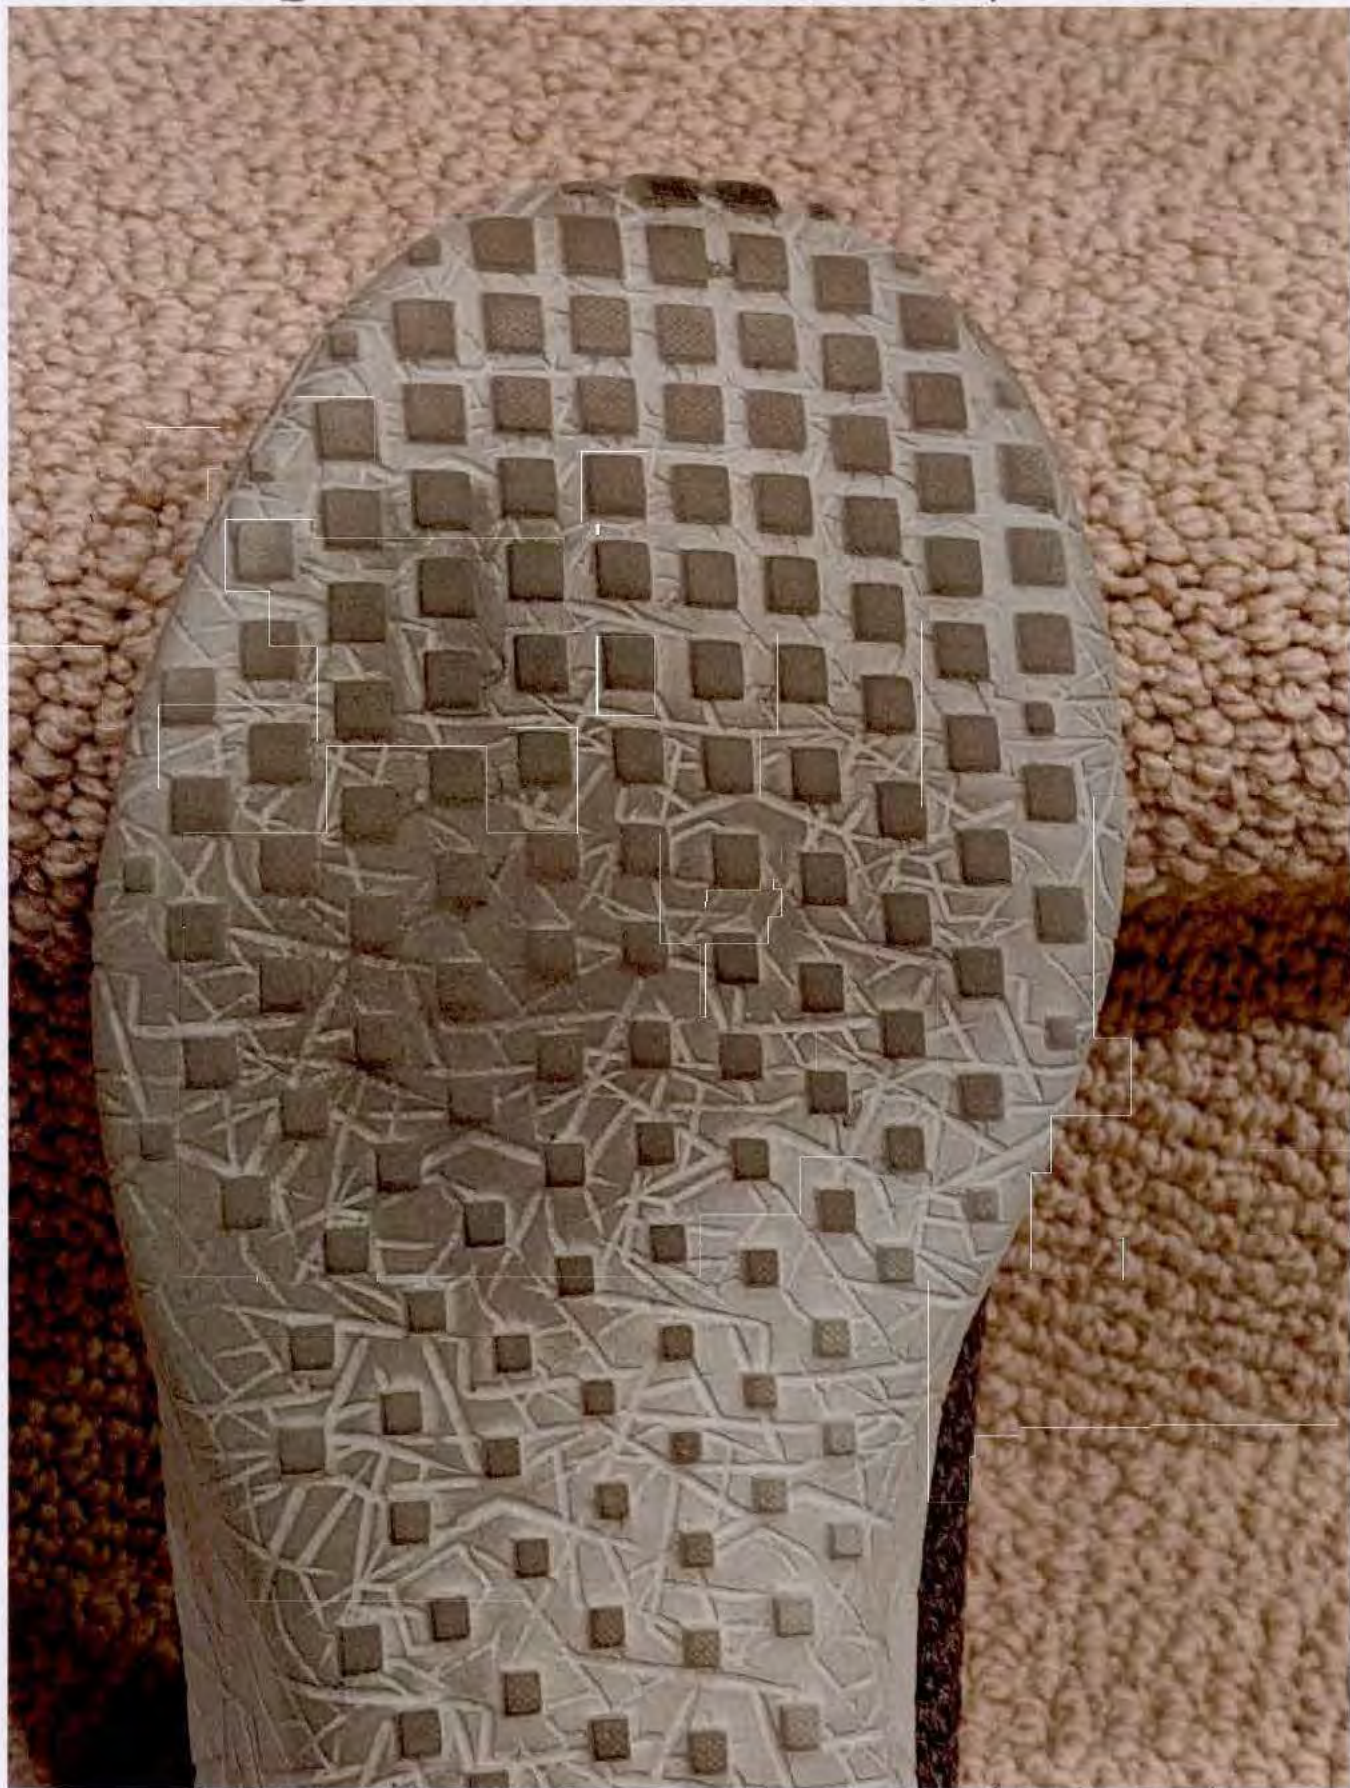
Sole of SKECHERS worn during Accident,  
2/23/19 by Driver of Subject Car.

For visual reference to position of steel dowel pins,  
Reader/viewer is respectfully referred to Photo No.:  
IMG\_20190325\_120506.jpg; 12.2MP 4032x3025  
2.5 MB ISO395; Google Pixel 3 XL; f/1.8 1/17 sec. Taken:  
03/05/2019 @ 12:05 pm; original: /storage/emulated/0/DCIM/camera

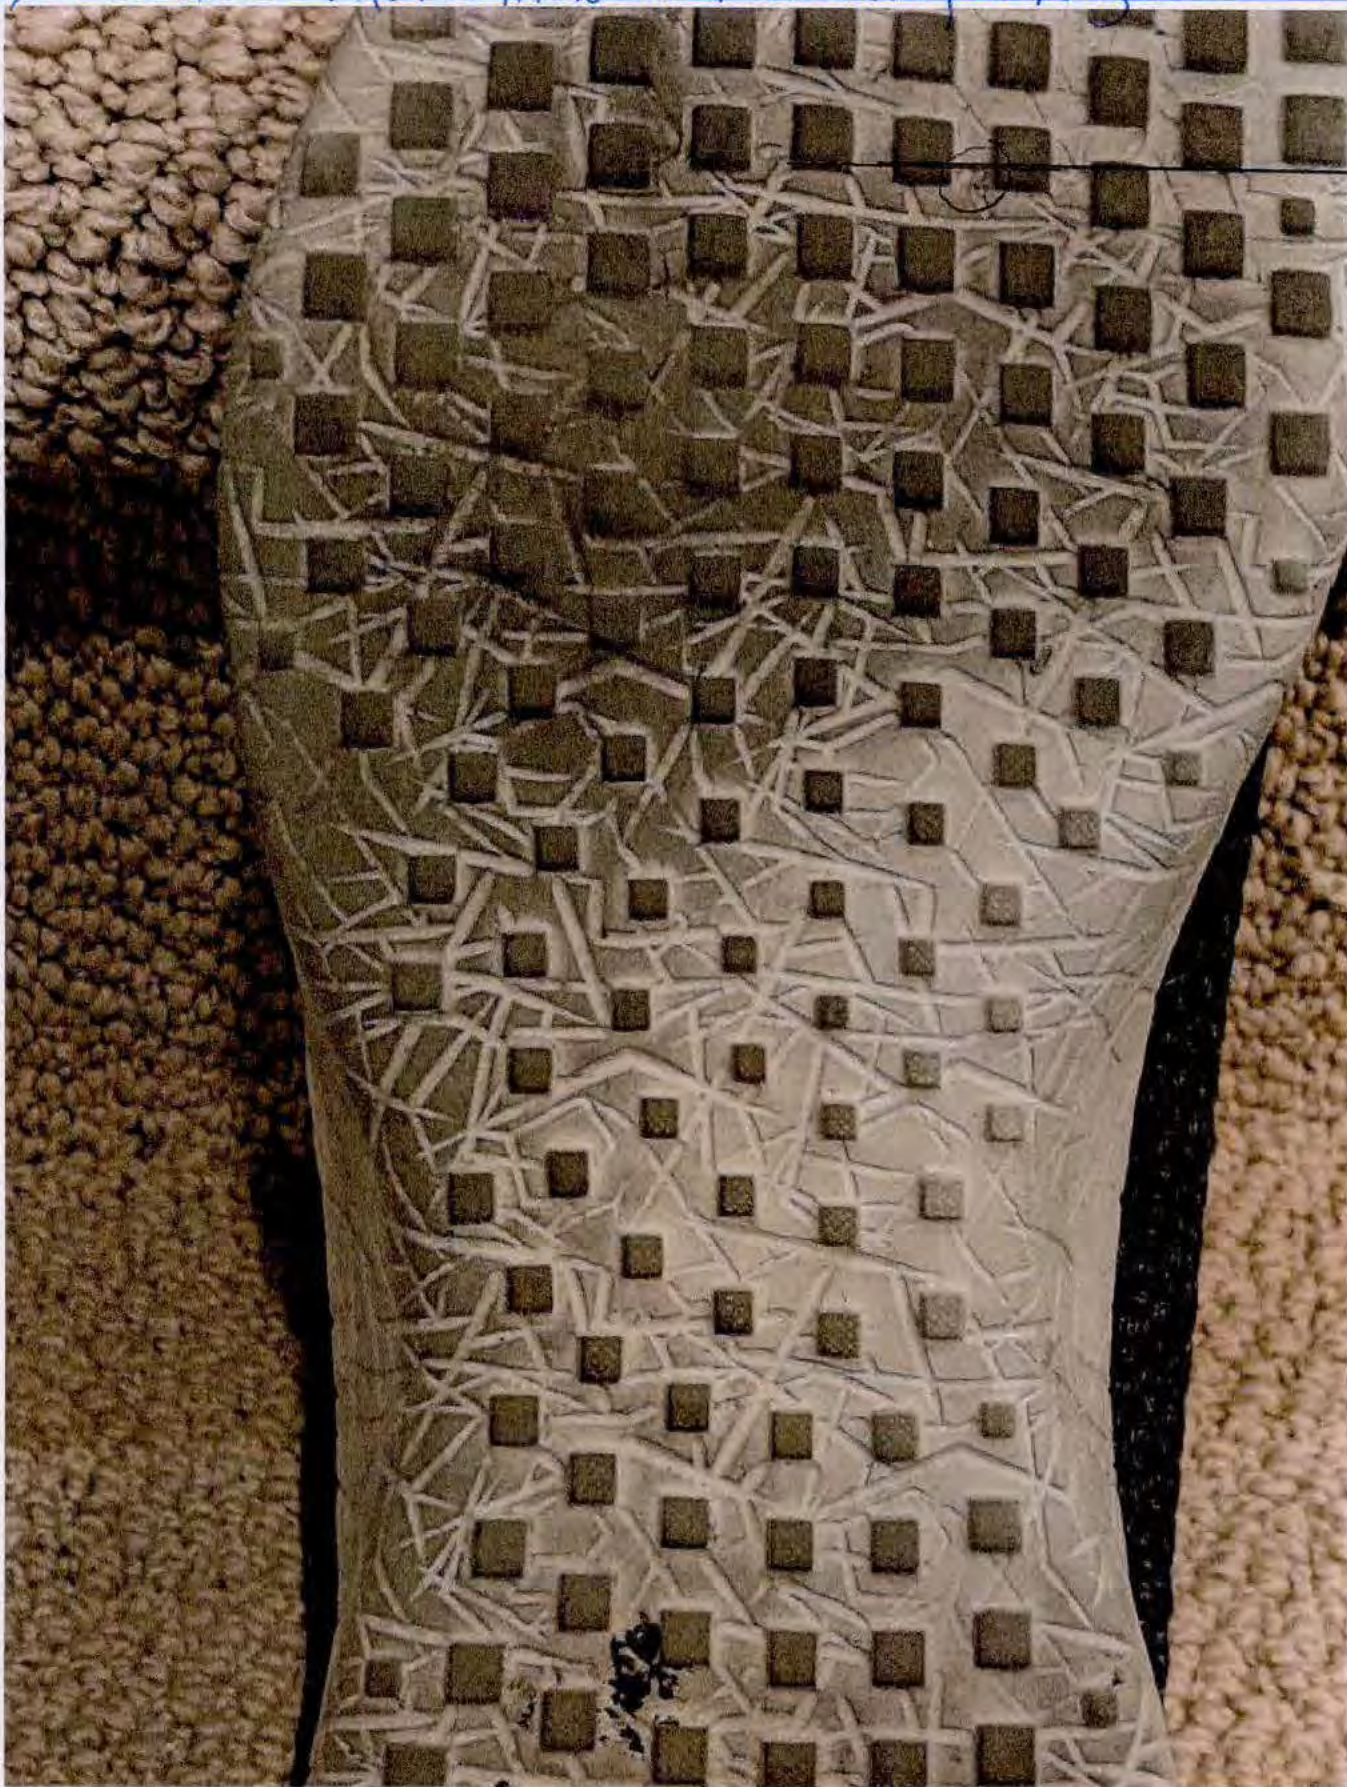
See circled area. See Blow-up photo ID No. 1ME-20190703-212101.jpg

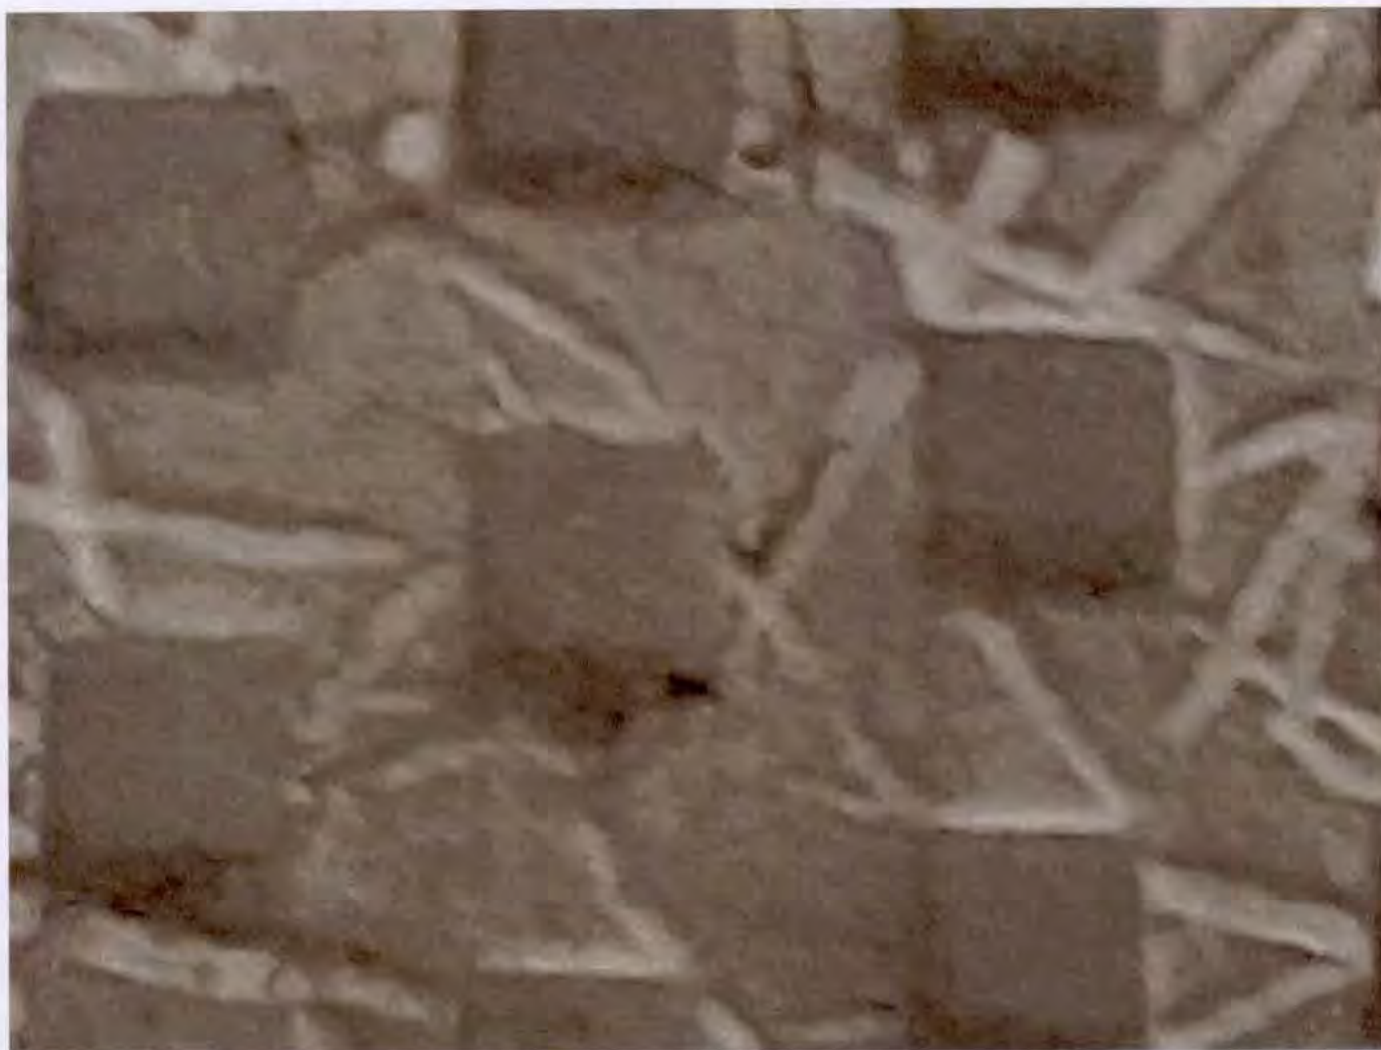
MISCELLANEOUS Photograph, Blow-Up of sole of right SKECHERS shoe worn during 4-car injury accident, 2/23/19. Use as a comparison.

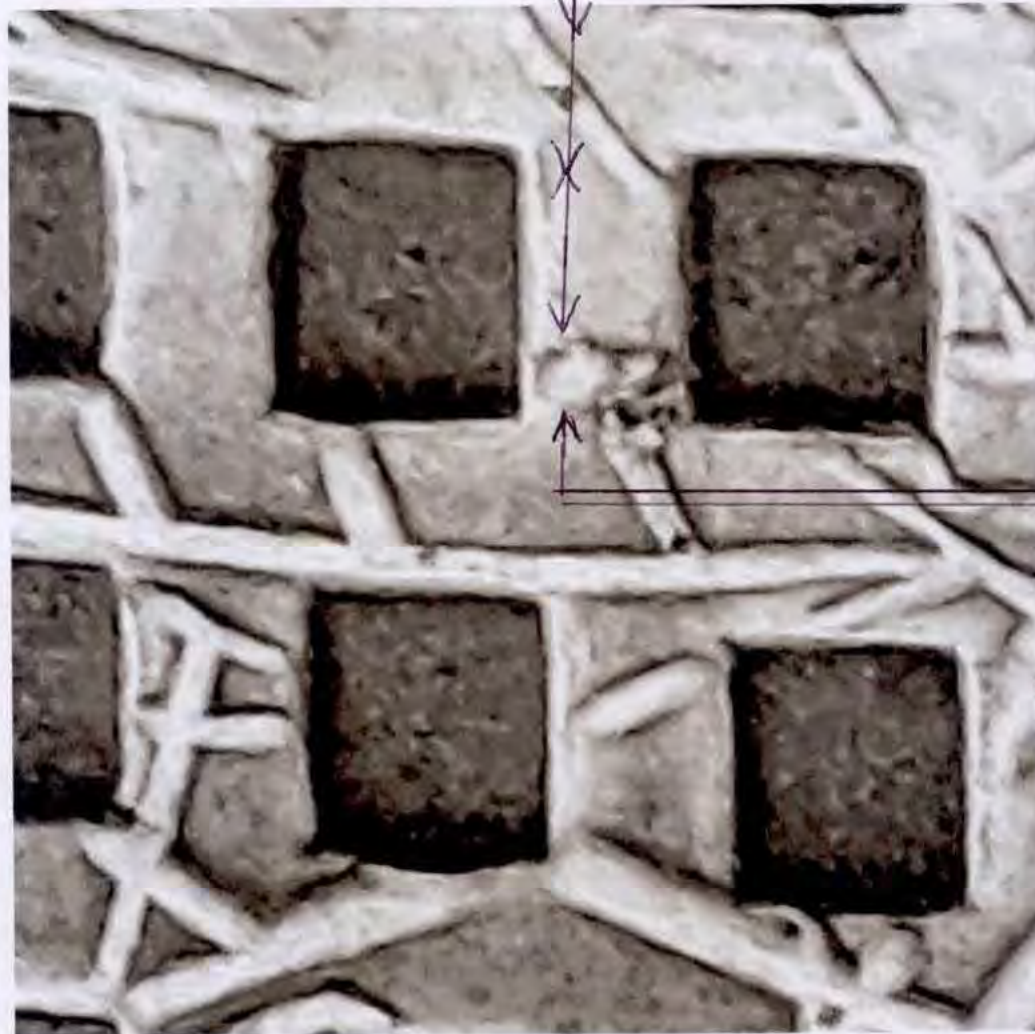
Possible Accelerator  
Pin Damage, impression  
Pedal (in-sev)

The dowel pin, steel,  
at top fastening-plate  
shoulder could easily  
make the impression  
seen in photo to left,  
(sole of shoe is soft-  
rubber)

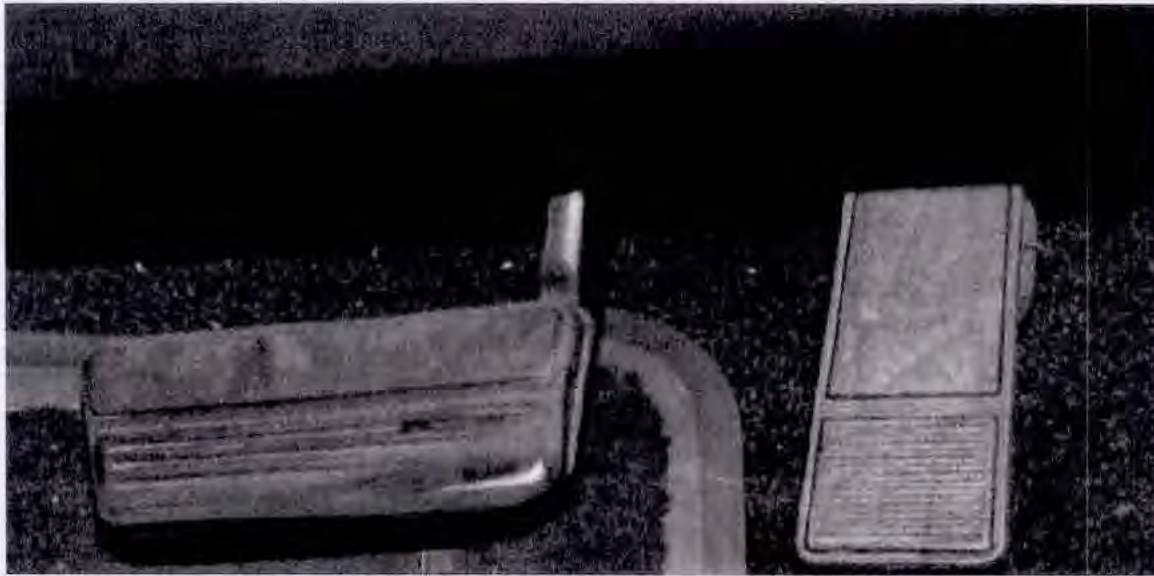
**Figure 3.** Accident vehicle's brake pedal.

The Buick was equipped with a power-assisted, dual-circuit hydraulic brake system configured with front disc brakes and rear drum brakes. The master cylinder was adequately filled with fluid and the power booster supply check valve functioned properly. All wheel hubs rotated freely and without indications of drag or out-of-round conditions. Examination of each brake assembly and associated hydraulic lines revealed no leaks, restrictions, or operational defects. The brake pedal was intact and functional, offering consistent resistance and approximately 2 1/2 inches of nonpower-assisted travel. The rubber cover on the brake pedal was worn on the lower right edge, revealing the metal beneath (see figure 3). Separation between the brake pedal and the accelerator at the closest point was 2 inches.

California Highway Patrol (CHP) officers tested the vehicle's brake operation before the Buick was removed from the scene. They reported that an initial (booster-assisted) brake application was held for 30 seconds without pedal drop or fade and that all wheel assemblies locked when force was applied to the brake pedal.

Inspection results of the service and parking brake systems were unremarkable, except for slight fluid seepage noted at the right rear wheel cylinder dust covers. The brake components showed no signs of active fluid loss or contamination.

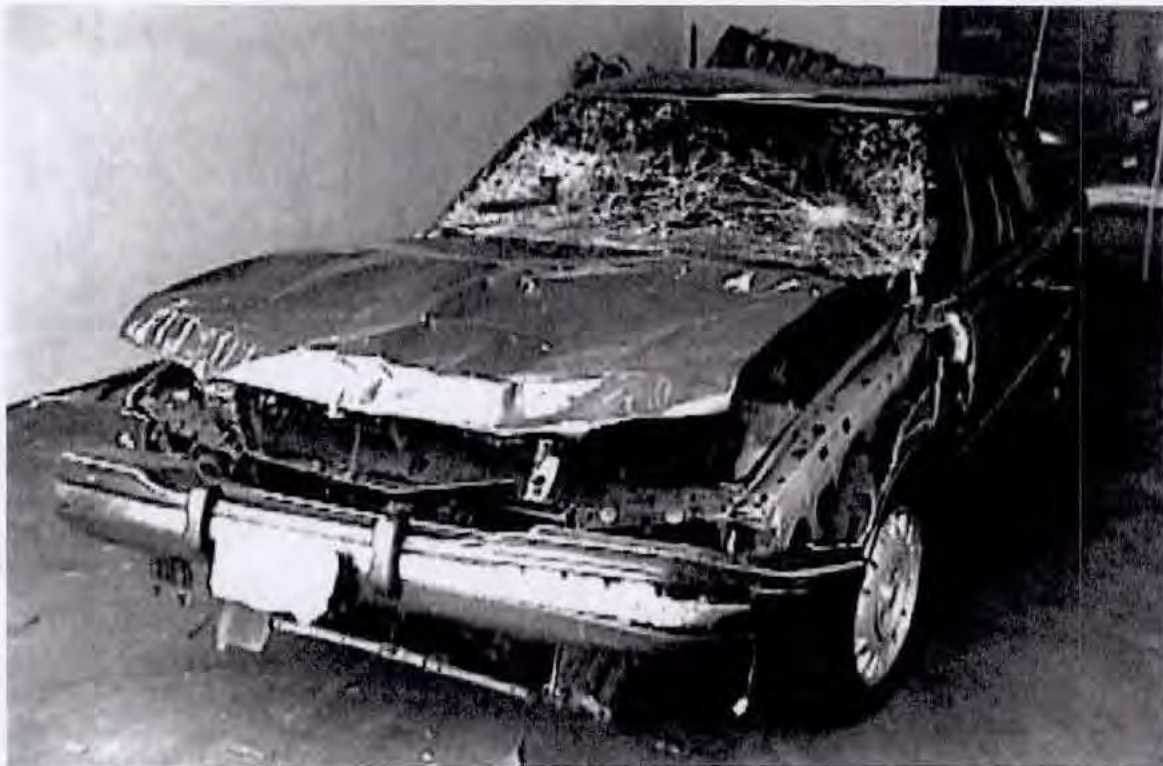
**Figure 4.** Postaccident damage to 1992 Buick LeSabre.

The Buick sustained frontal damage encompassing the front bumper, forward light fixtures, radiator grill, radiator and support, left front quarter panel, windshield, roof, both side mirrors, and rear antenna. (See figure 4.) The two side-view mirrors were missing, and the shattered windshield had two distinct impact or indentation locations; remnants and debris from items struck were found embedded in the windshield. The right side of the front bumper had light blue paint transfer, and the rubber portion of the right rear bumper had white paint transfer. The left bumper quarter panel was missing and exhibited exposed, jagged edges. The bumper was angled upward from the frame, consistent with accident damage. The Buick's airbag had deployed.
