| <b>DOT Auto Safety Hotline</b><br><b>Vehicle Owner's Questionnaire</b><br>To Report Vehicle Safety Defects<br>1-888-DASH-2-DOT<br>(1-888-327-4236)<br>INTERNET: <a href="http://www.nhtsa.dot.gov/hotline">www.nhtsa.dot.gov/hotline</a> | | | | FOR AGENCY USE ONLY 100148 | |
| 17 digit Vehicle Identification Number Located at bottom of windshield on driver's side<br><b>1F65F5DY8G</b> <span style="background-color: black; color: black;">[REDACTED]</span> | | | Make<br><b>THOR</b> | | Model<br><b>ACE</b> |

Safety Complaint on Thor Ace 29.3 Motorhome defective entry door latch ext plunger mfg. by  
Timark Corp. Part #80-1650 series exterior handle.

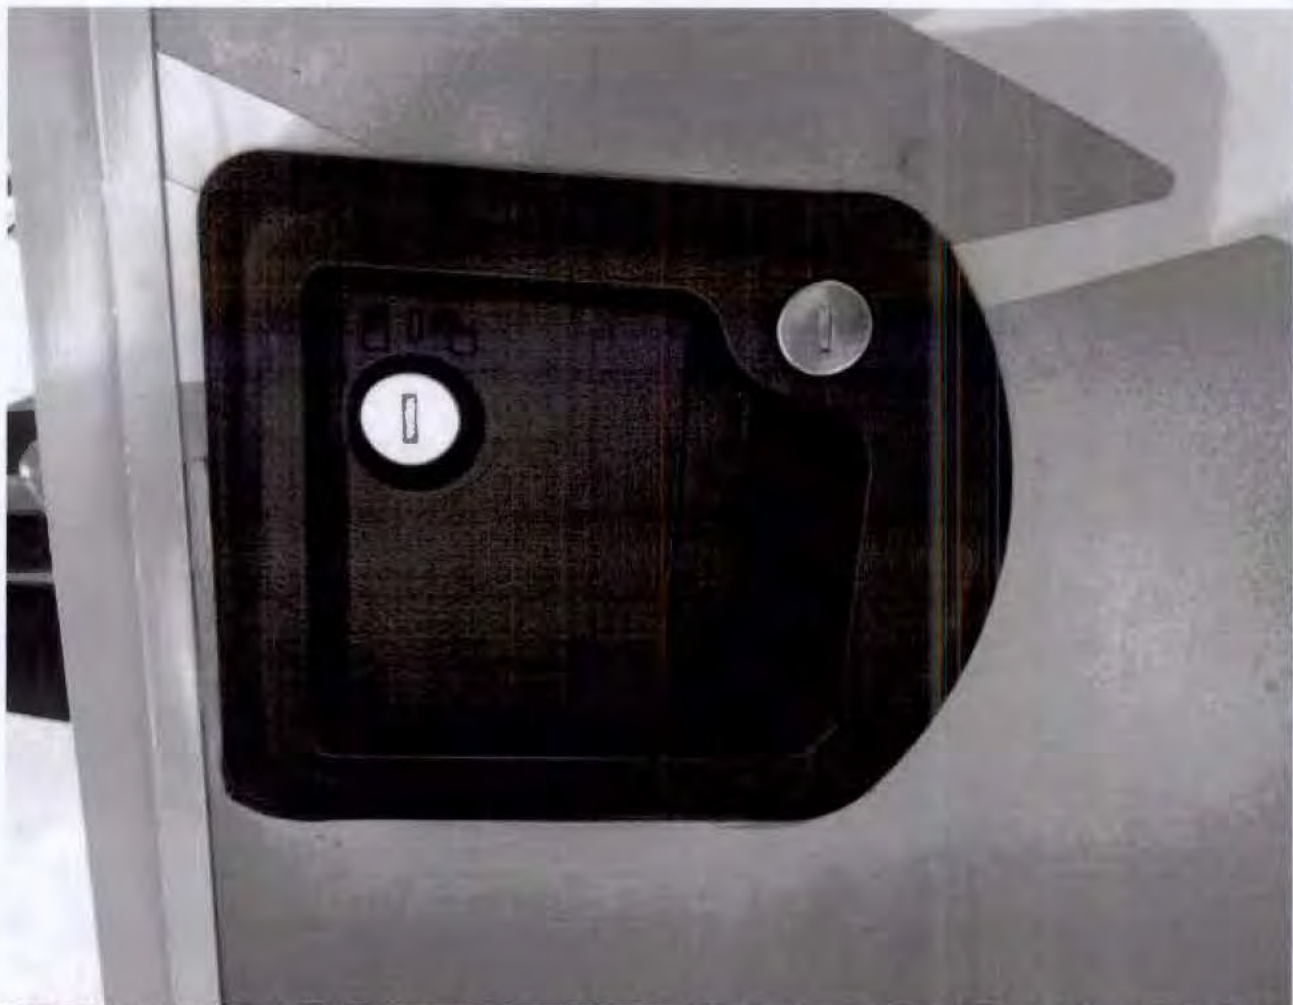
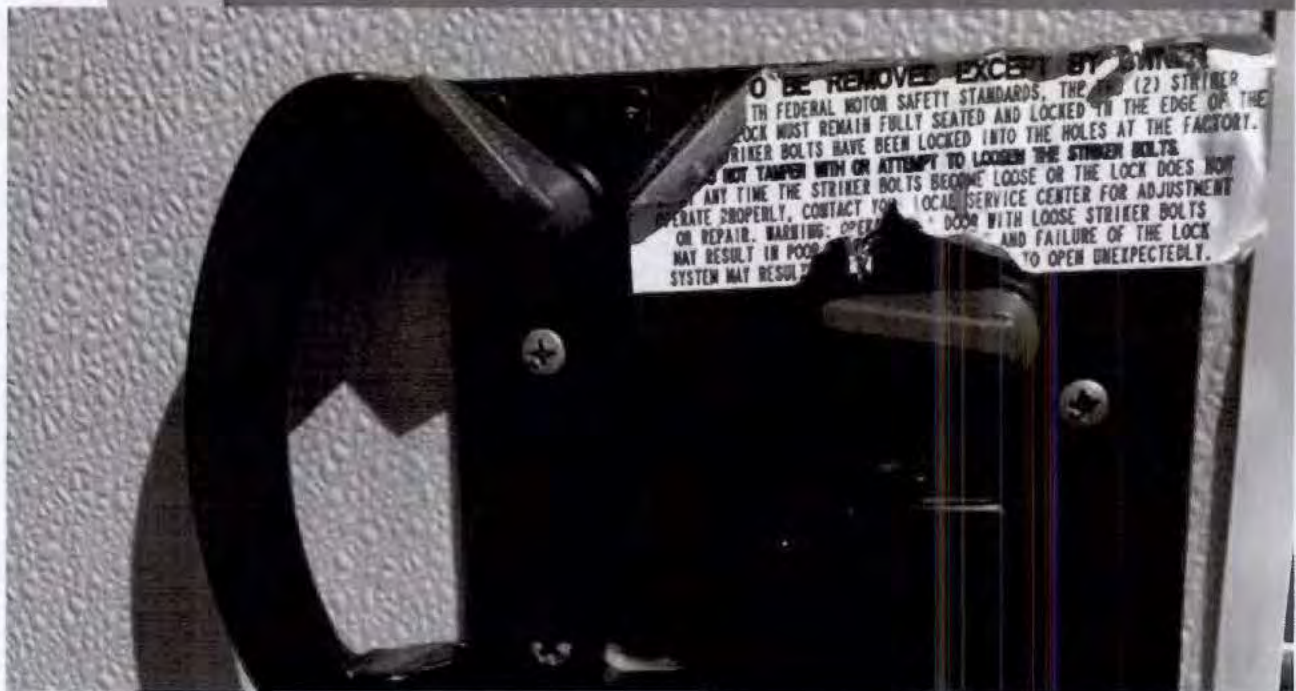
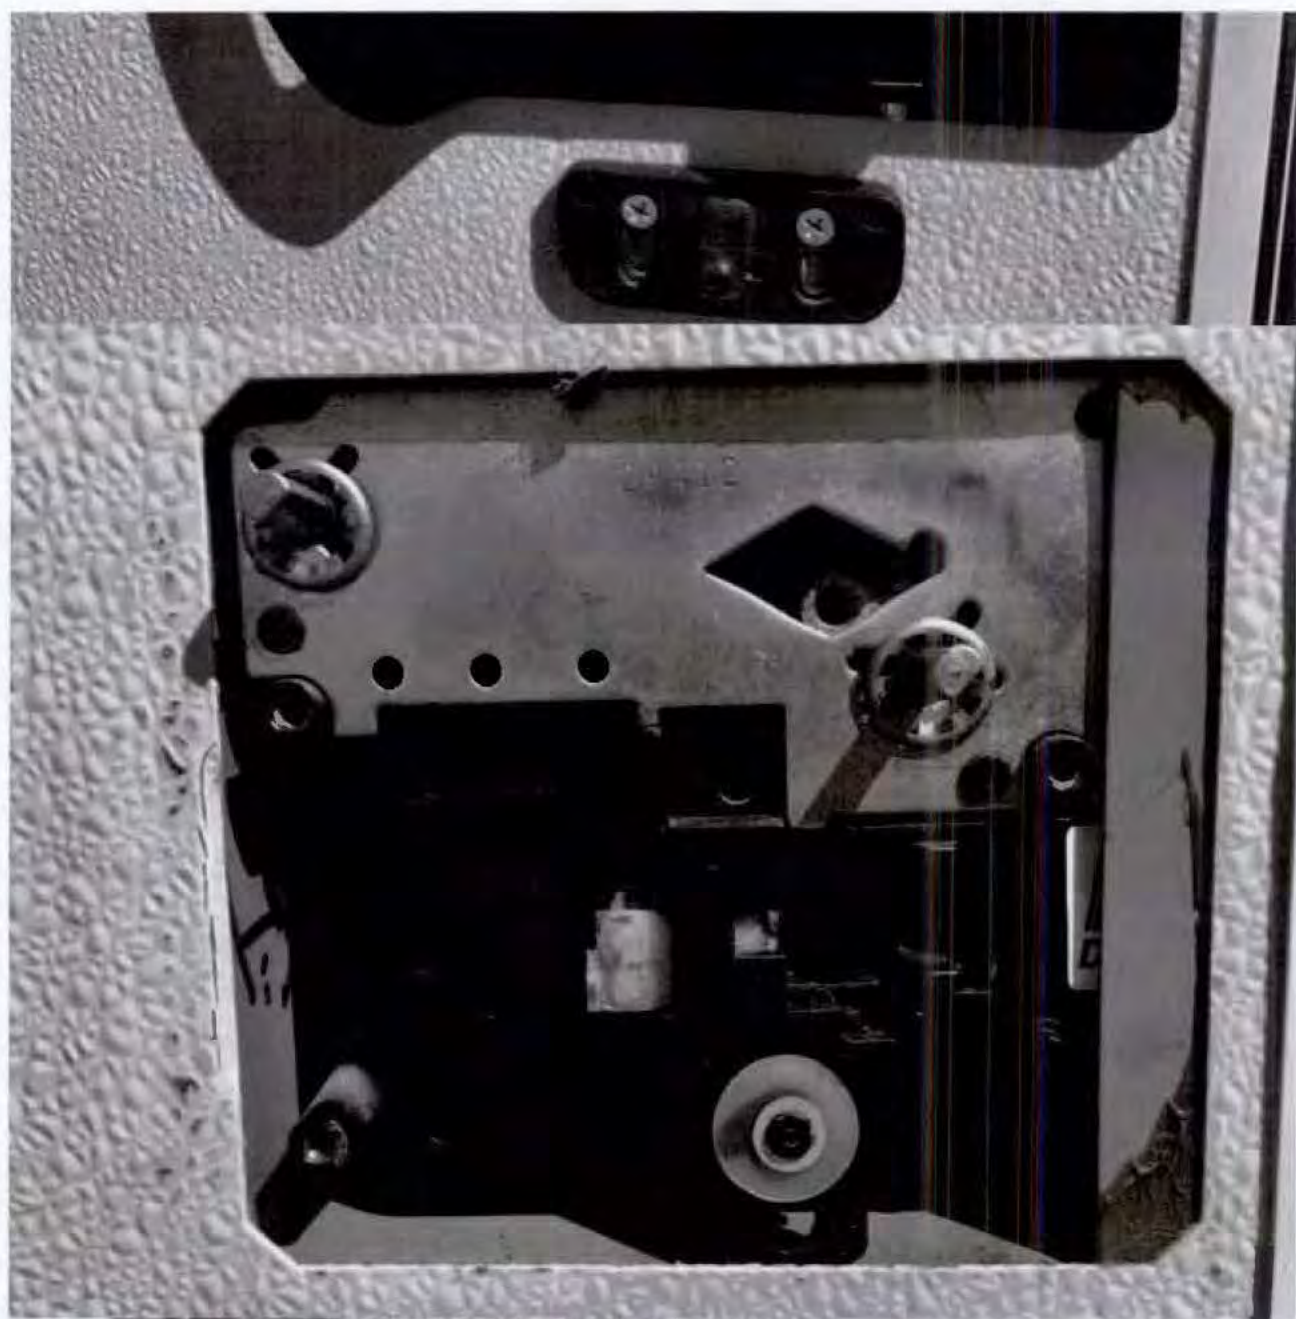
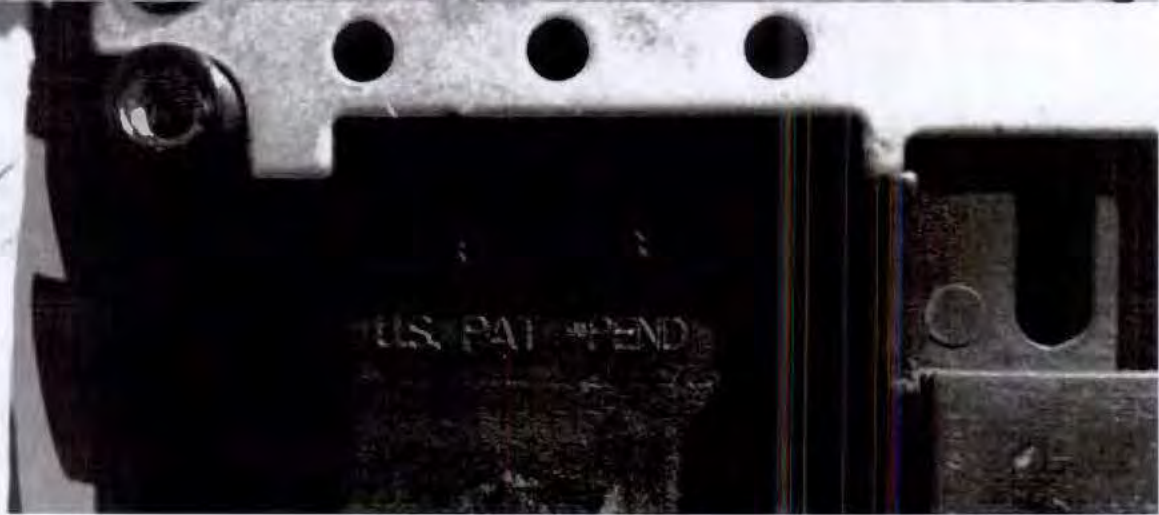
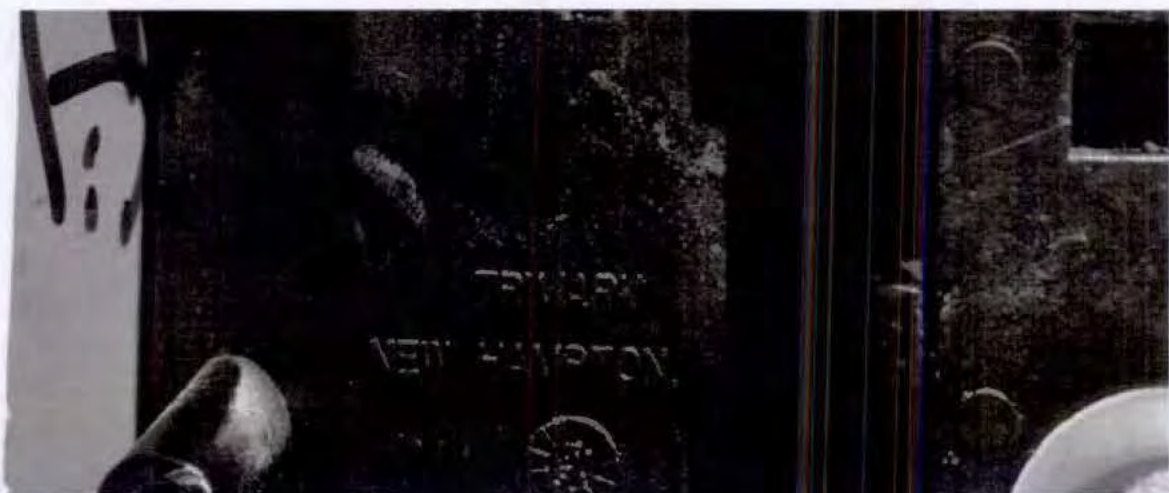
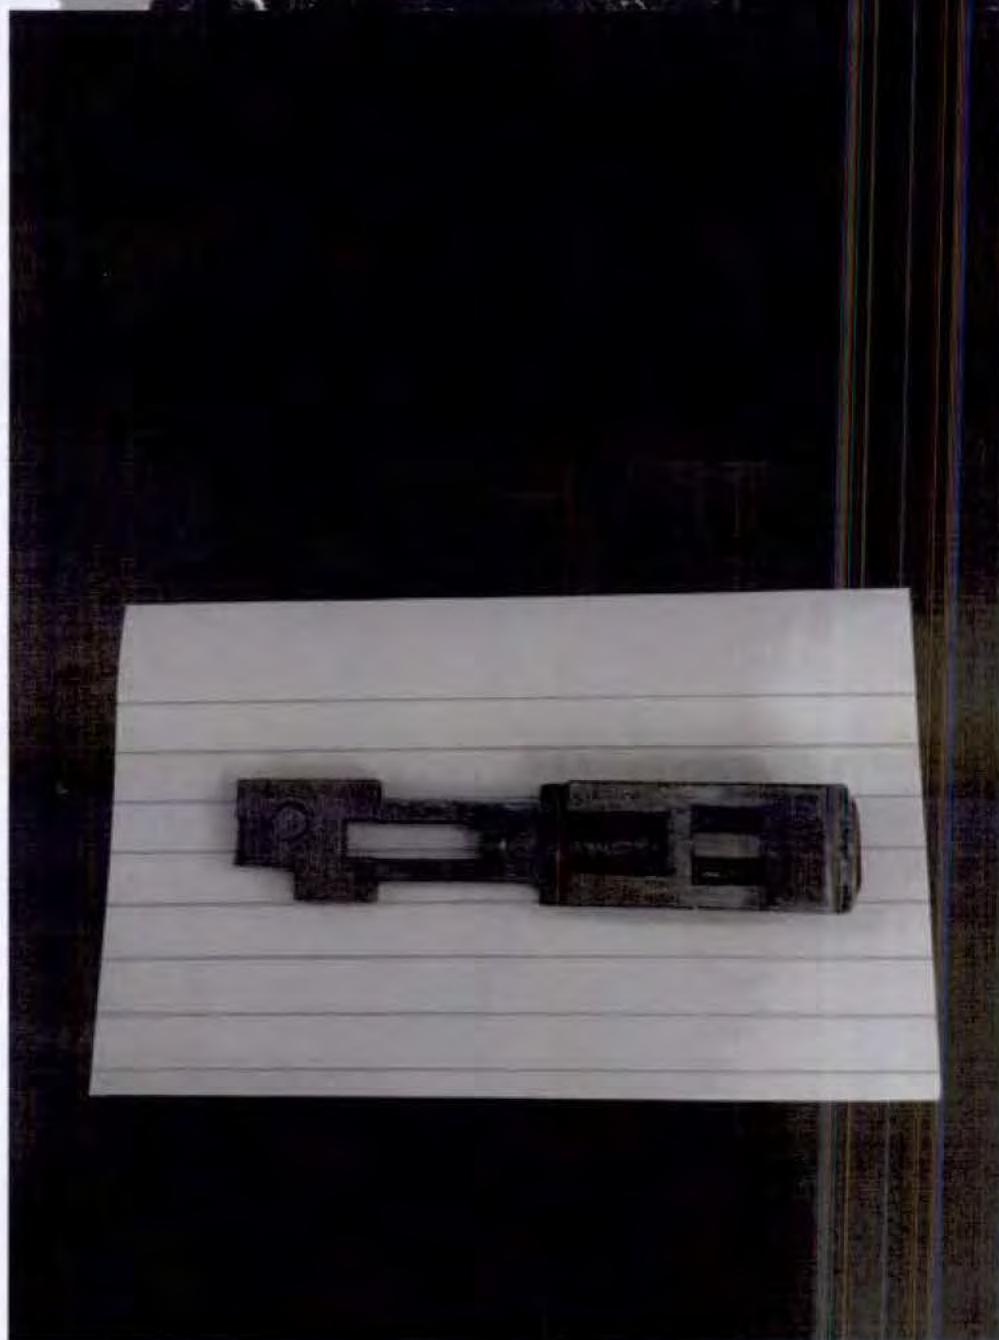
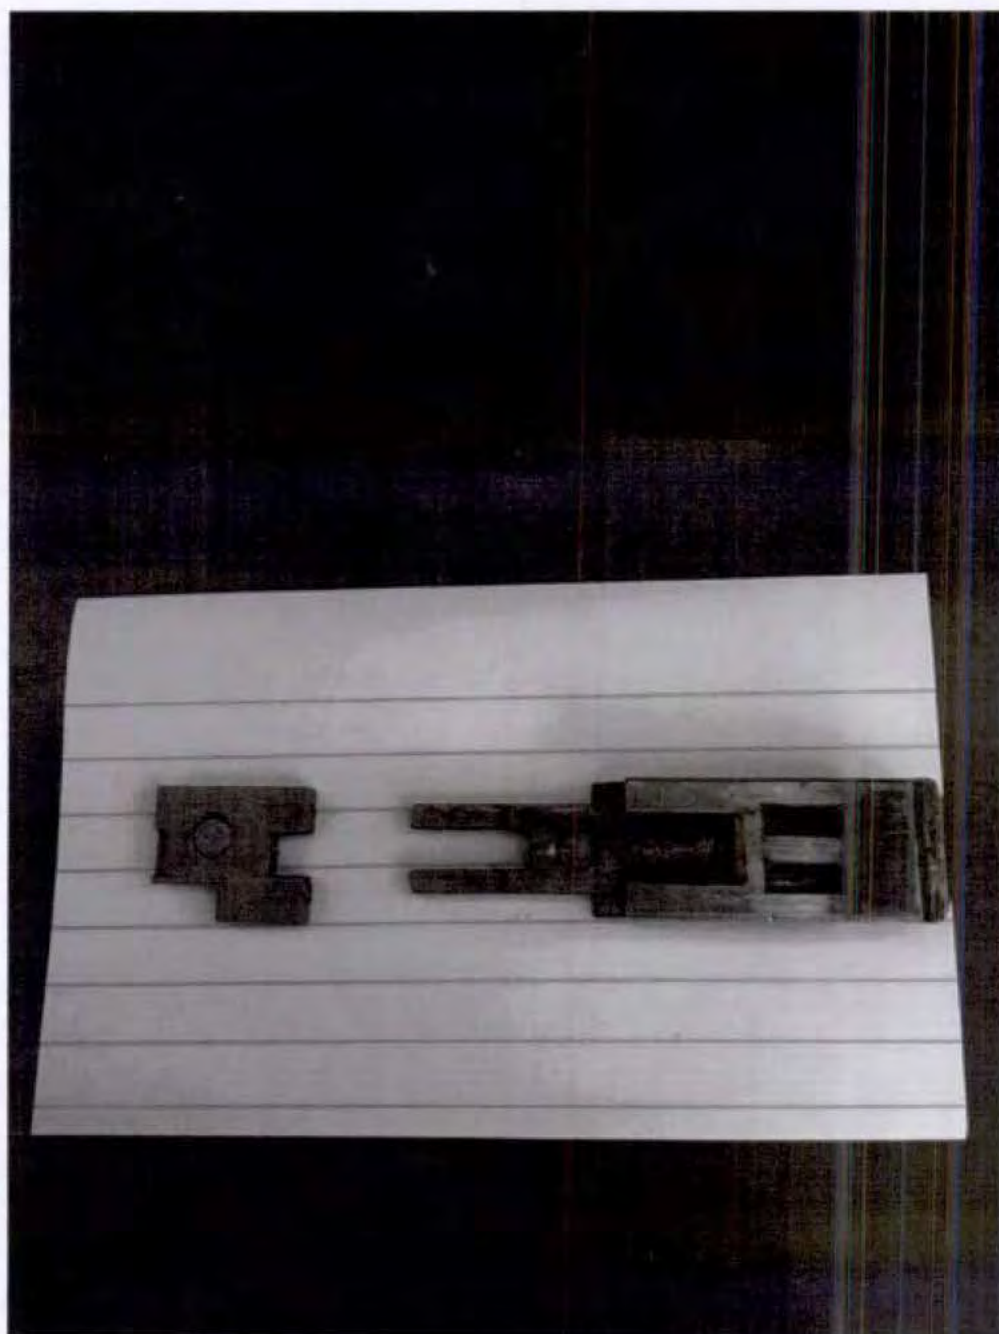
The door just would NOT OPEN. My wife handed me a tool box through the window at which time I took off the cover plate and broken pieces came flying out. I had to disassemble the lock from the inside to release the plunger which was in two pieces. We had tried to call a locksmith but none available to get into the RV. He wouldn't have been able to get to it from the outside anyway. What I discovered was a defective plunger that was made out of POT METAL and not steel.

We bought a whole new lock for less than the \$143.12 plus shipping that Trimark Corp. wanted to charge. They knew they had a defective lock. (see email). We should be reimbursed for this and a memo sent to the dealers.

I contacted Timark Corp. about the problem and received an email from Abby Lechtenberg. She gave me the part #28412-13 that has an upgraded steel plunger but are not honoring the fact that they had a defective part and want to charge me \$143.12 plus shipping to get the replacement. This would not count the labor if I was not able to install. I am forwarding the email conversation. My warranty from Thor does not cover this but needs to be placed on a recall to hold Thor and the Lock manufacturer responsible.

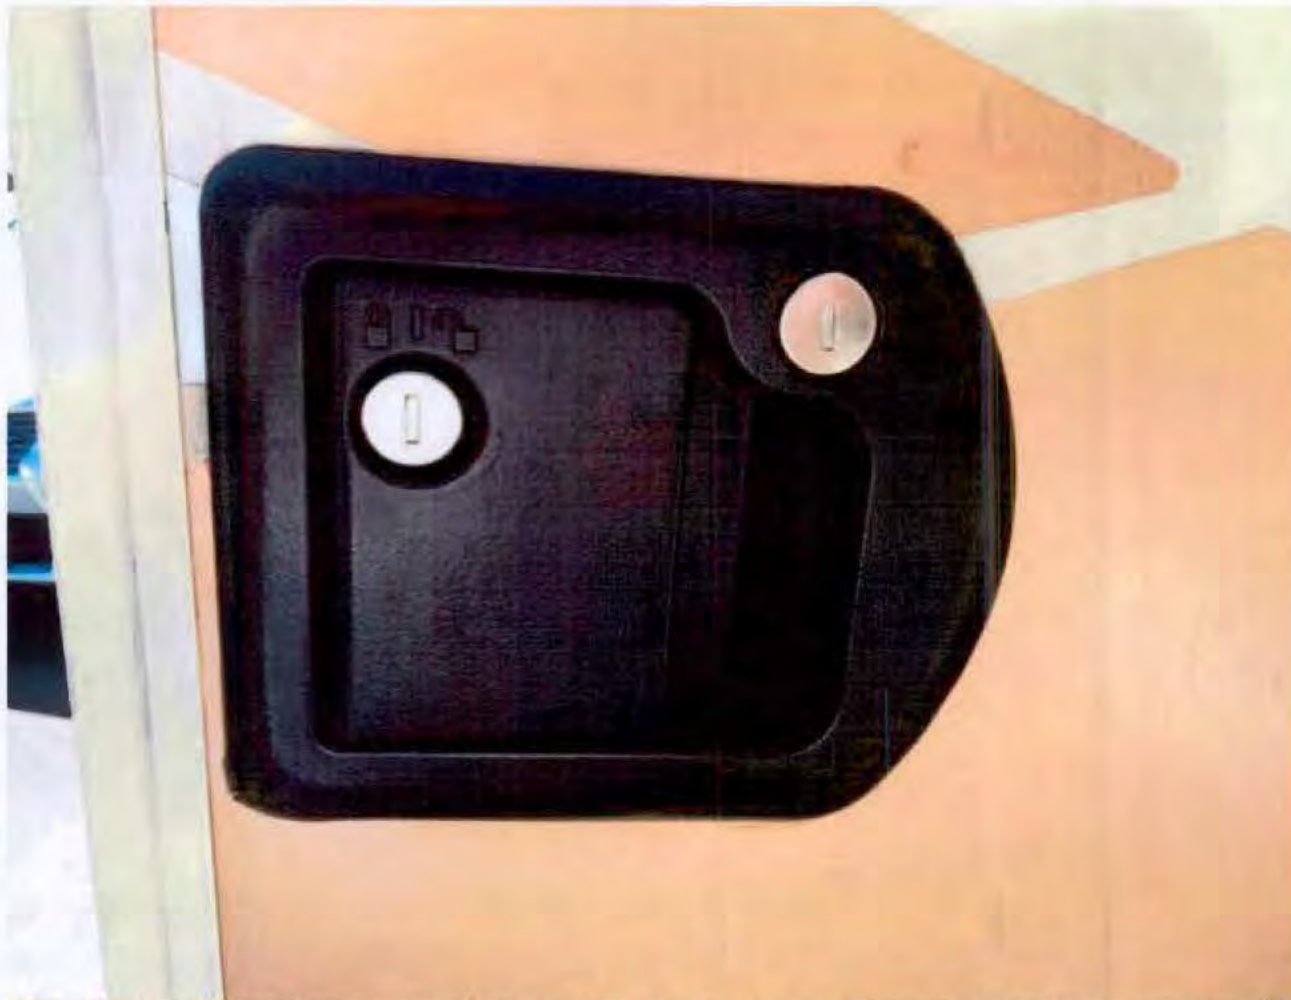
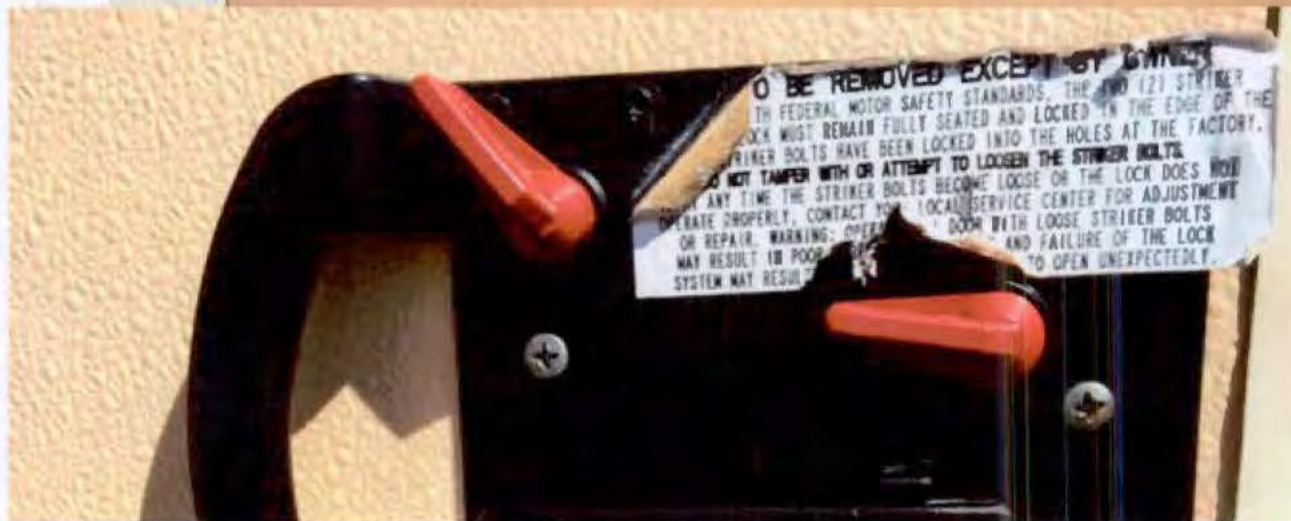
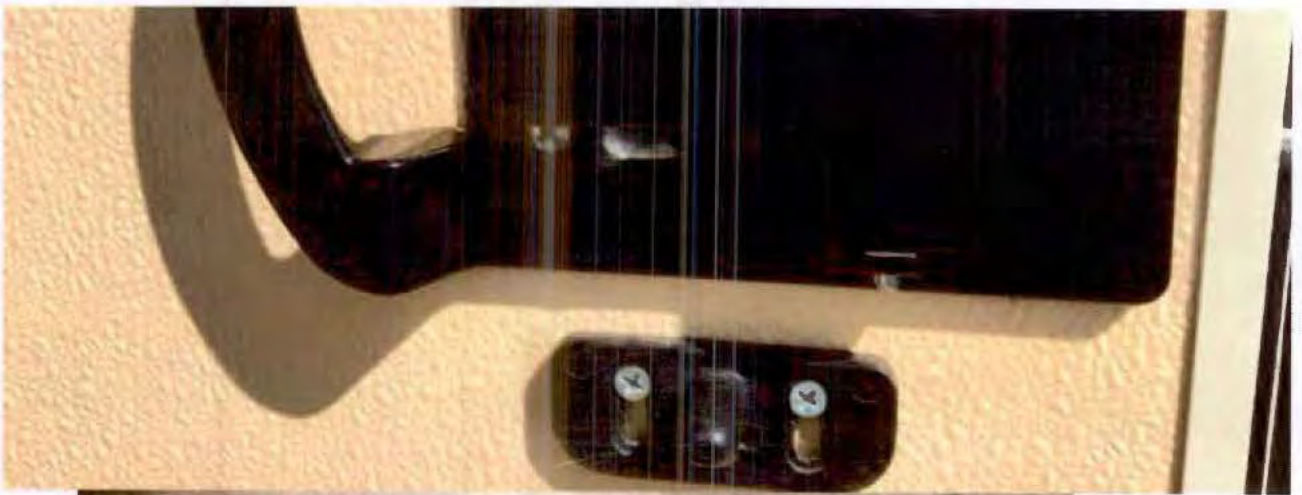
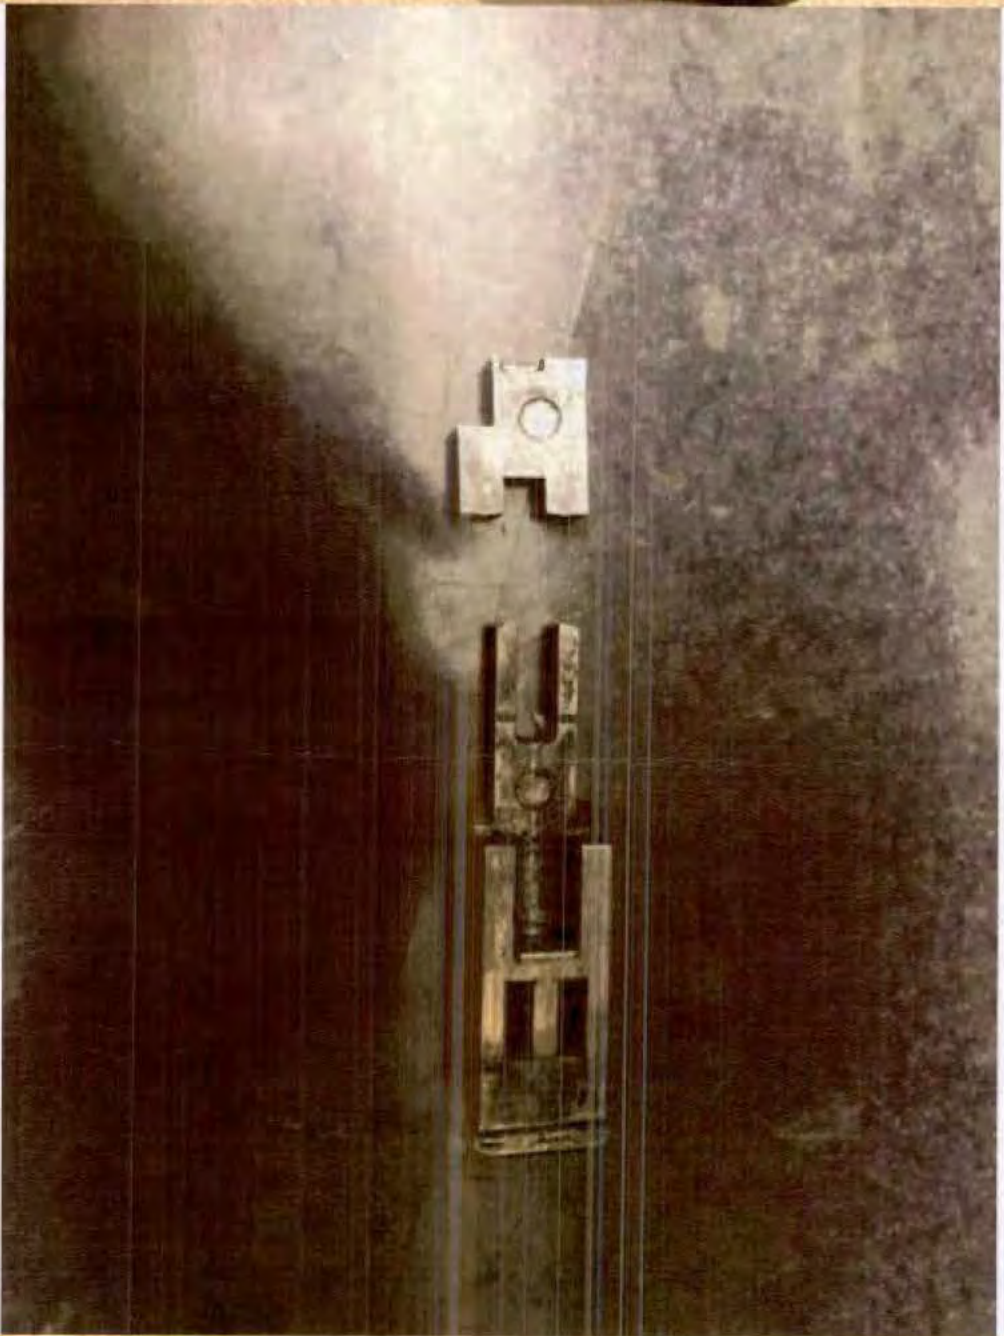
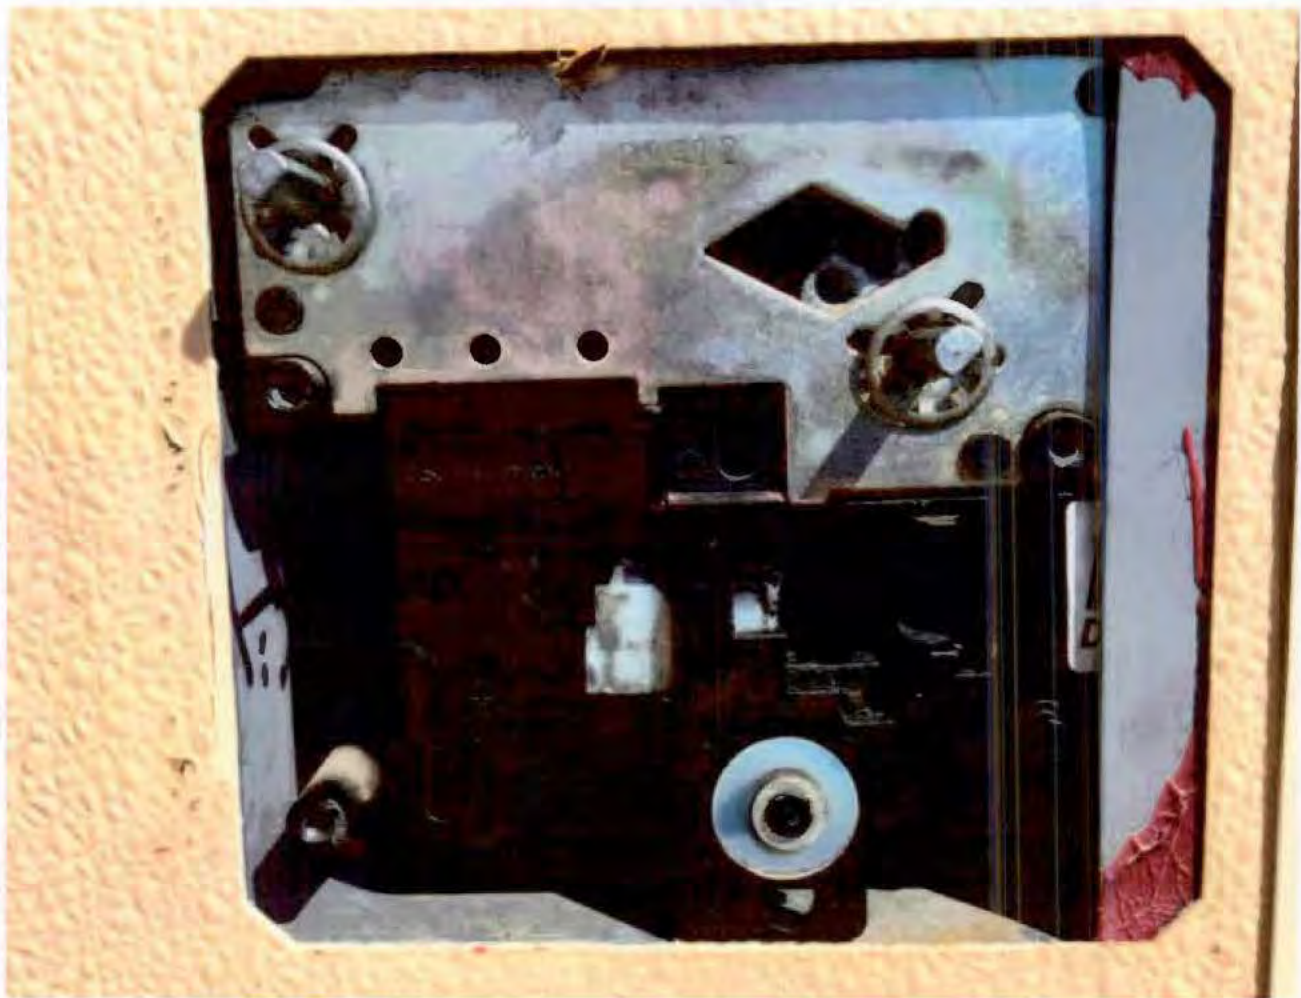
We were locked out of our motorhome last weekend due to a defective plunger that is made out of pot metal and not steel .Had to crawl in thru drivers window and disassemble lock from inside to release plunger which was in two pieces. With some investigation I find that this is a known failure part with this lock and has left many people either locked out or in their rv's Please help me with repair solutions.

Here are the pictures of the inside and outside of the lock.

[REDACTED]  
The handle you have the plunger is made of zinc. We do carry this handle with a steel plunger.  
➔ The part number for the handle with a steel plunger is 29412-13. The cost of this item is \$143.12 plus shipping. This is only the exterior handle. If your interior handle is fine I would not replace it. We can ship by UPS or USPS. Would you like to place an order?

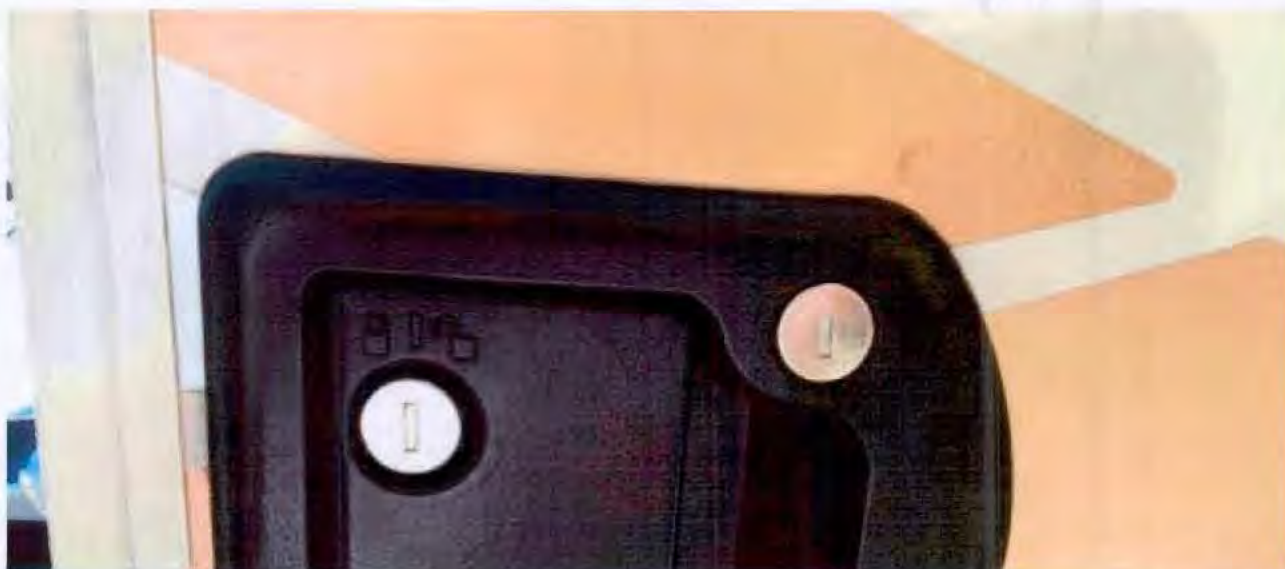
Here are the pictures of the inside and outside of the lock.
