**From:** [REDACTED]  
**To:** Vehicle Safety Hotline; [REDACTED]  
**Cc:** [REDACTED]  
**Subject:** ODI # 11267990  
**Date:** Tuesday, October 15, 2019 2:11:21 PM  
**Attachments:** [2006 BMW Repair history.pdf](#)  
[Fuel Leak NHTSA Investigation.docx](#)  
[RCAK-13V617-1263.pdf](#)  
[RCMN-13V617-2678.pdf](#)  
[RCNL-13V617-0123.pdf](#)  
[RCRIT-13V617-4409.pdf](#)

## **Fuel Leak - Motorcycle**

**Subject:** Fuel Pump Flange may Leak

**Model:** Model variants of R 1200 (K2x), K 1200 (K4x), K 1300 (K4x), K 1600 (K48), S 1000 RR (K46) across model years 2005-2012

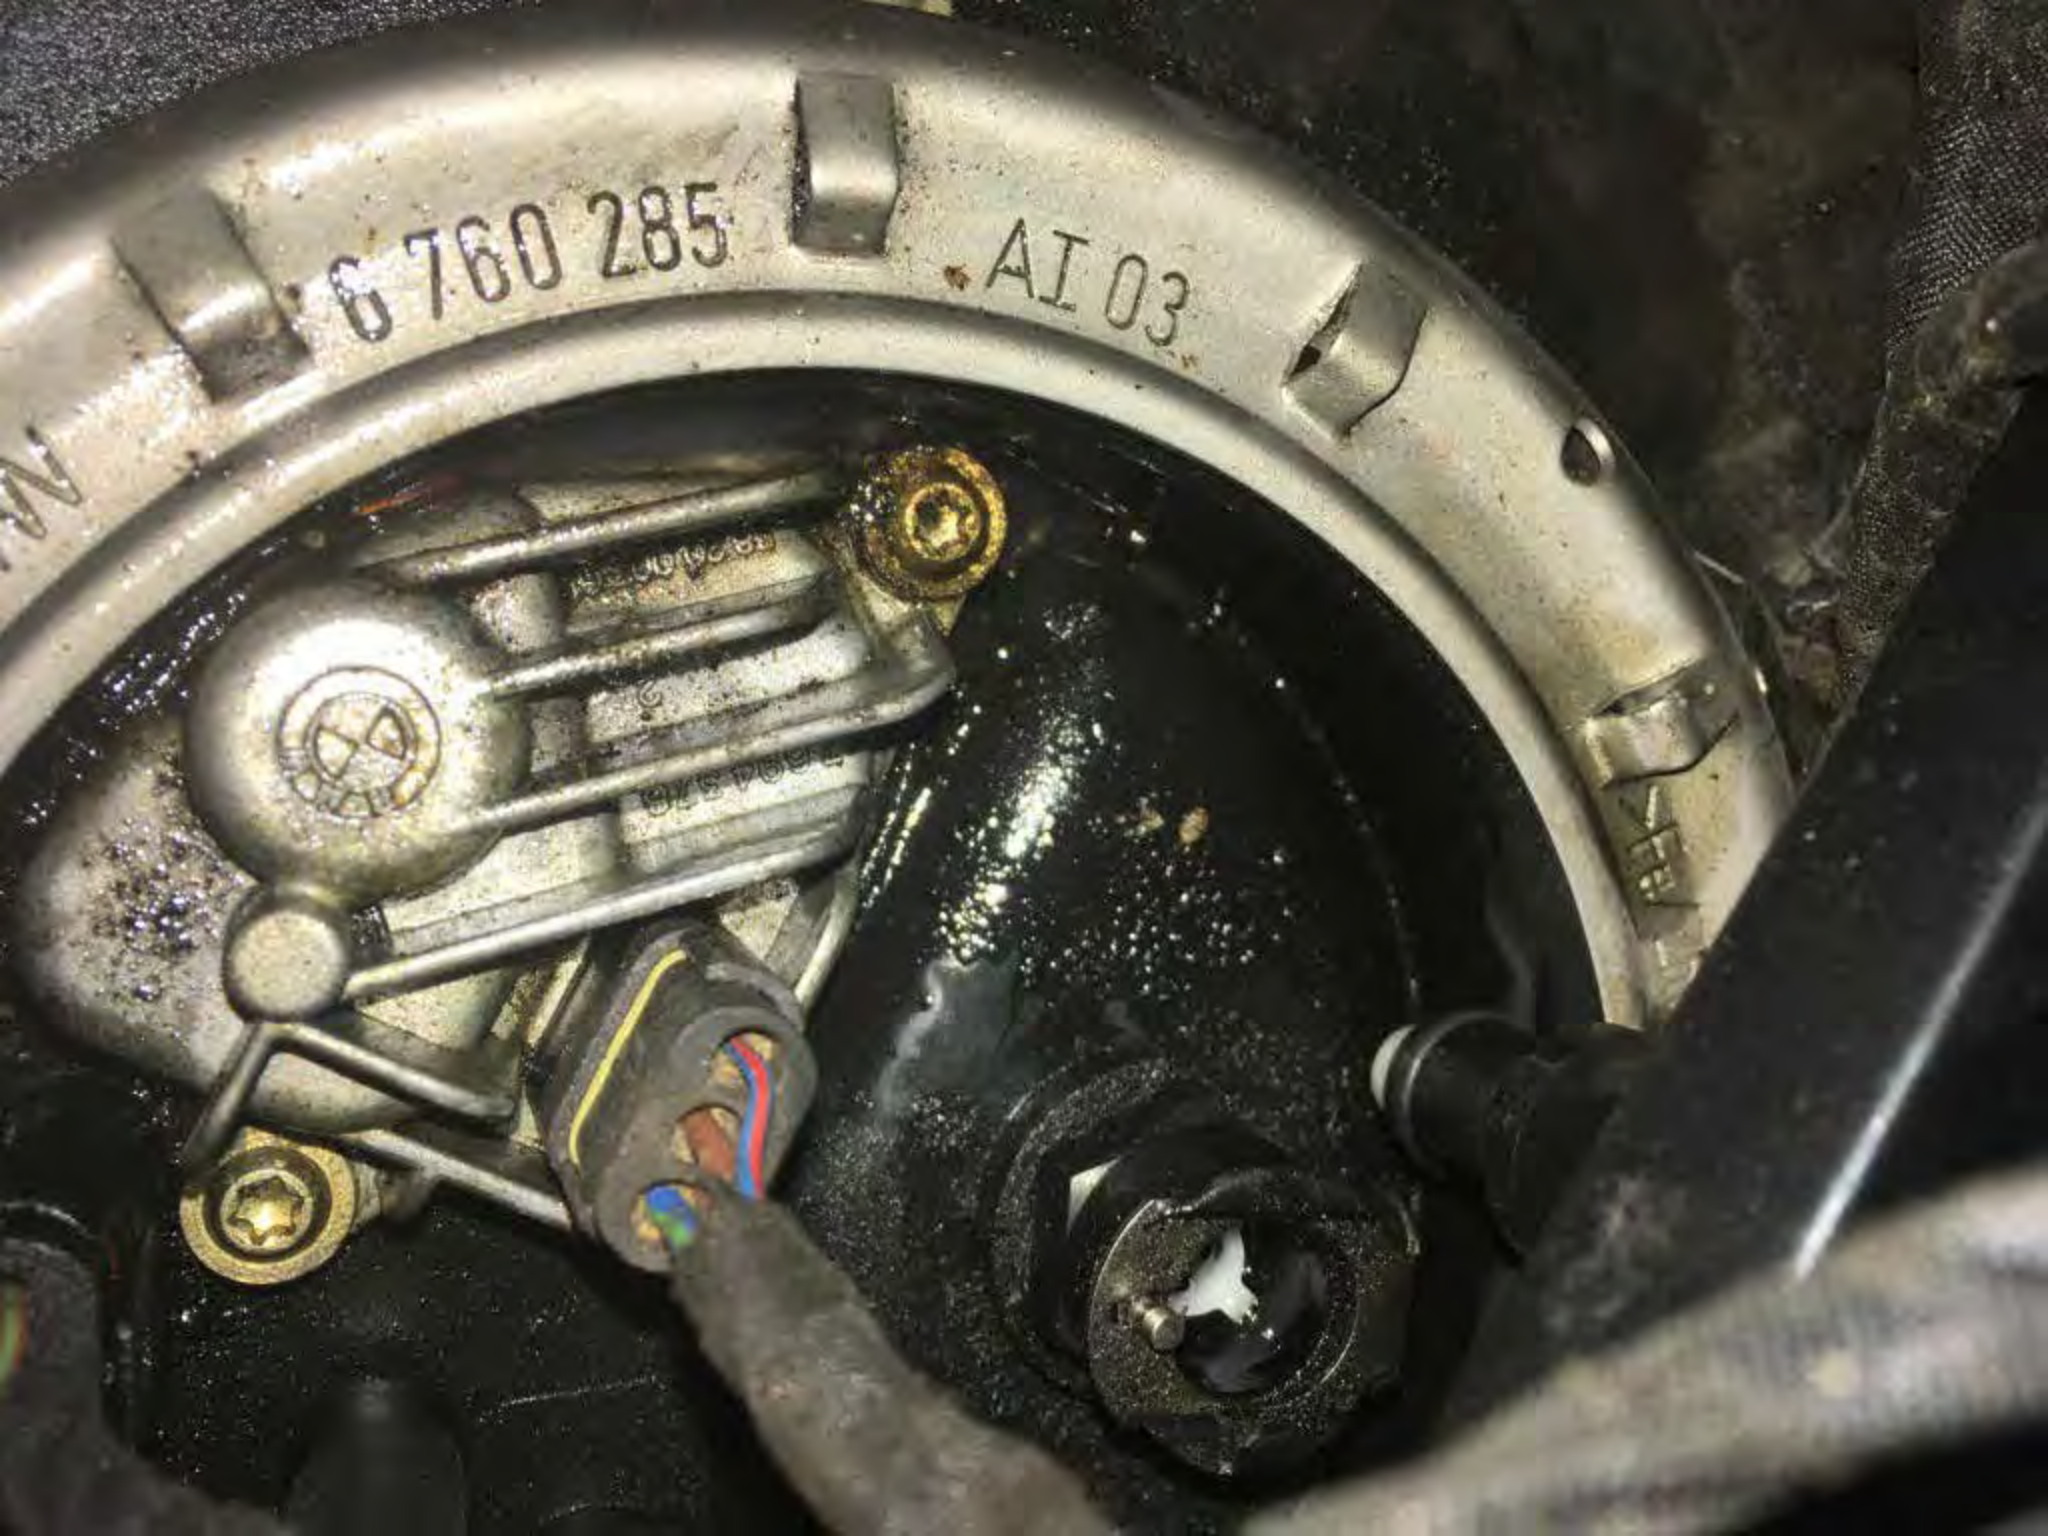
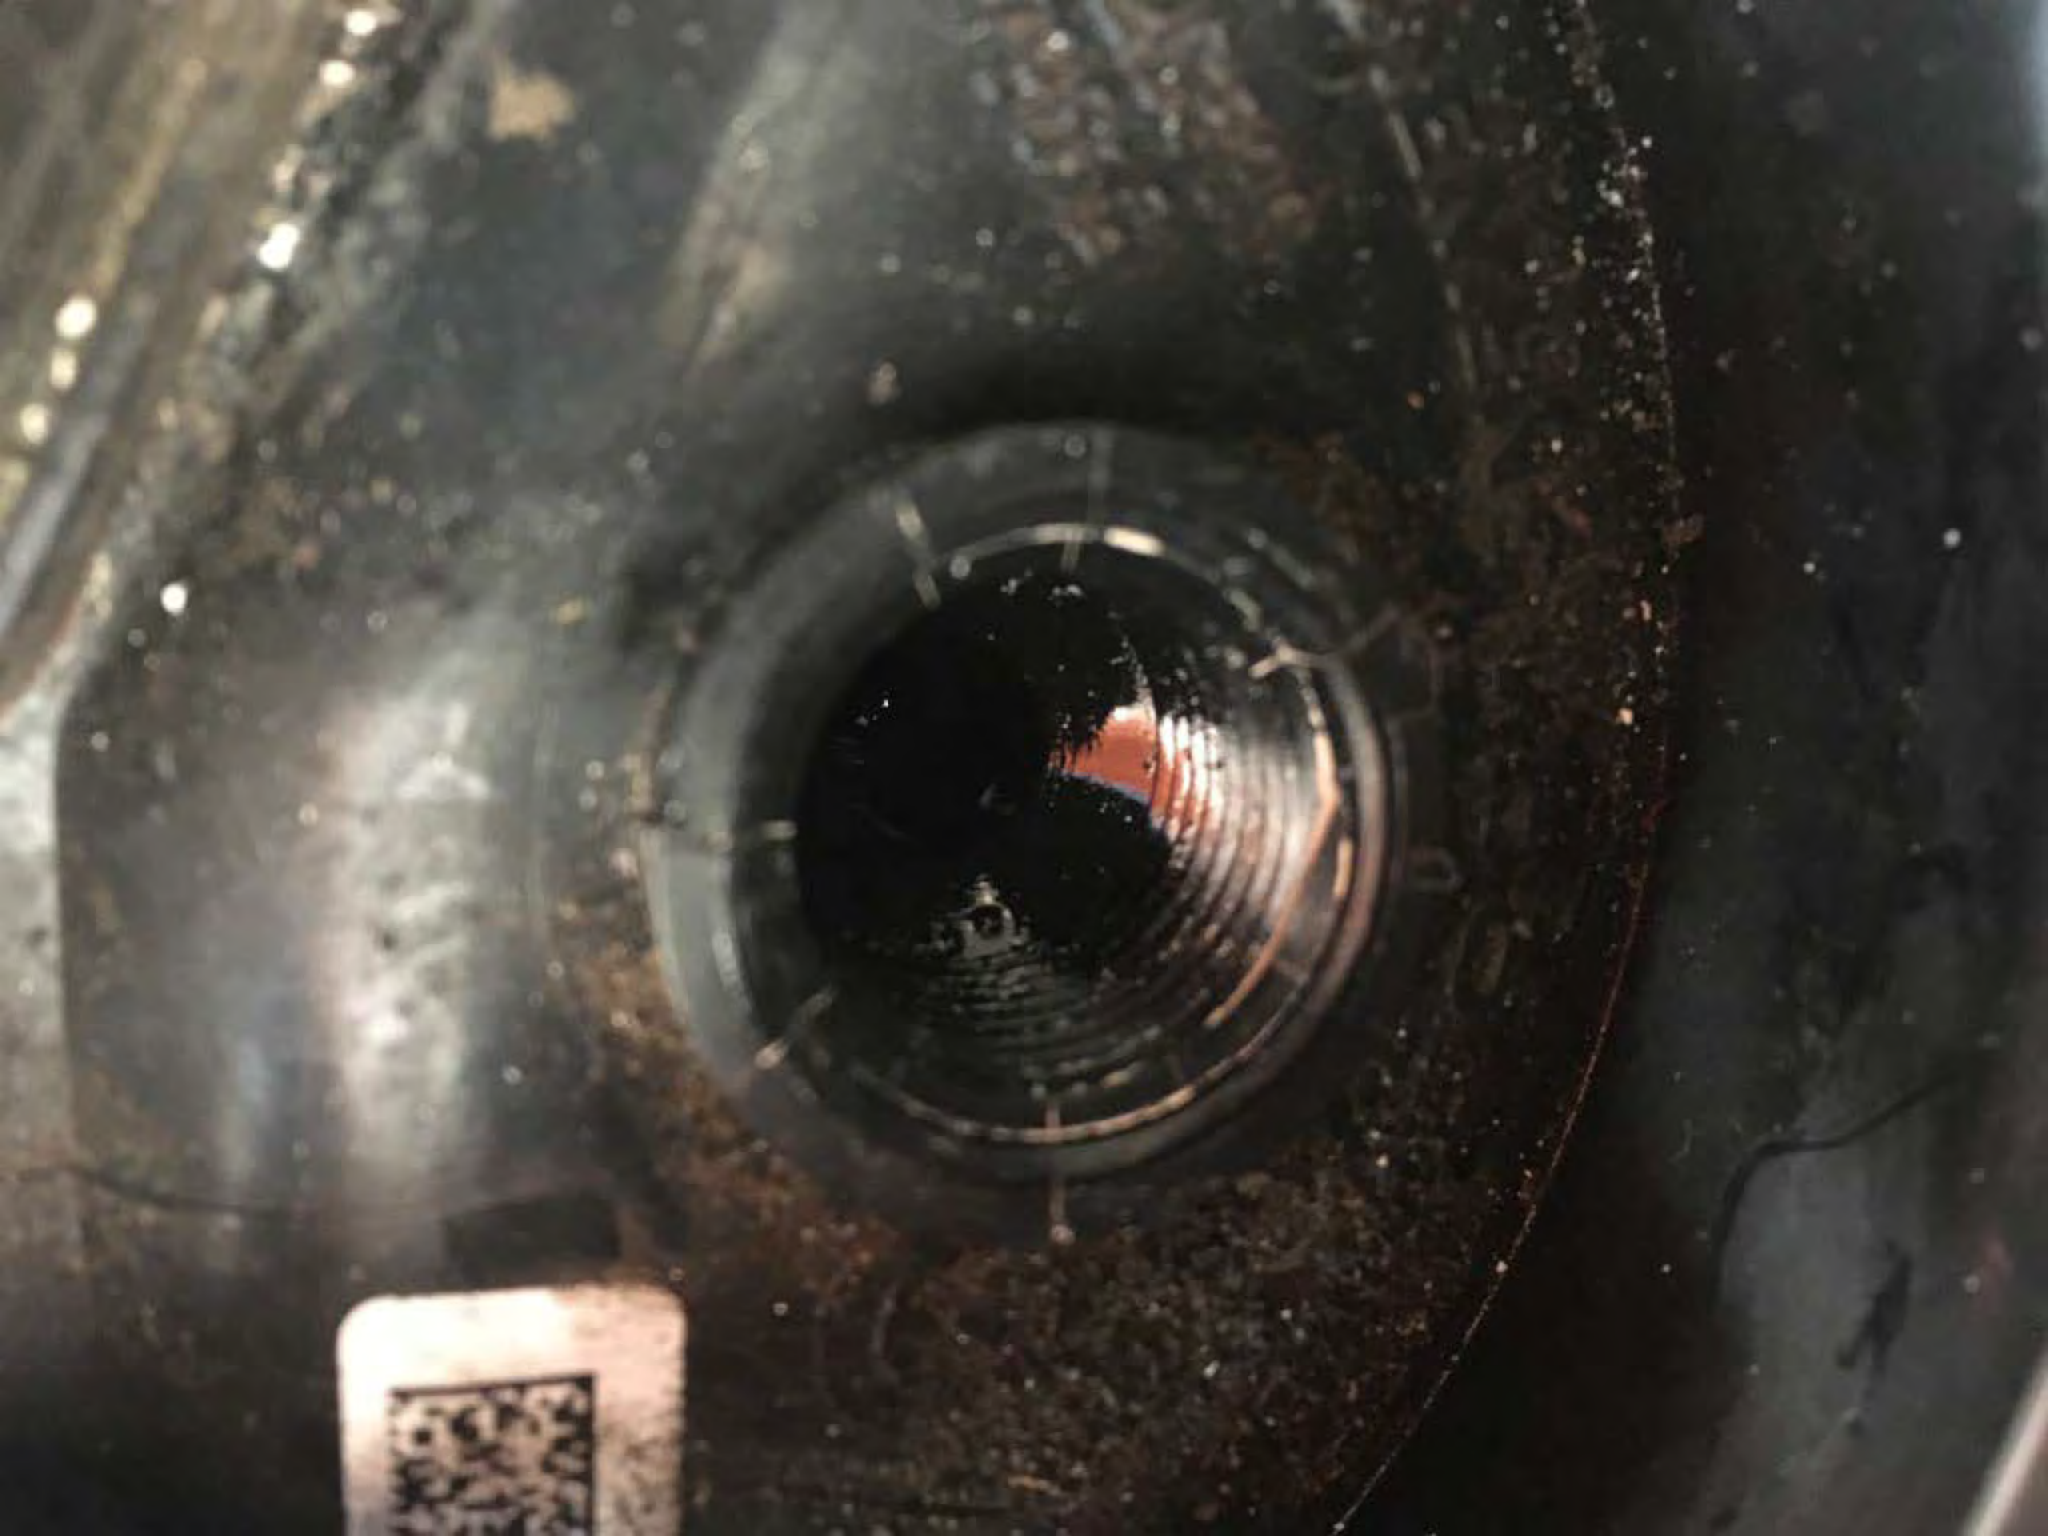
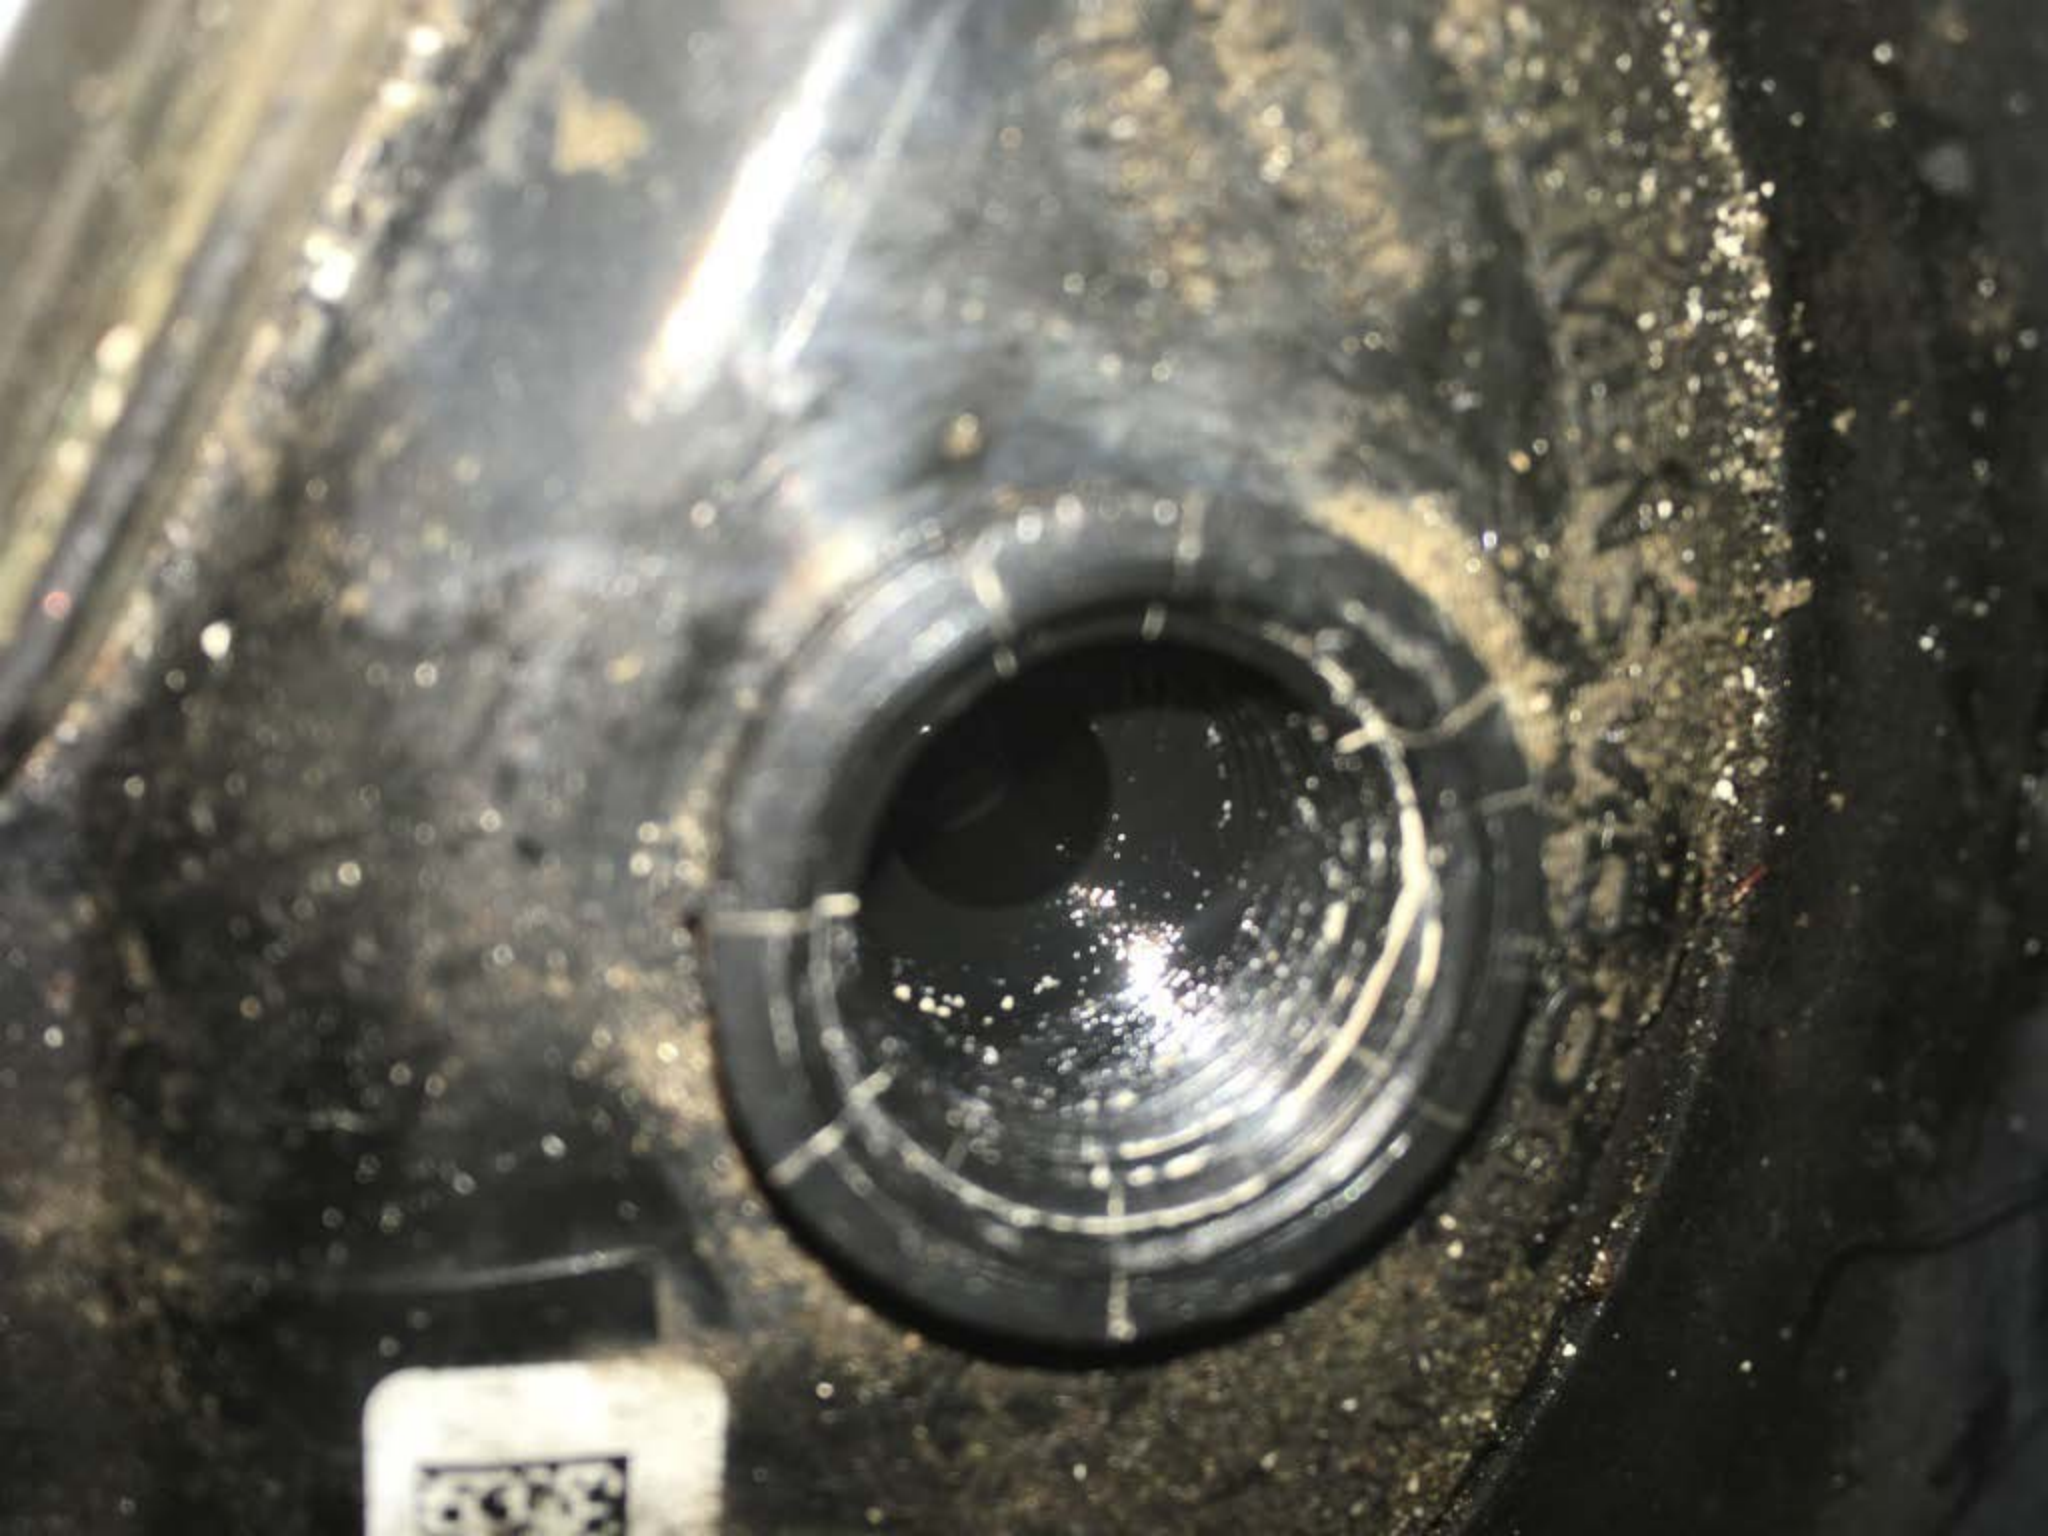
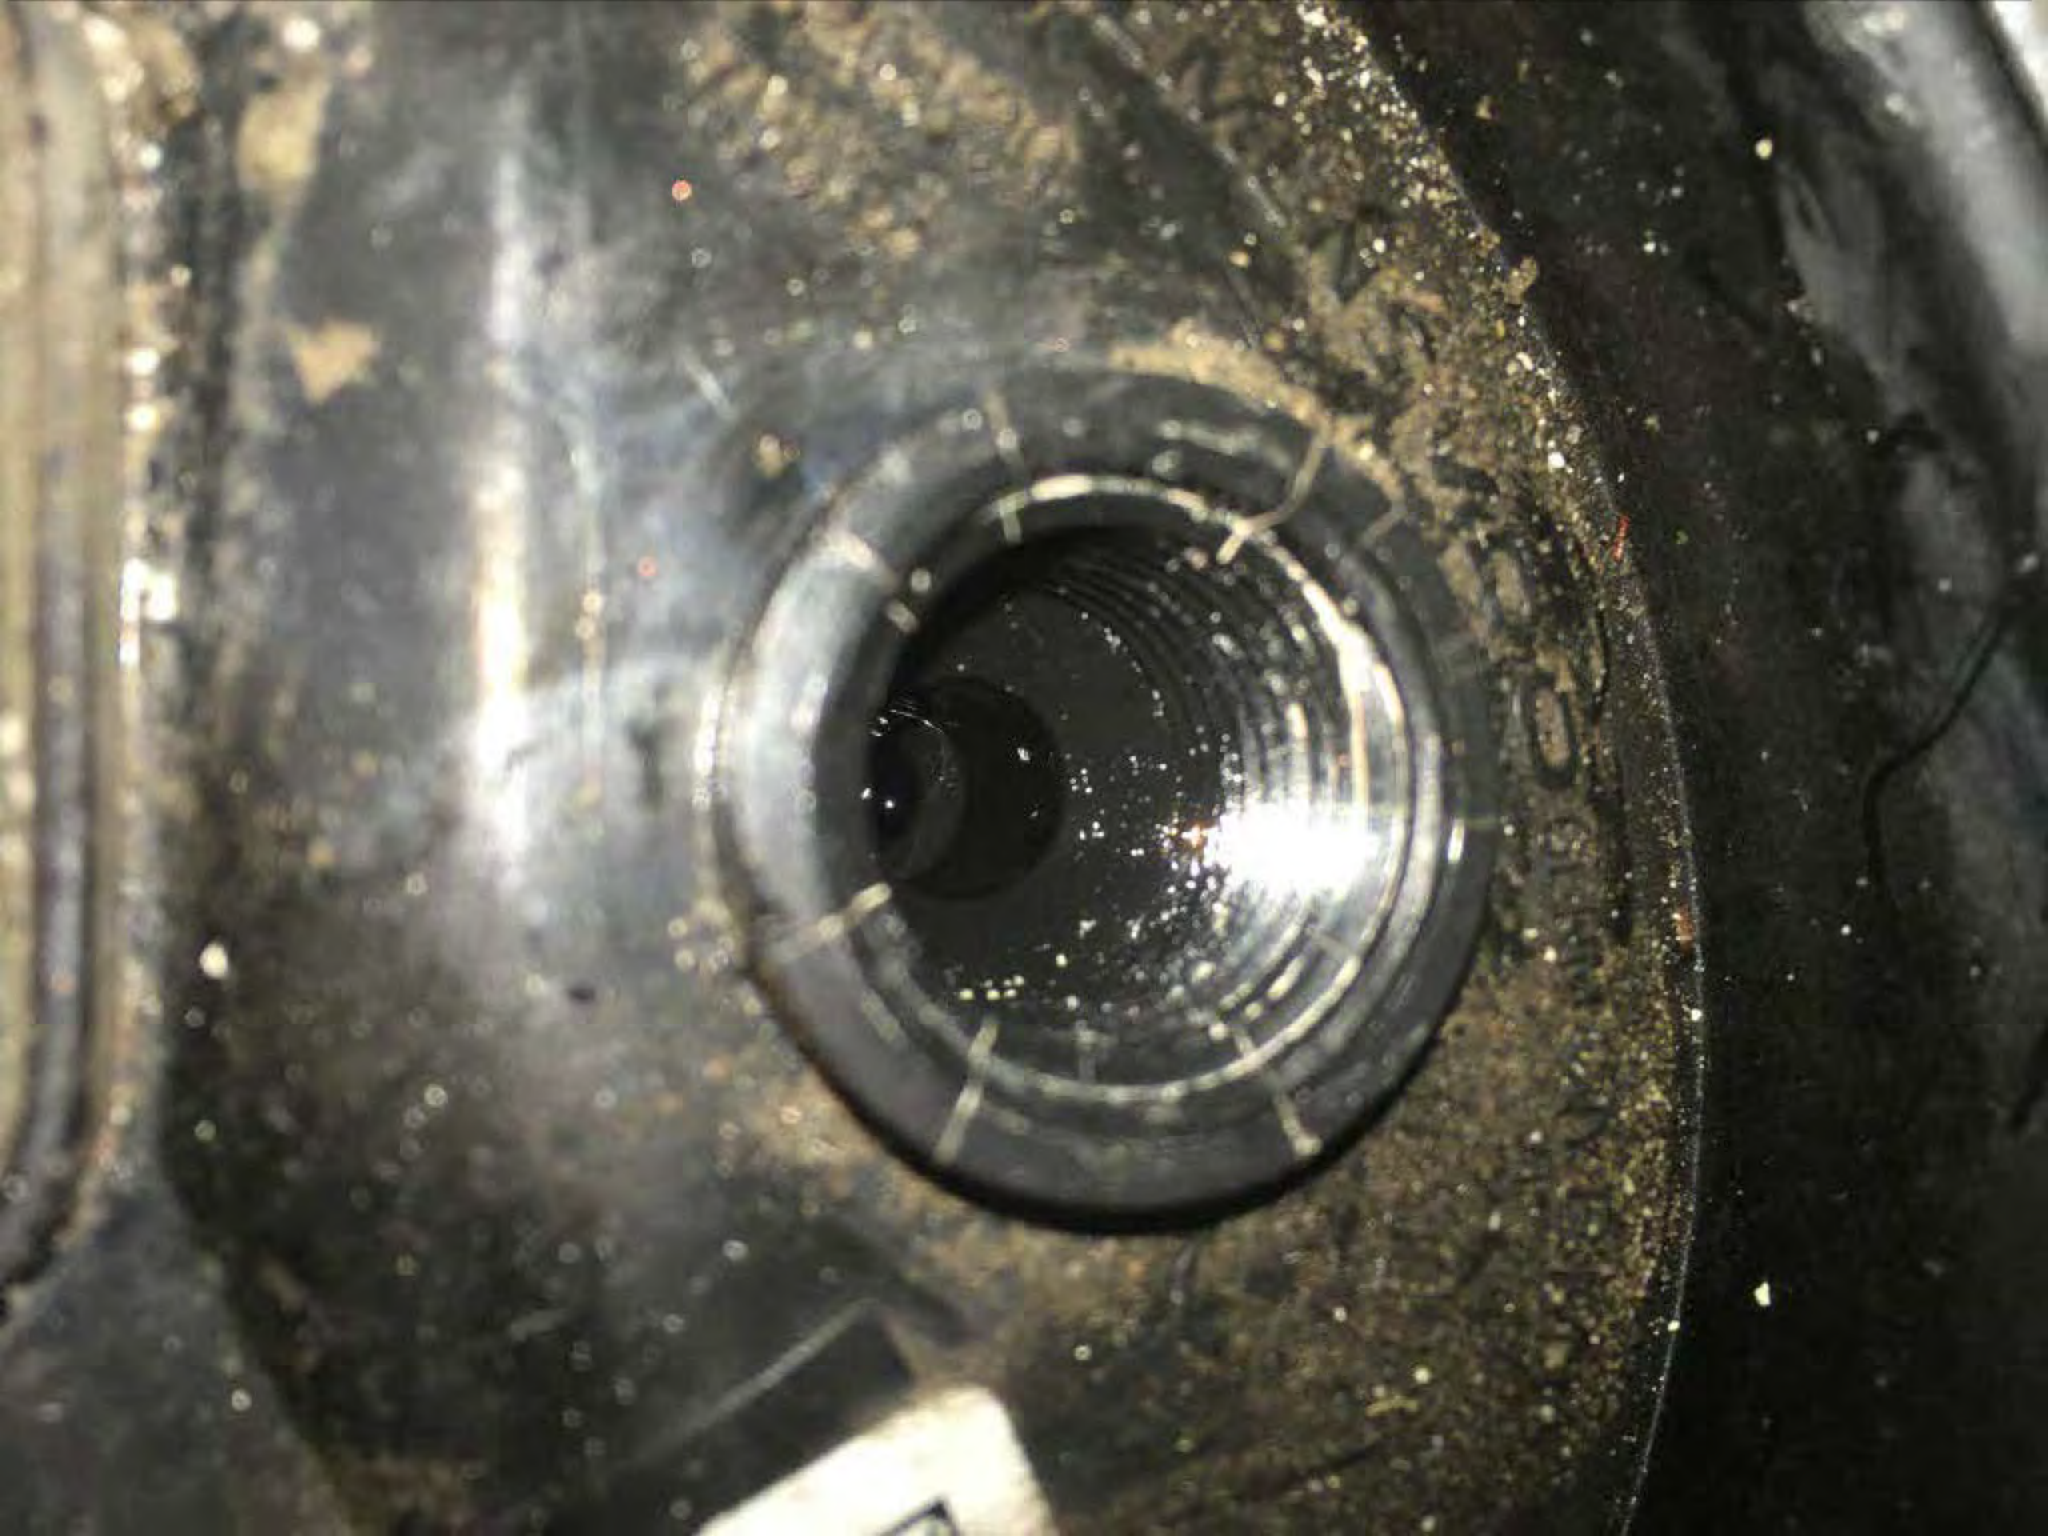
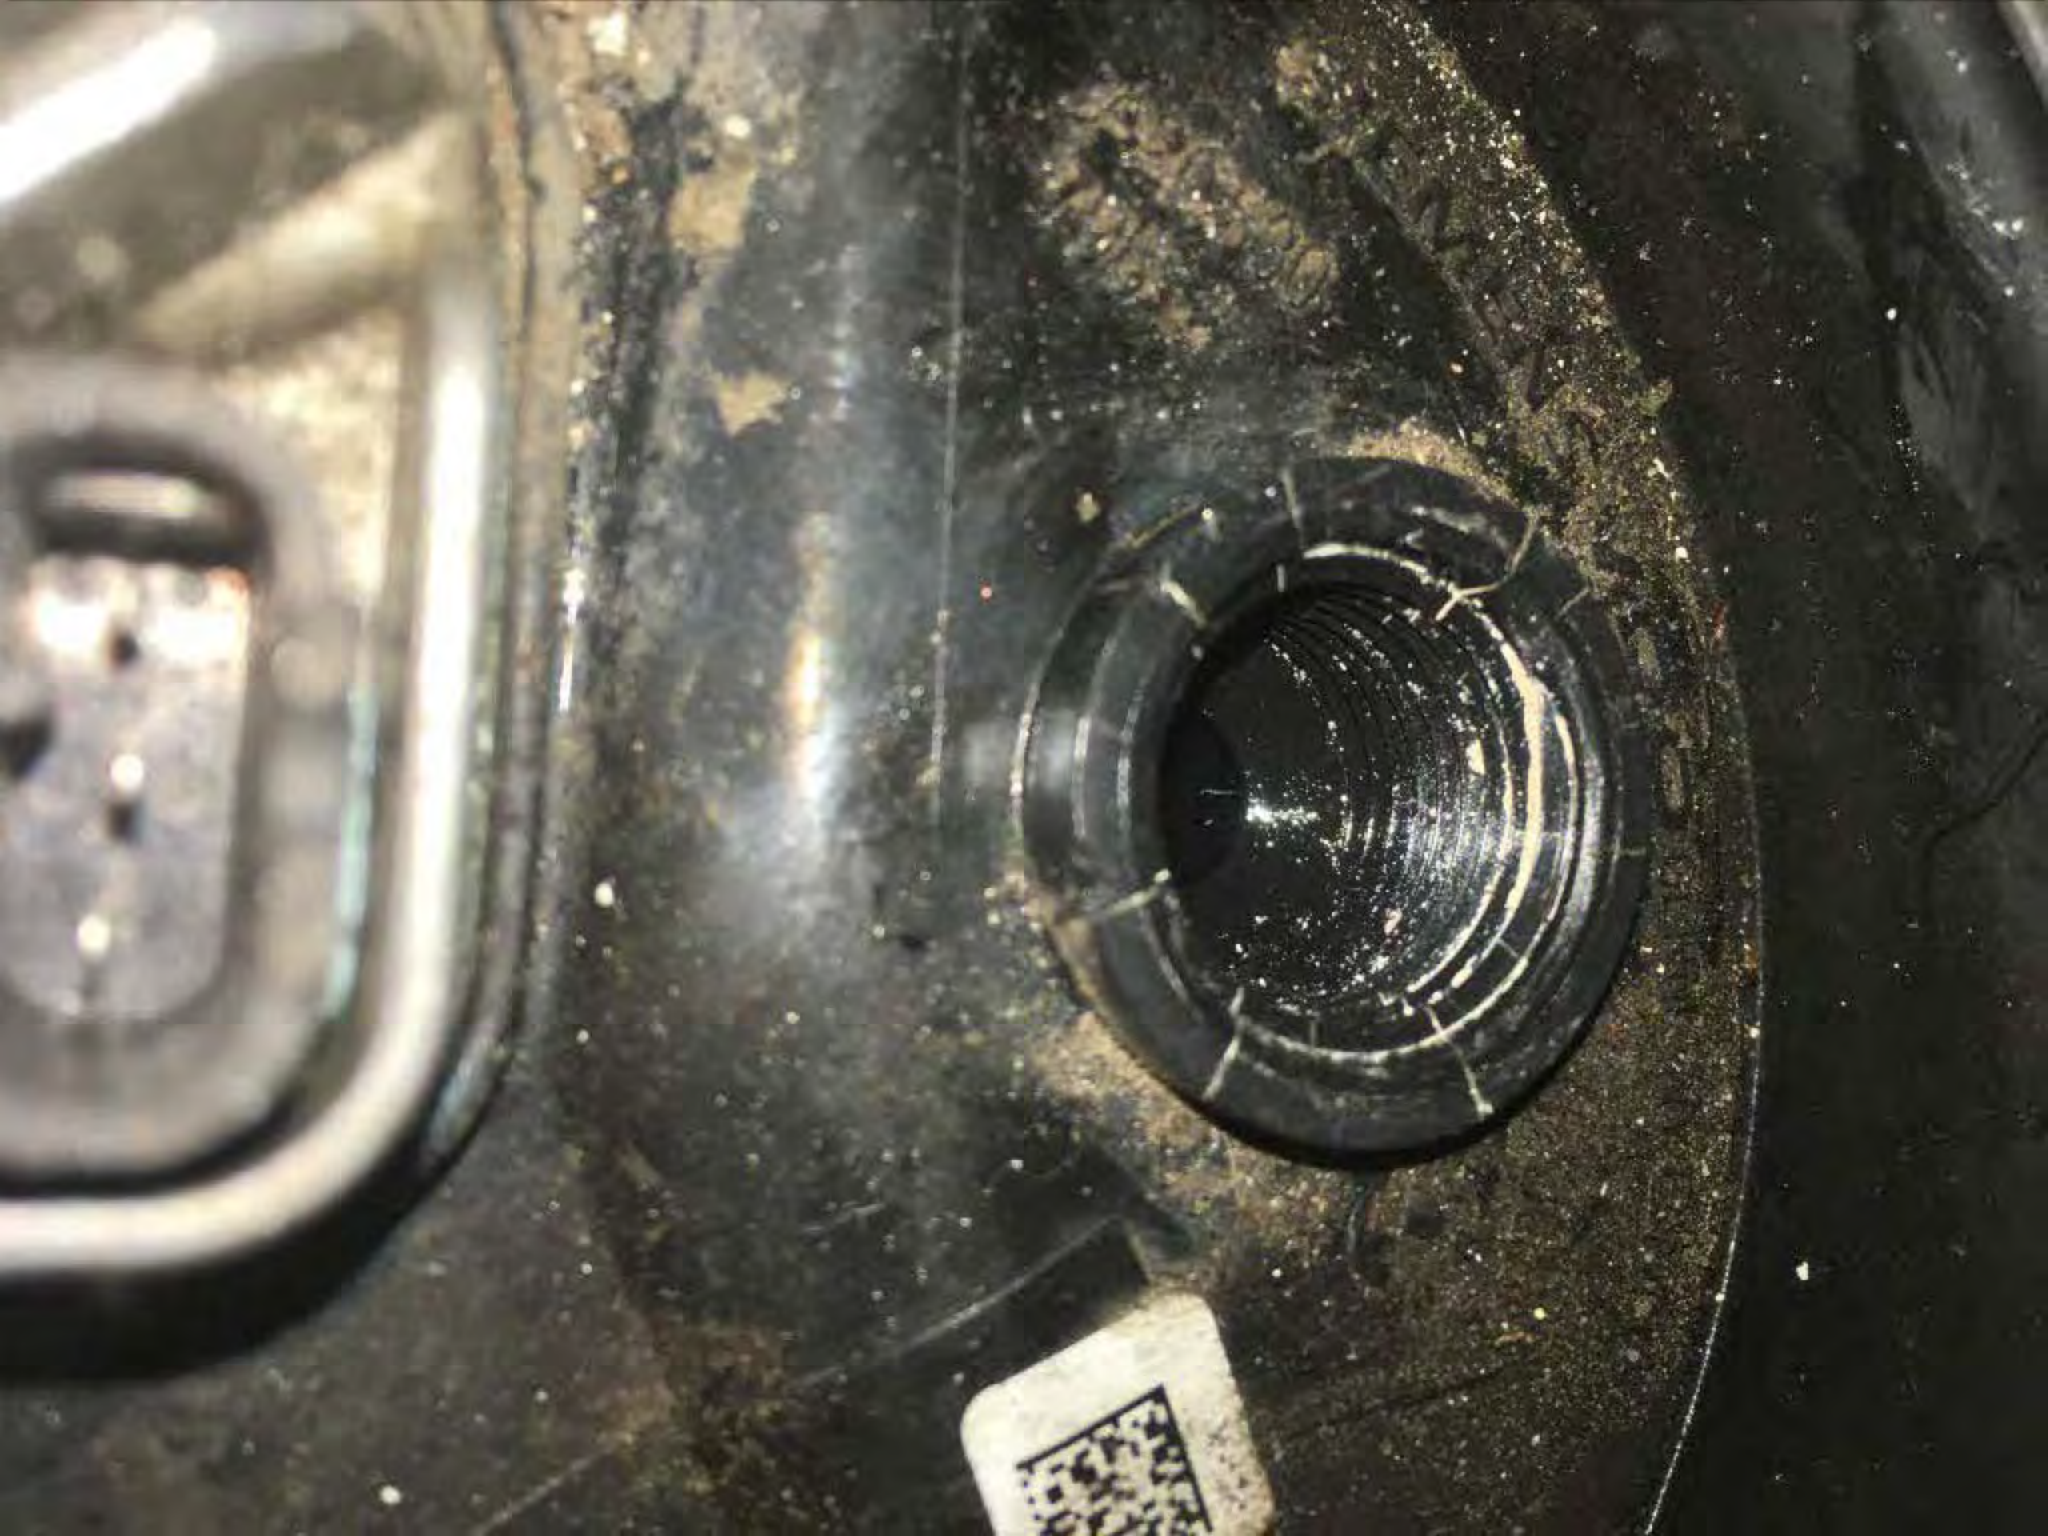
Repair history indicates my bike was checked for this issue but there is no information on whether repairs were performed. Given the information in the technical document, either the pump was replaced entirely or there was nothing done. No metal reinforcing ring was placed on the fuel pump, so either the pump was replaced with another faulty pump or no repairs were made. This recall was not addressed on my bike even though the bike was checked.

I am having the exact issue mentioned for Siemens fuel pumps in BMW motorcycles under the recall.

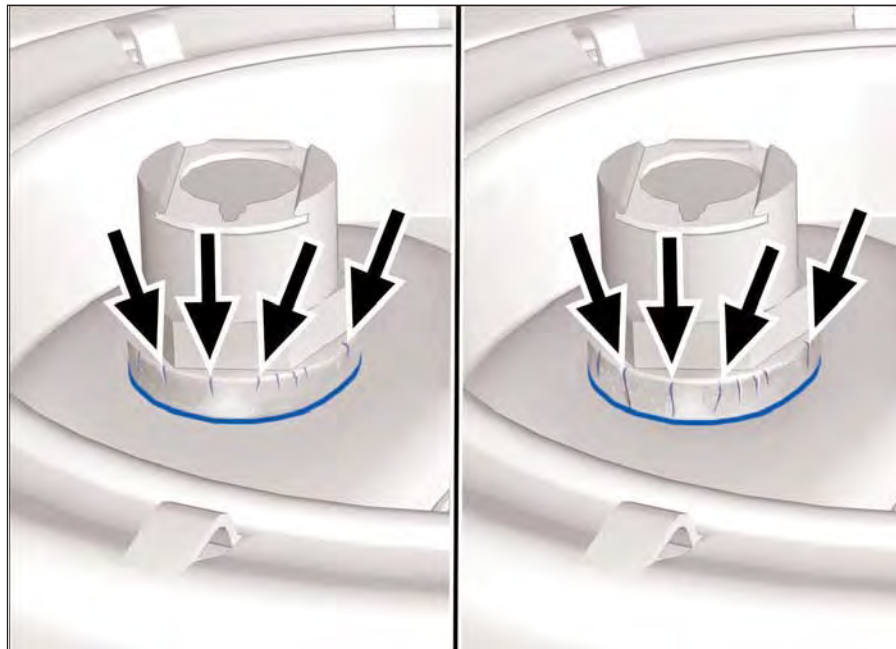
**Details:** BMW Motorrad has ascertained that fuel pump units and depending on the model, additional fuel pump units, might develop cracks at the mounting location for the quick-action coupling. In very rare cases leaks can occur with a perceptible odor of fuel or the escape of fuel in small quantities.

Illustration: Examples of fuel pump flange with cracks (arrows) in the mounting location for the quick-action coupling. Left - No cracks or cracks that do not perceptibly extend to the edge. Right - Cracks extend to or past the edge.

**Aftersales Solution:** When next brought to the workshop, each vehicle affected by this issue will have to have the fuel pump unit and, depending on the model, the additional fuel pump unit checked. These units will have to be repaired or replaced as necessary, in accordance with the findings of the check (see work items 00 60 277 and 00 60 661 for the descriptions).

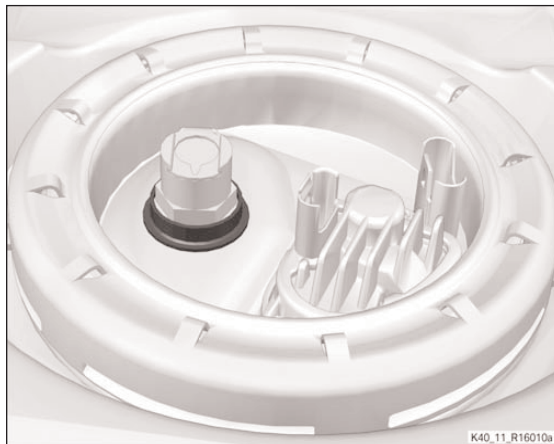
Illustration: Fuel pump flange with support ring (dark gray ring) at the mounting location for the quick-action coupling

**Production Solution:** Since spring 2011 a support ring made of steel has been installed at the mounting location for the quick-action coupling in series production.

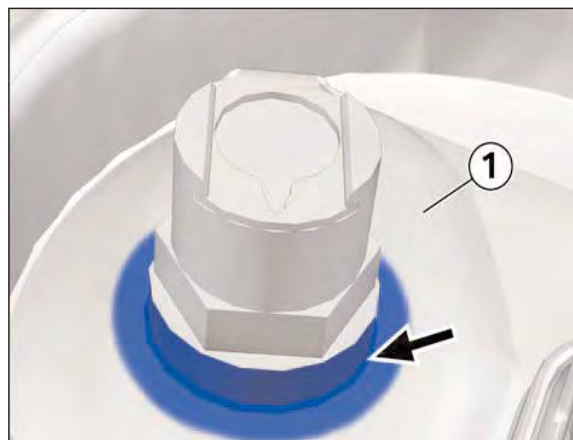
Clean fuel pump unit / additional fuel pump unit (1) where indicated (arrow) with a solvent-free cleaning agent and a cloth.

Fuel pump unit / additional fuel pump unit (1) is absolutely clean, dry and free of dust and grease.

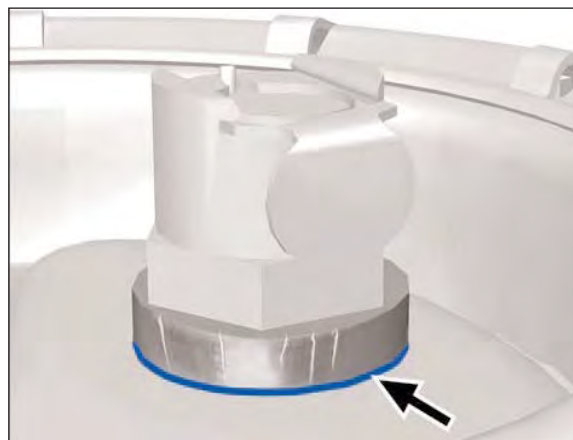
**3: When checking, note the distance of the cracks from the edge (arrow) of the mounting location.**

The number and width of cracks are of no relevance in the assessment.

If leaks are present, if cracks in the mounting location extend to the bottom (arrow), or if the mounting location diameter exceeds a certain measurement, then the fuel pump must be replaced with the current production design which includes the reinforcing ring.

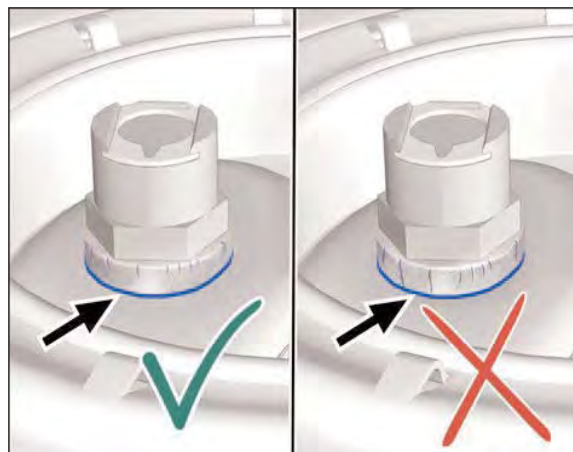
Check the fuel pump unit / additional fuel pump unit for cracks extending all the way to the edge

No cracks or cracks that do not perceptibly extend to the edge (arrow with check mark).

Cracks extend to or past the edge (arrow with x).

Repair the fuel pump unit.

Replace the fuel pump unit / additional fuel pump unit.
