**From:** [DataQuality, DataQuality \(NHTSA\)](#)  
**To:** [EVOQ \(NHTSA\)](#)  
**Subject:** FW: Vehicle Owner's Questionnaire To Report Vehicle Safety Defects and Additional Information  
**Date:** Tuesday, January 14, 2020 2:48:40 PM  
**Attachments:** [REDACTED]

Date: 01/07/20  
To: U.S. Department of Transportation National Highway Traffic Safety Administration  
From: [REDACTED]  
Subject: 2013 BMW R1200R Fuel Pump Defect / Failure/Hazard  
Problem: Leaking Fuel pump on 2013 BMW R1200R with 11,000 miles

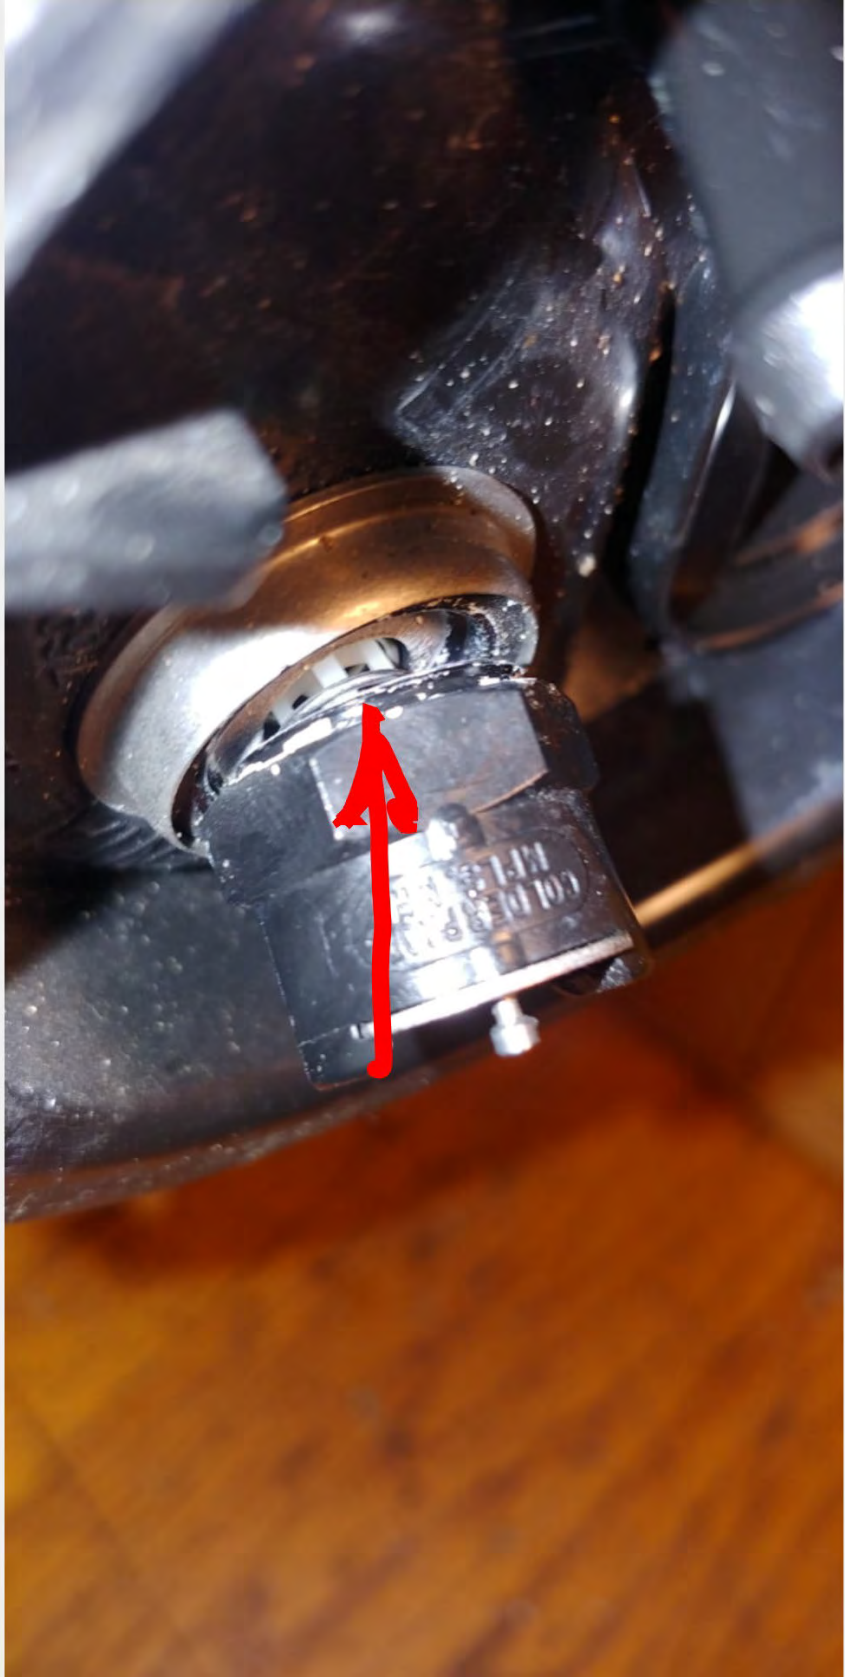
My motorcycle was built in November of 2012 according to the VIN code and it has the fuel pump with the metal band installed from the factory. (See photo of old fuel pump attached). Again, it is the same fuel pump model that was replaced under the recall with the modified band attached. The problem is a design flaw. The metal band doesn't work as intended and the reason is that the plastic is subjected to stress from a tapered thread from the fuel line quick connect fitting. The manufacturer of the pump is

Siemens and the pump demonstrates a design flaw from poor engineering. Siemens should have used a different material or configuration to allow for the inherent stress of the fitting as well as a plastic that does not deteriorate over time when exposed to gasoline.

Photo of the broken flange on my R1200R Fuel Pump. The flange was cracked all the way around the metal band.

I decided to bring the motorcycle to another dealer, Haps BMW located in Sarasota, Florida for a second opinion and they also said it needed a new fuel pump and that it was a common problem. I had them order the new pump and they did the repair (pump replacement). (See attached invoice).

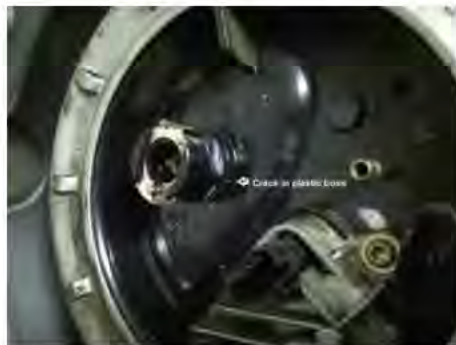
K1200S Fuel Pump-Unit Base cracked

☹️ So my K1200S 2006 has got the dreaded crack in the plastic boss where the Quick Disconnect screws into the base plate of the Fuel Pump-unit. Of course the base plate is not available seperately and the complete unit includes the fuel pump R\$,\$\$\$,\$\$

Apparently this is problem that occurs on a few models and the annotated photo attached, of the crack on my bike, could help identify a similar problem before the petrol squirts out under pressure from the pump - as it did on my bike. See also the forum thread from i-bmw.com:

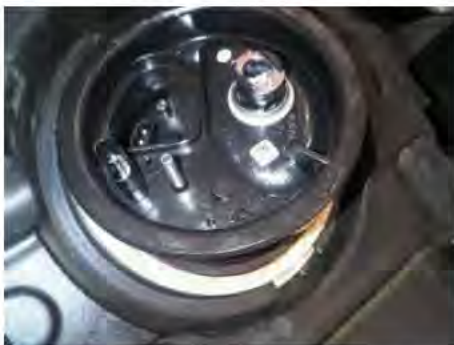
K1200S New Fuel Pump Unit - Metal Reinforcing Ring on Base Plate Boss

The new part comes with a metal reinforcing ring - see photo below. I'm going to reinforce the same place with a Oetiker clamp on the R1200GS.

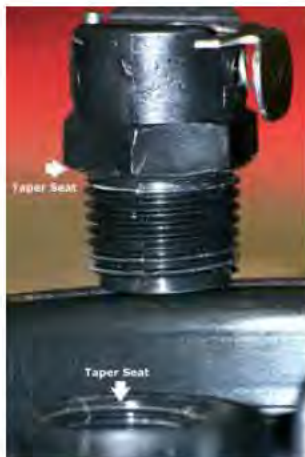
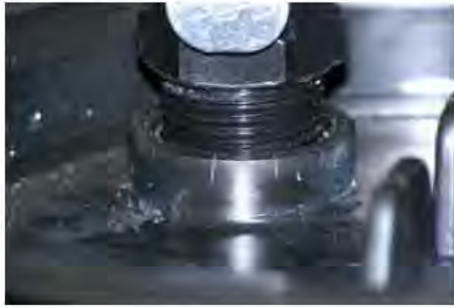
**BMW fuel leaks - The taper design of the couplings causing cracks in the flanges**

I've noticed a fuel smell that progressively got worse, (on my 1200 GSA which I bought new in 2009) but never paid real attention to it. Some time later I noticed a couple of drops on the floor when on her side stand with a full tank. It didn't take long to find the problem though - a BMW fuel coupling designed to fail sooner or later because of the taper design, causing permanent outward stress on the threaded plastic rim of the flange
