### **Settlement Demand**

On the morning of February 25, 2020, I [REDACTED] was involved in a head on collision with a tow truck on highway 210 headed east towards Fontana, California. I was driving a 2004 BMW X3 SUV that I purchased from my coworker/friend [REDACTED] for my daughter. I cannot recall the exact speed of impact, however the SUV suffered extensive damage while the tow truck had little to no damage. (see attached photos). If I were to estimate the speed of collision, I

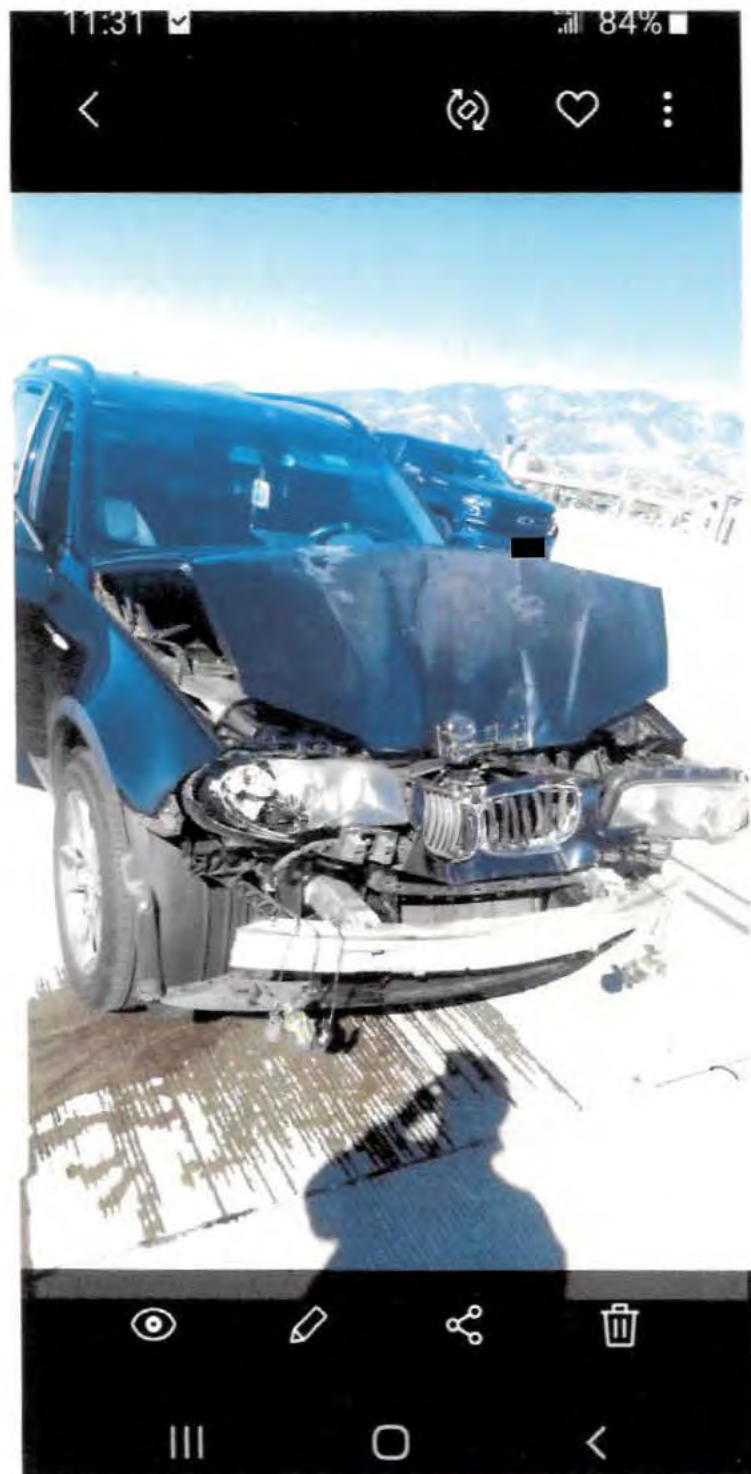
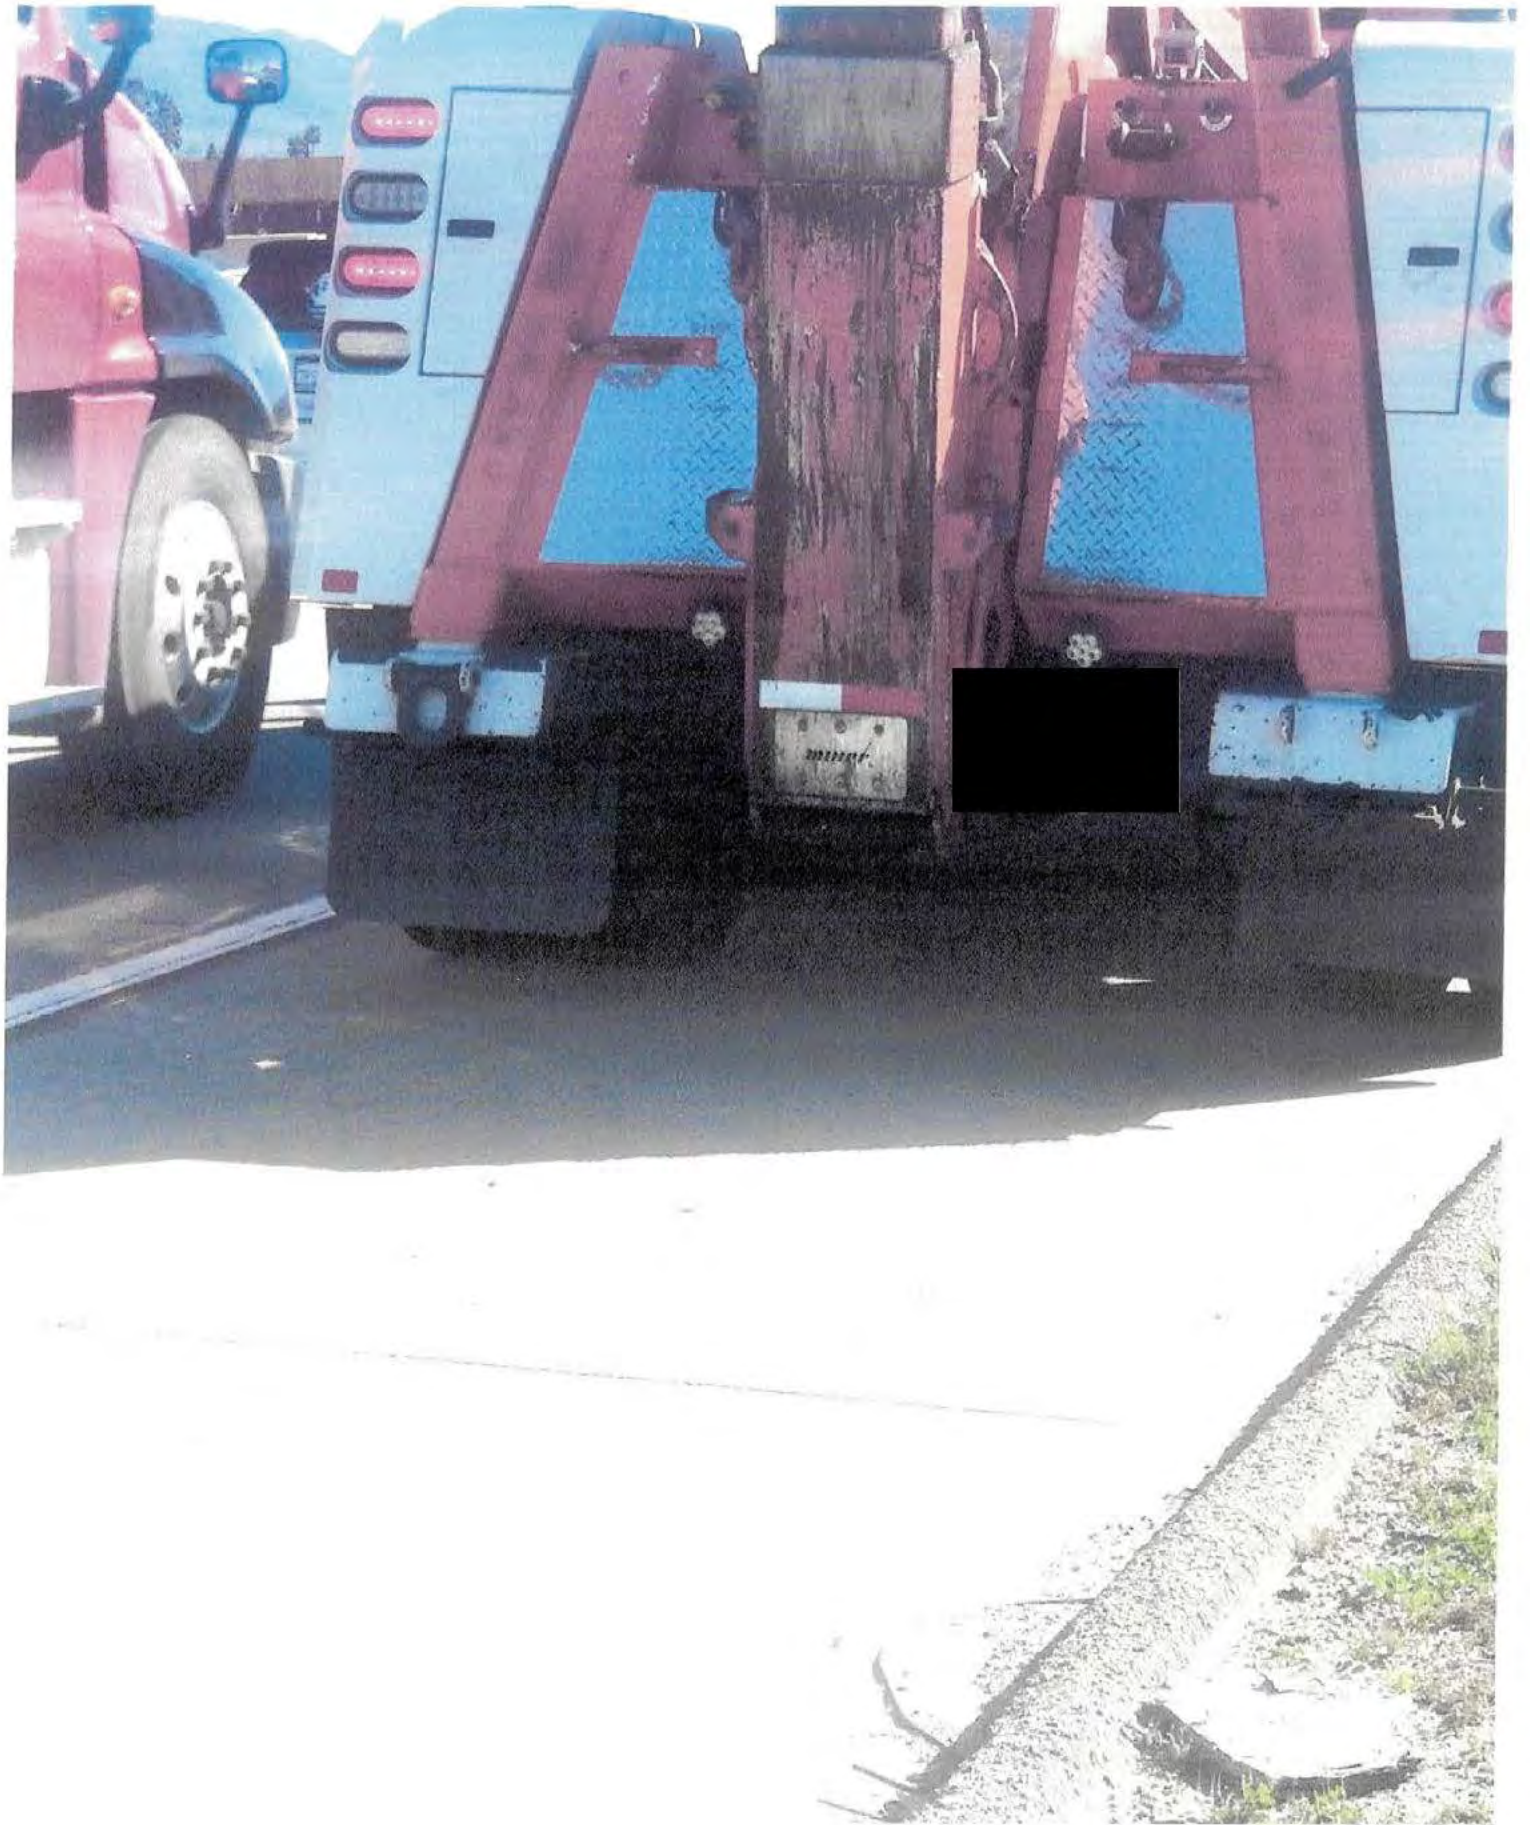
2/25/20 Post accident  
photo.

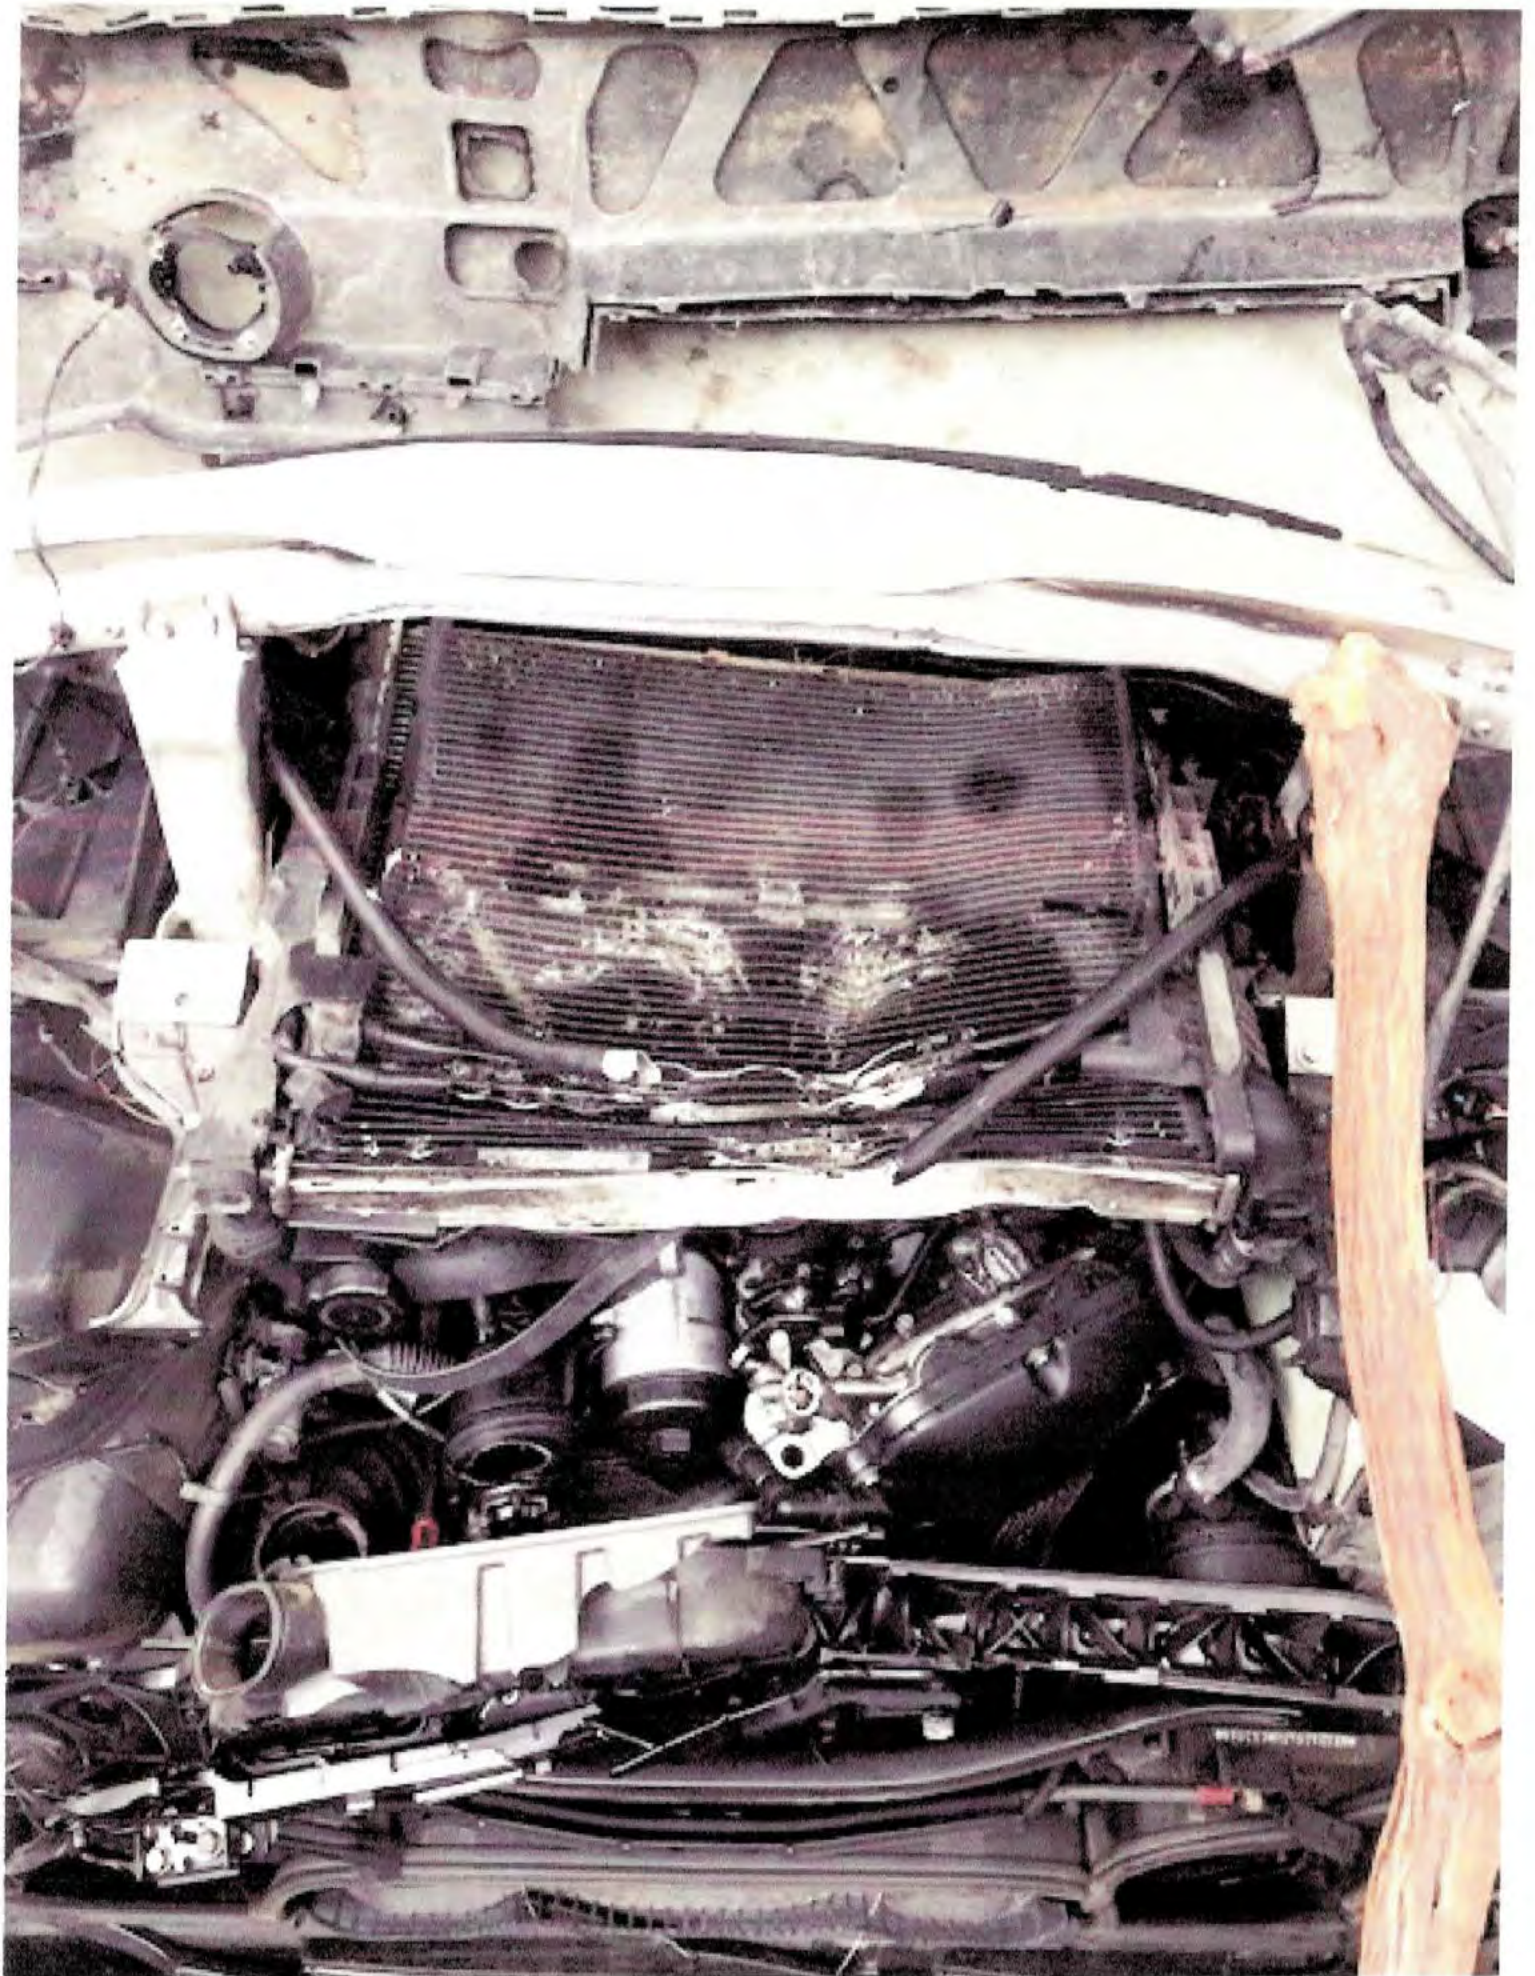
Front end damage  
located near defective  
airbag sensors.

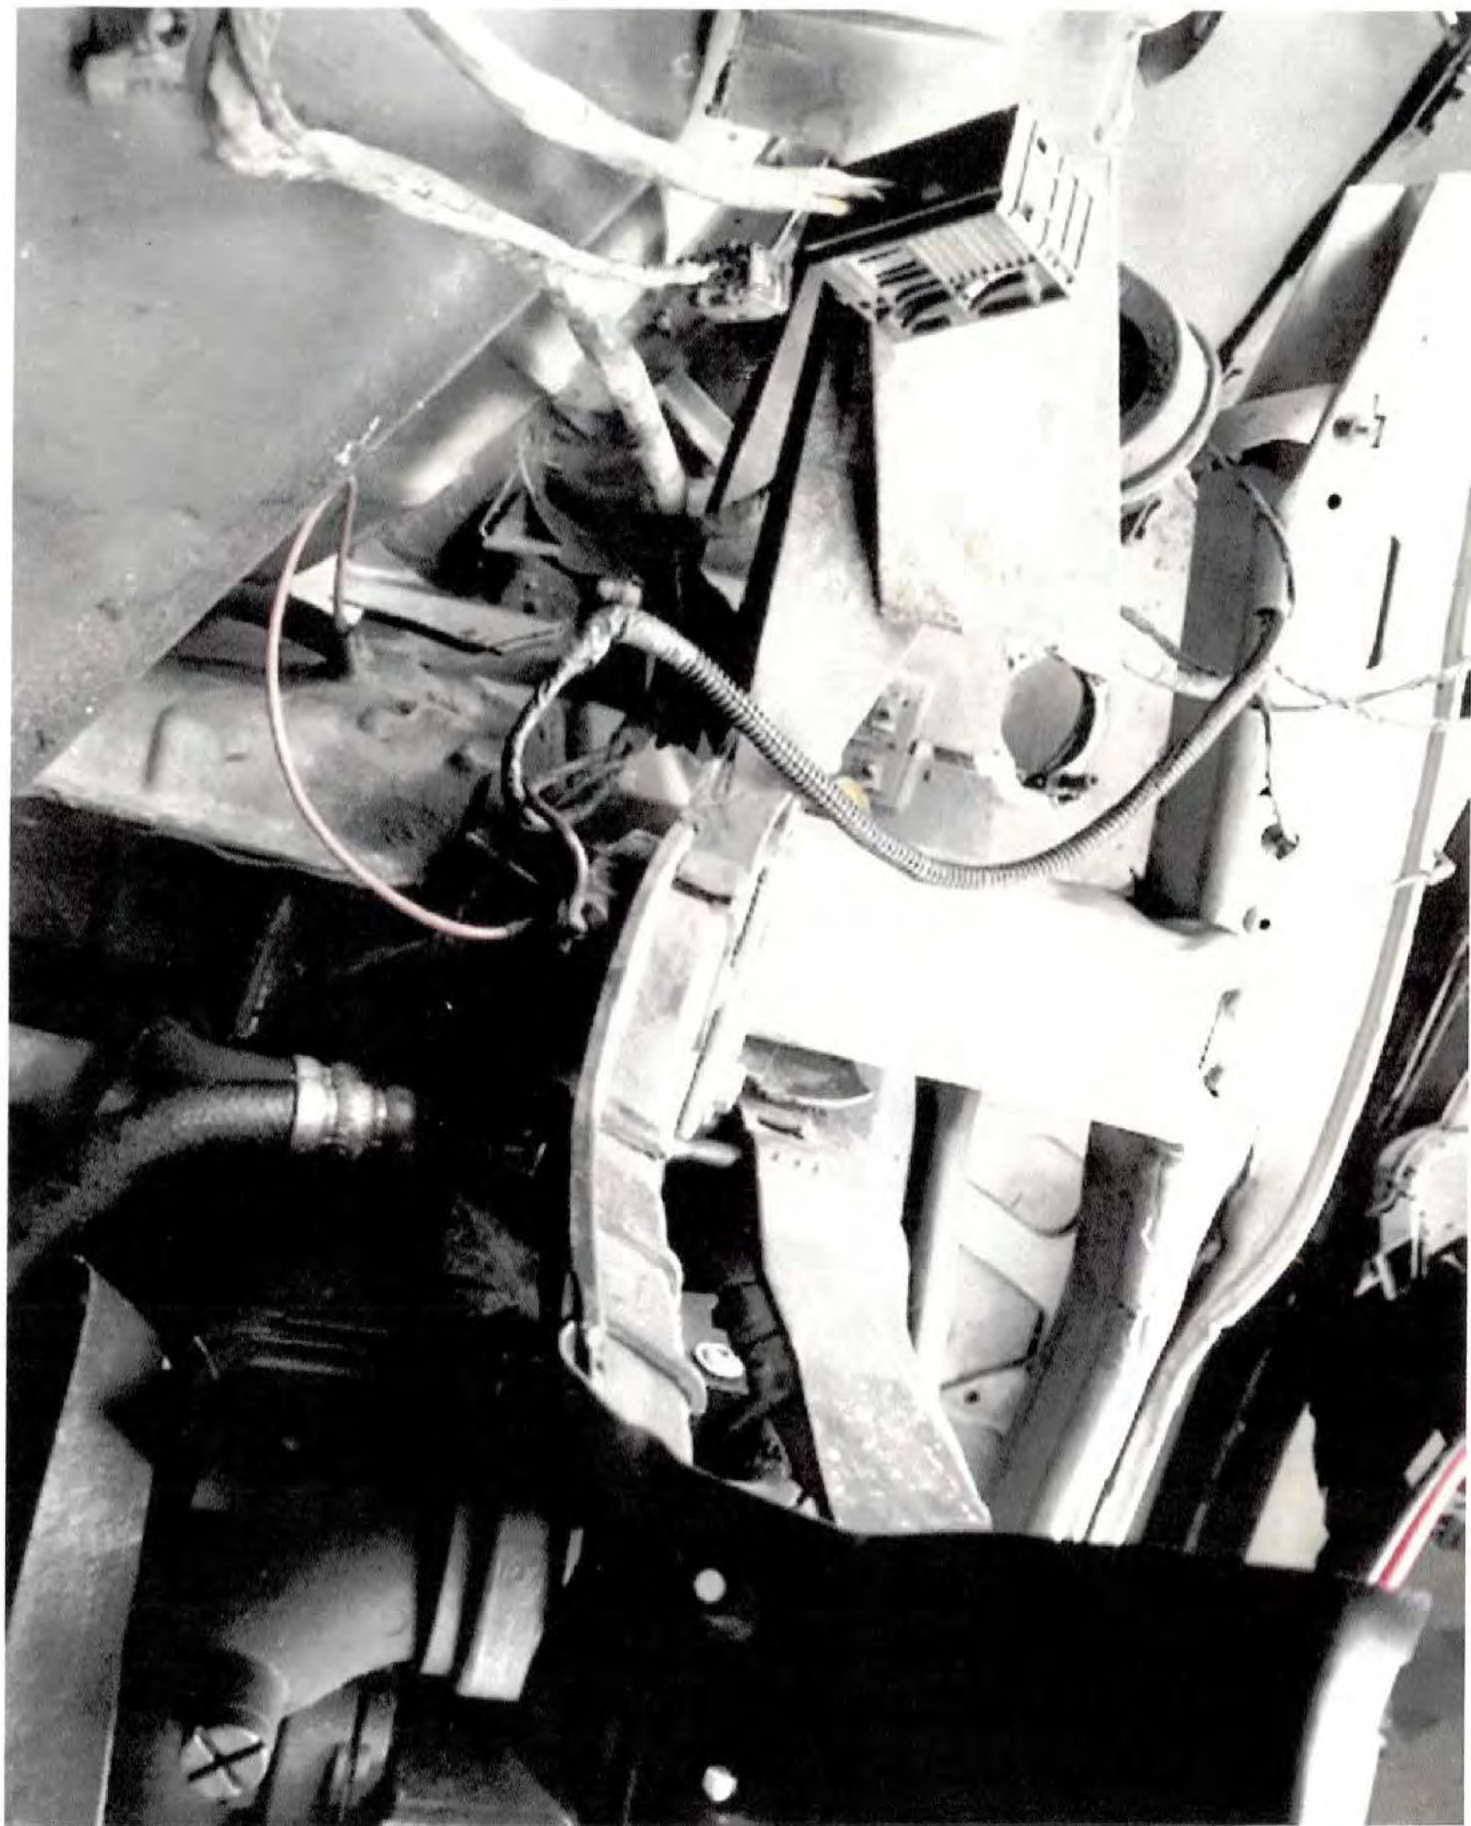
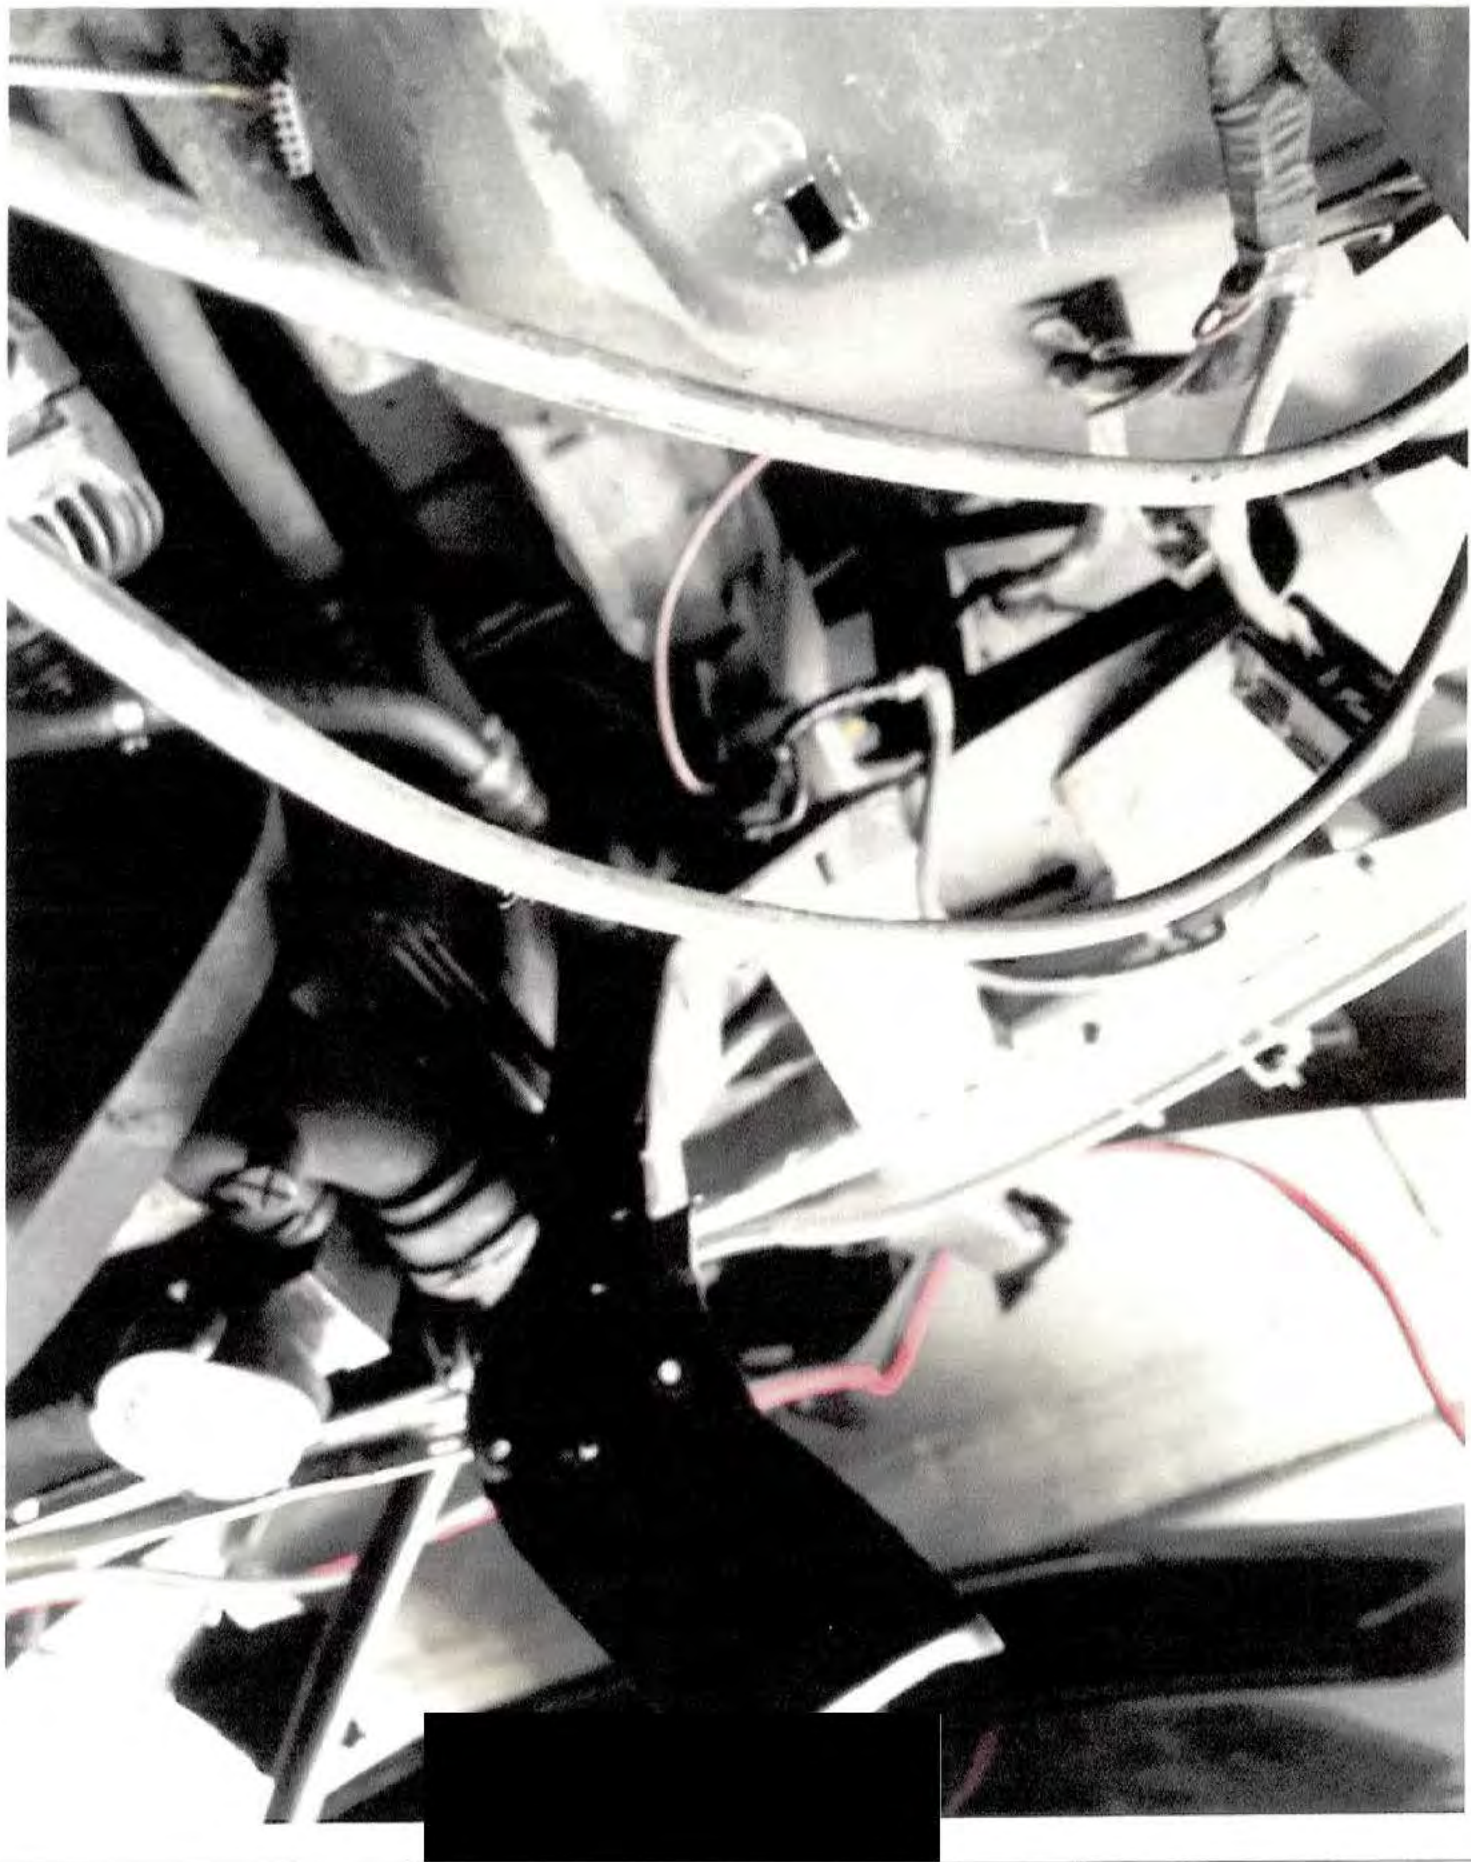
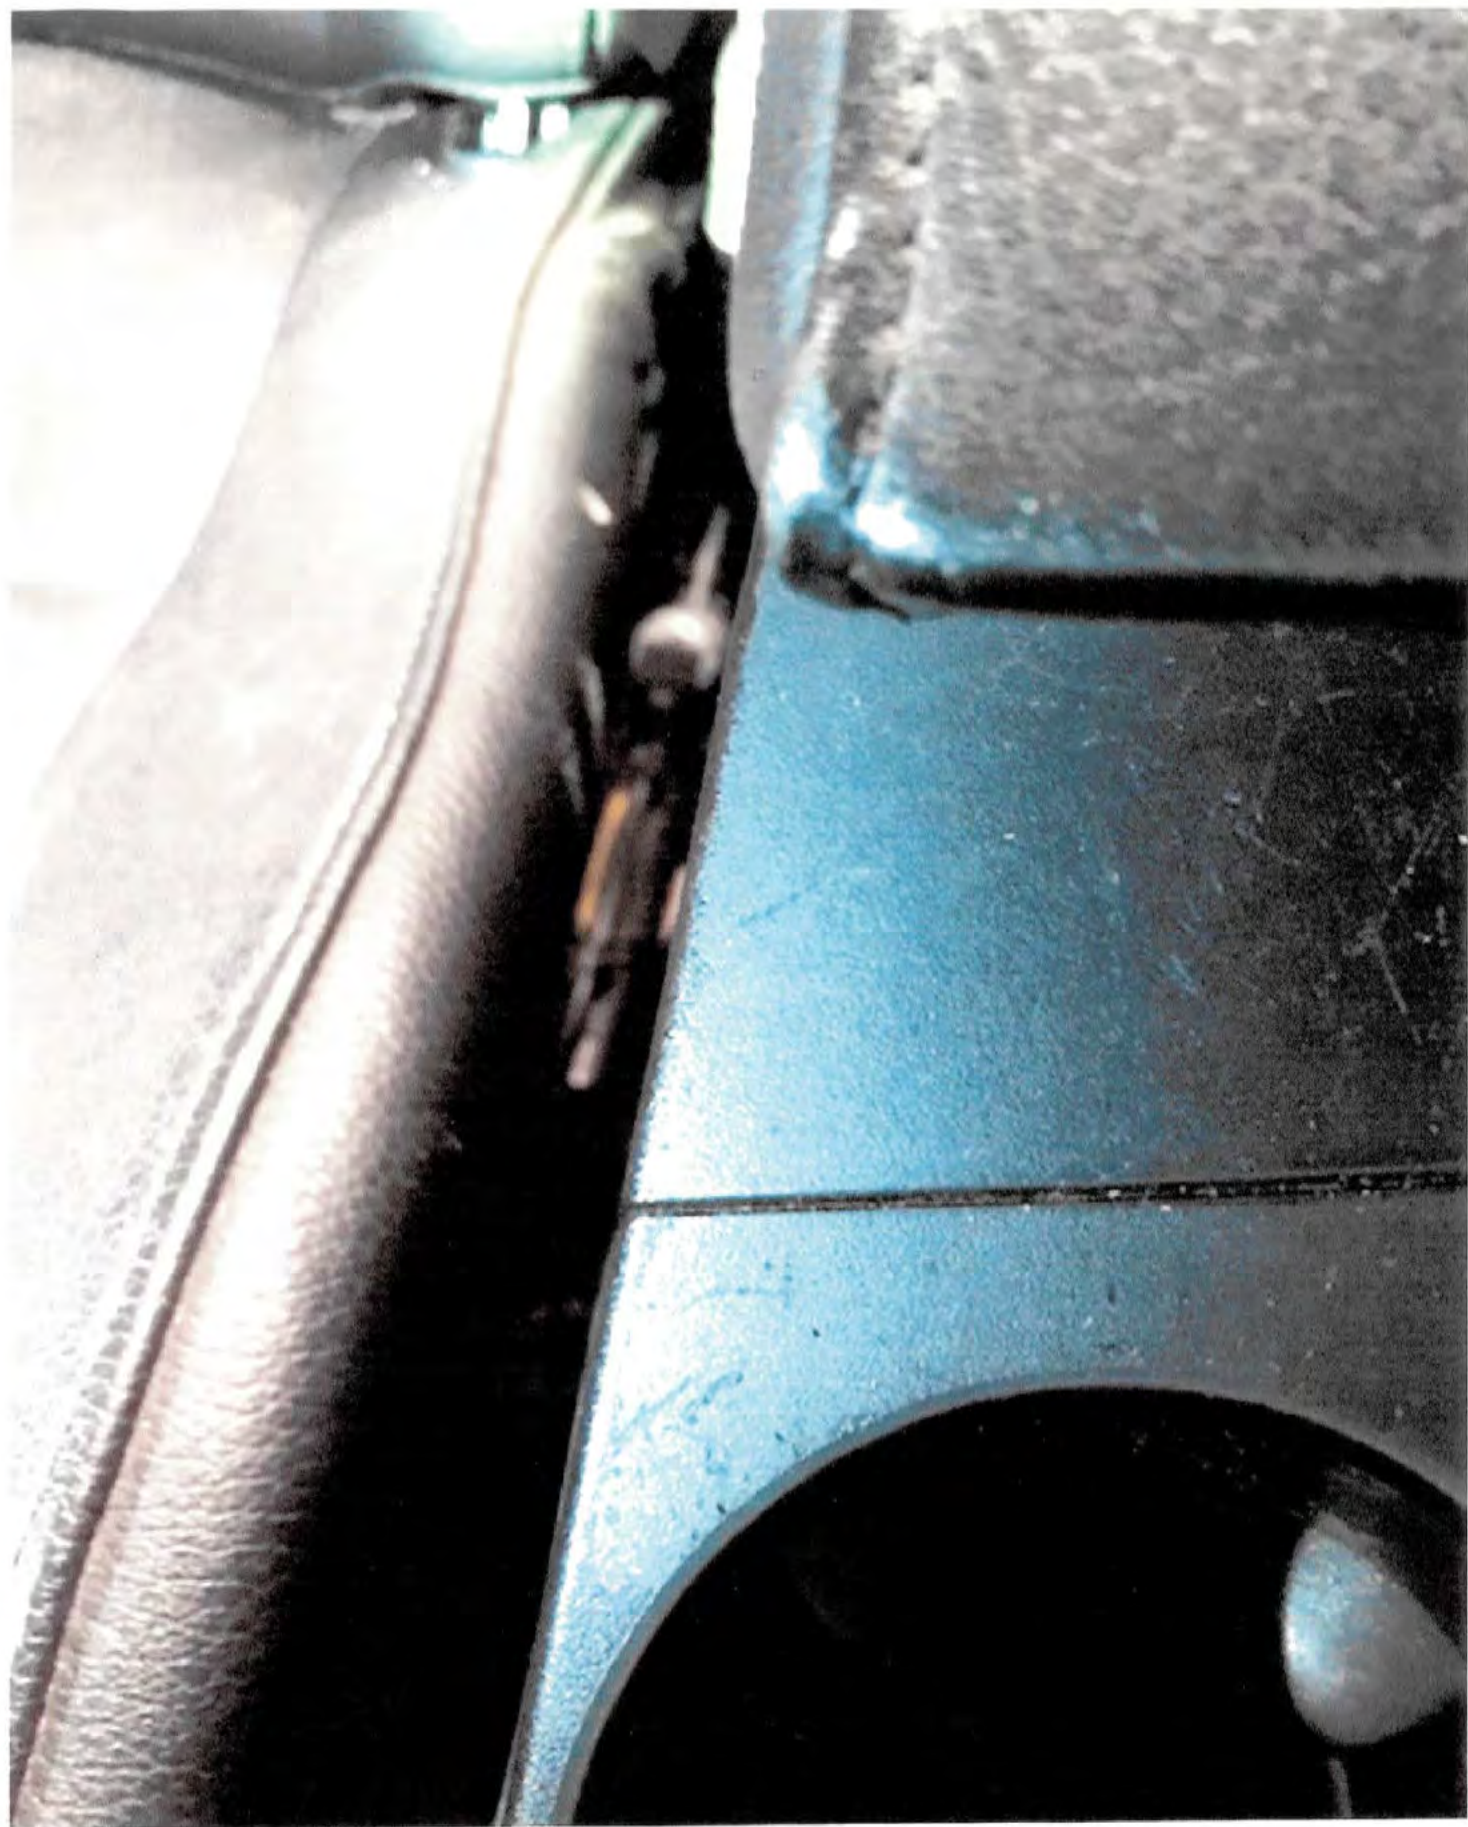
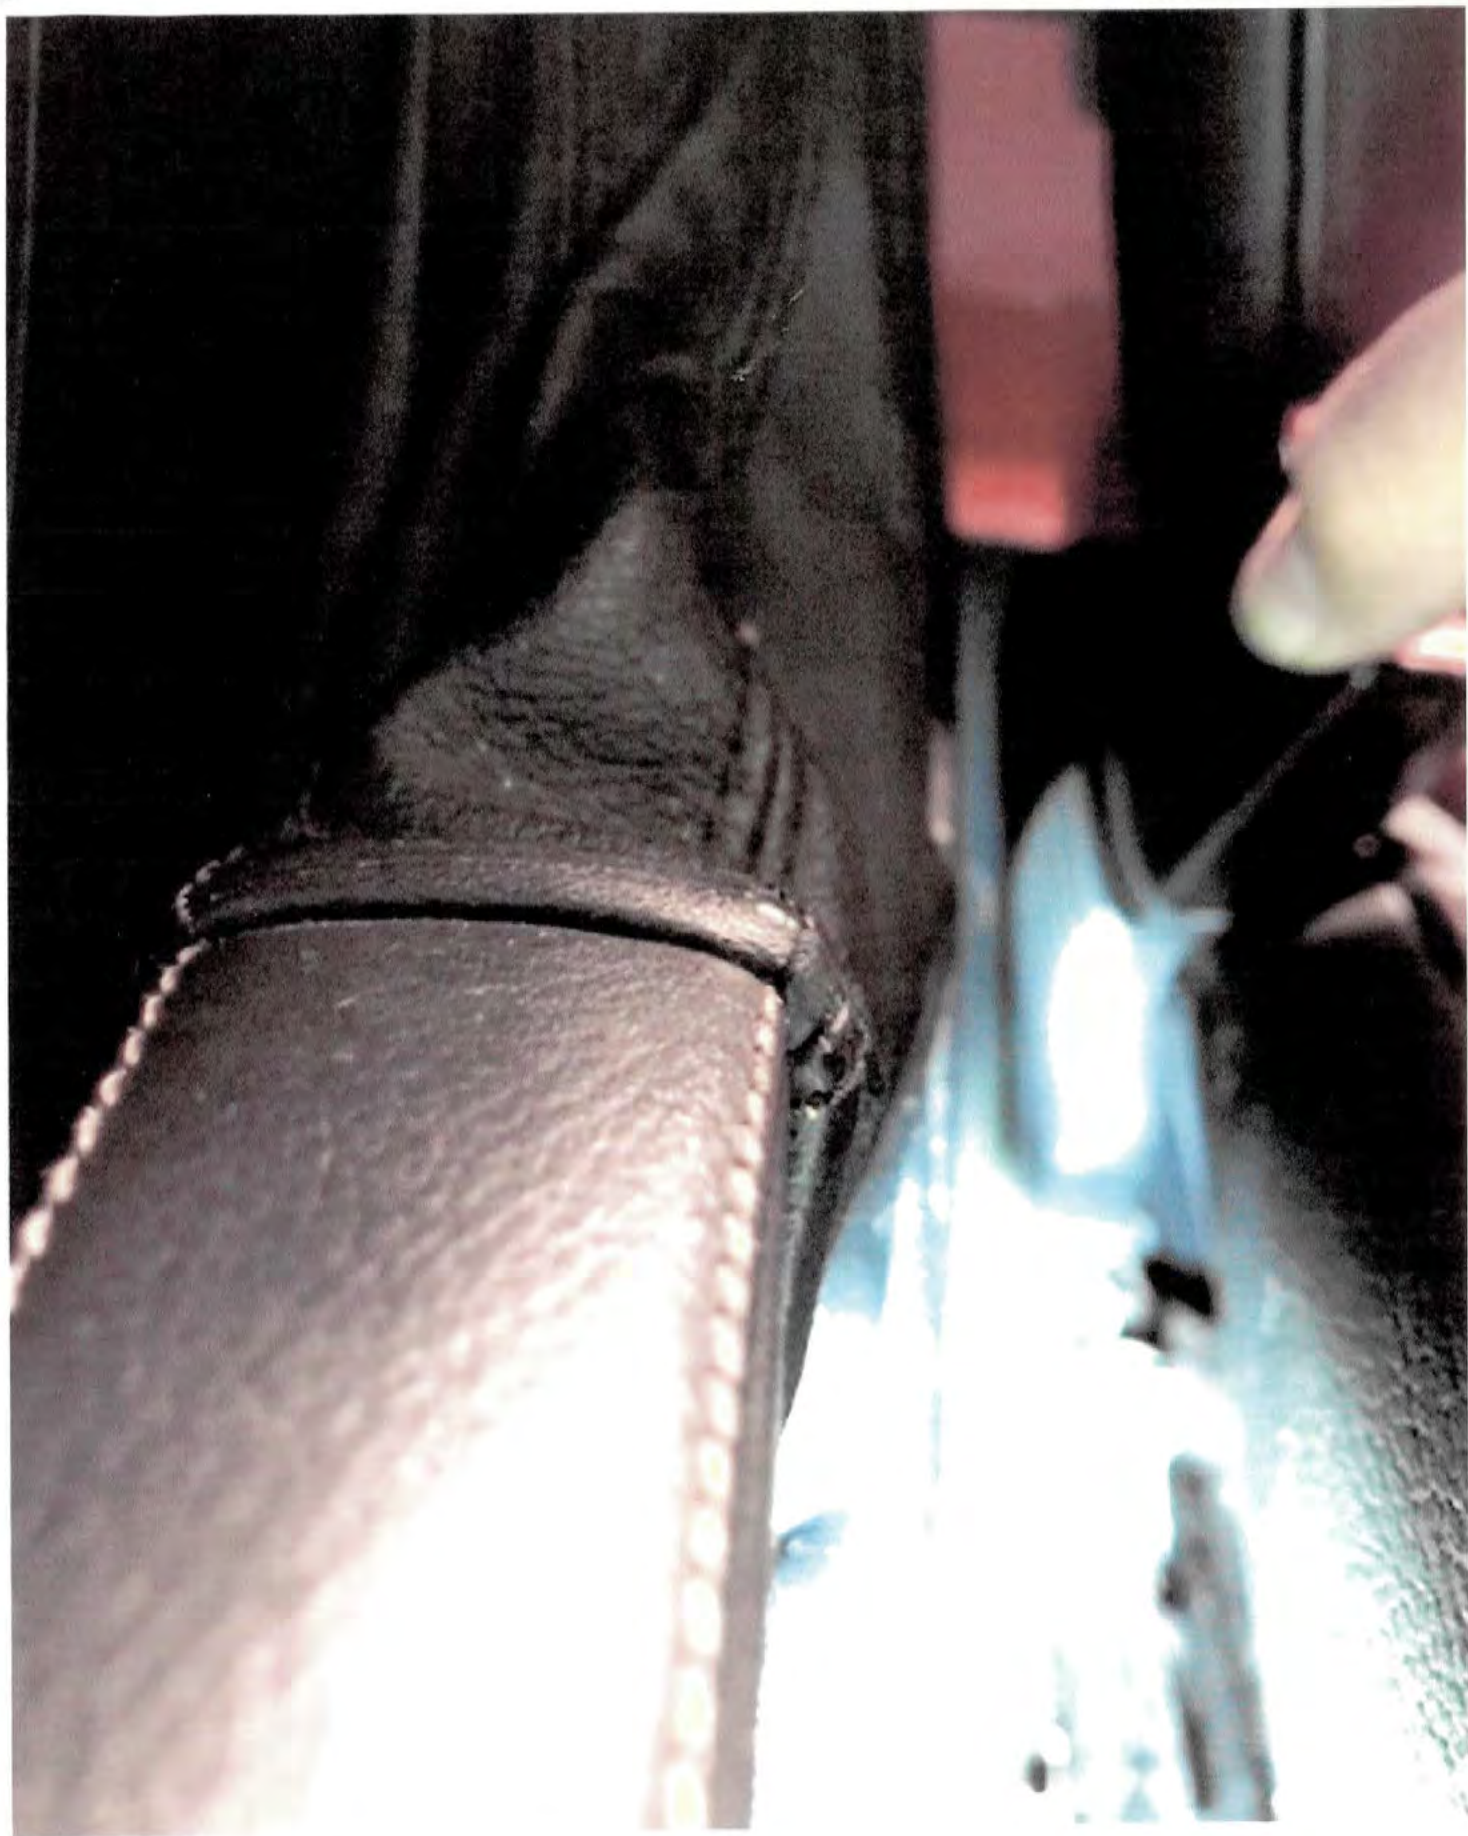
Photos of improperly  
wired recalled airbags  
in the 2004 BMW X3.

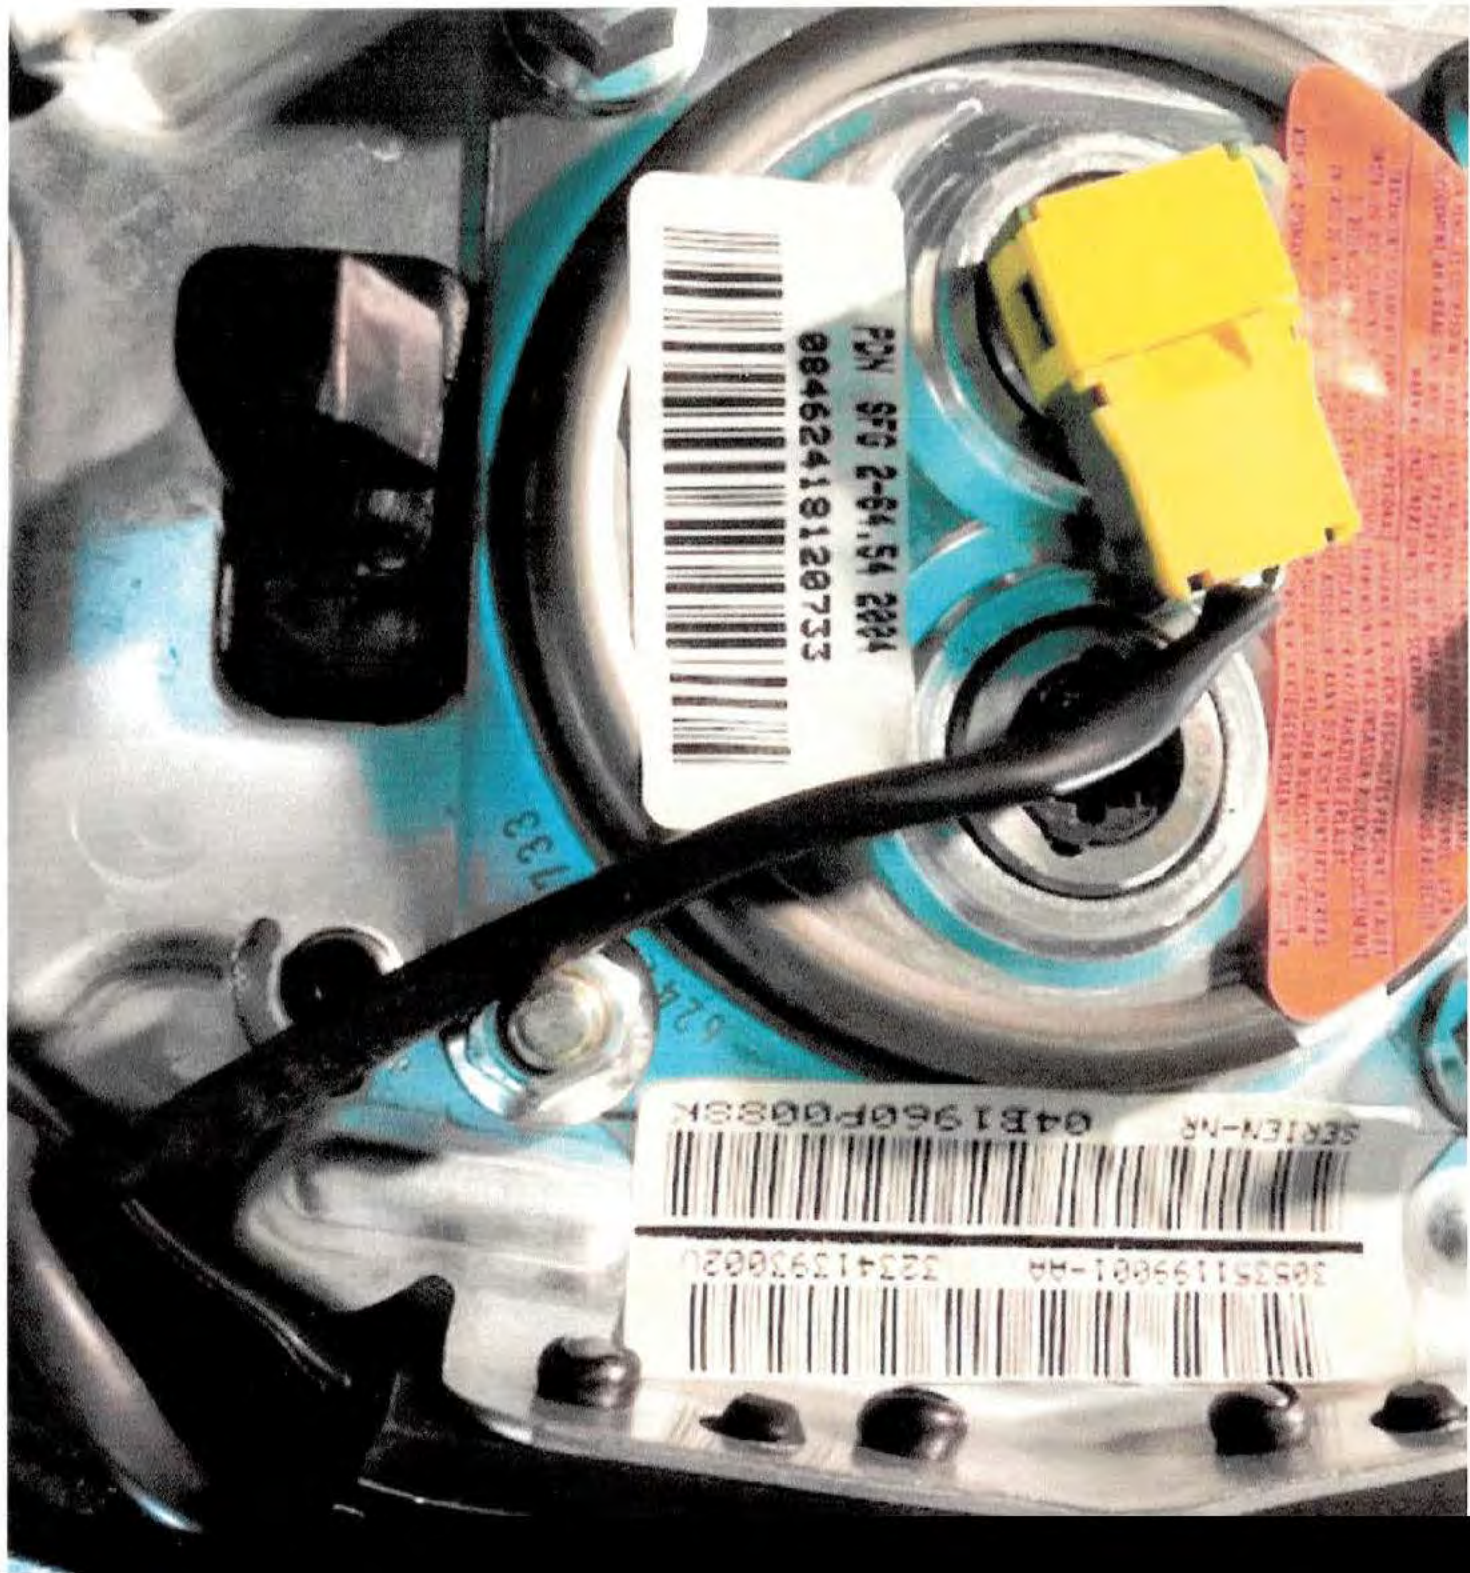
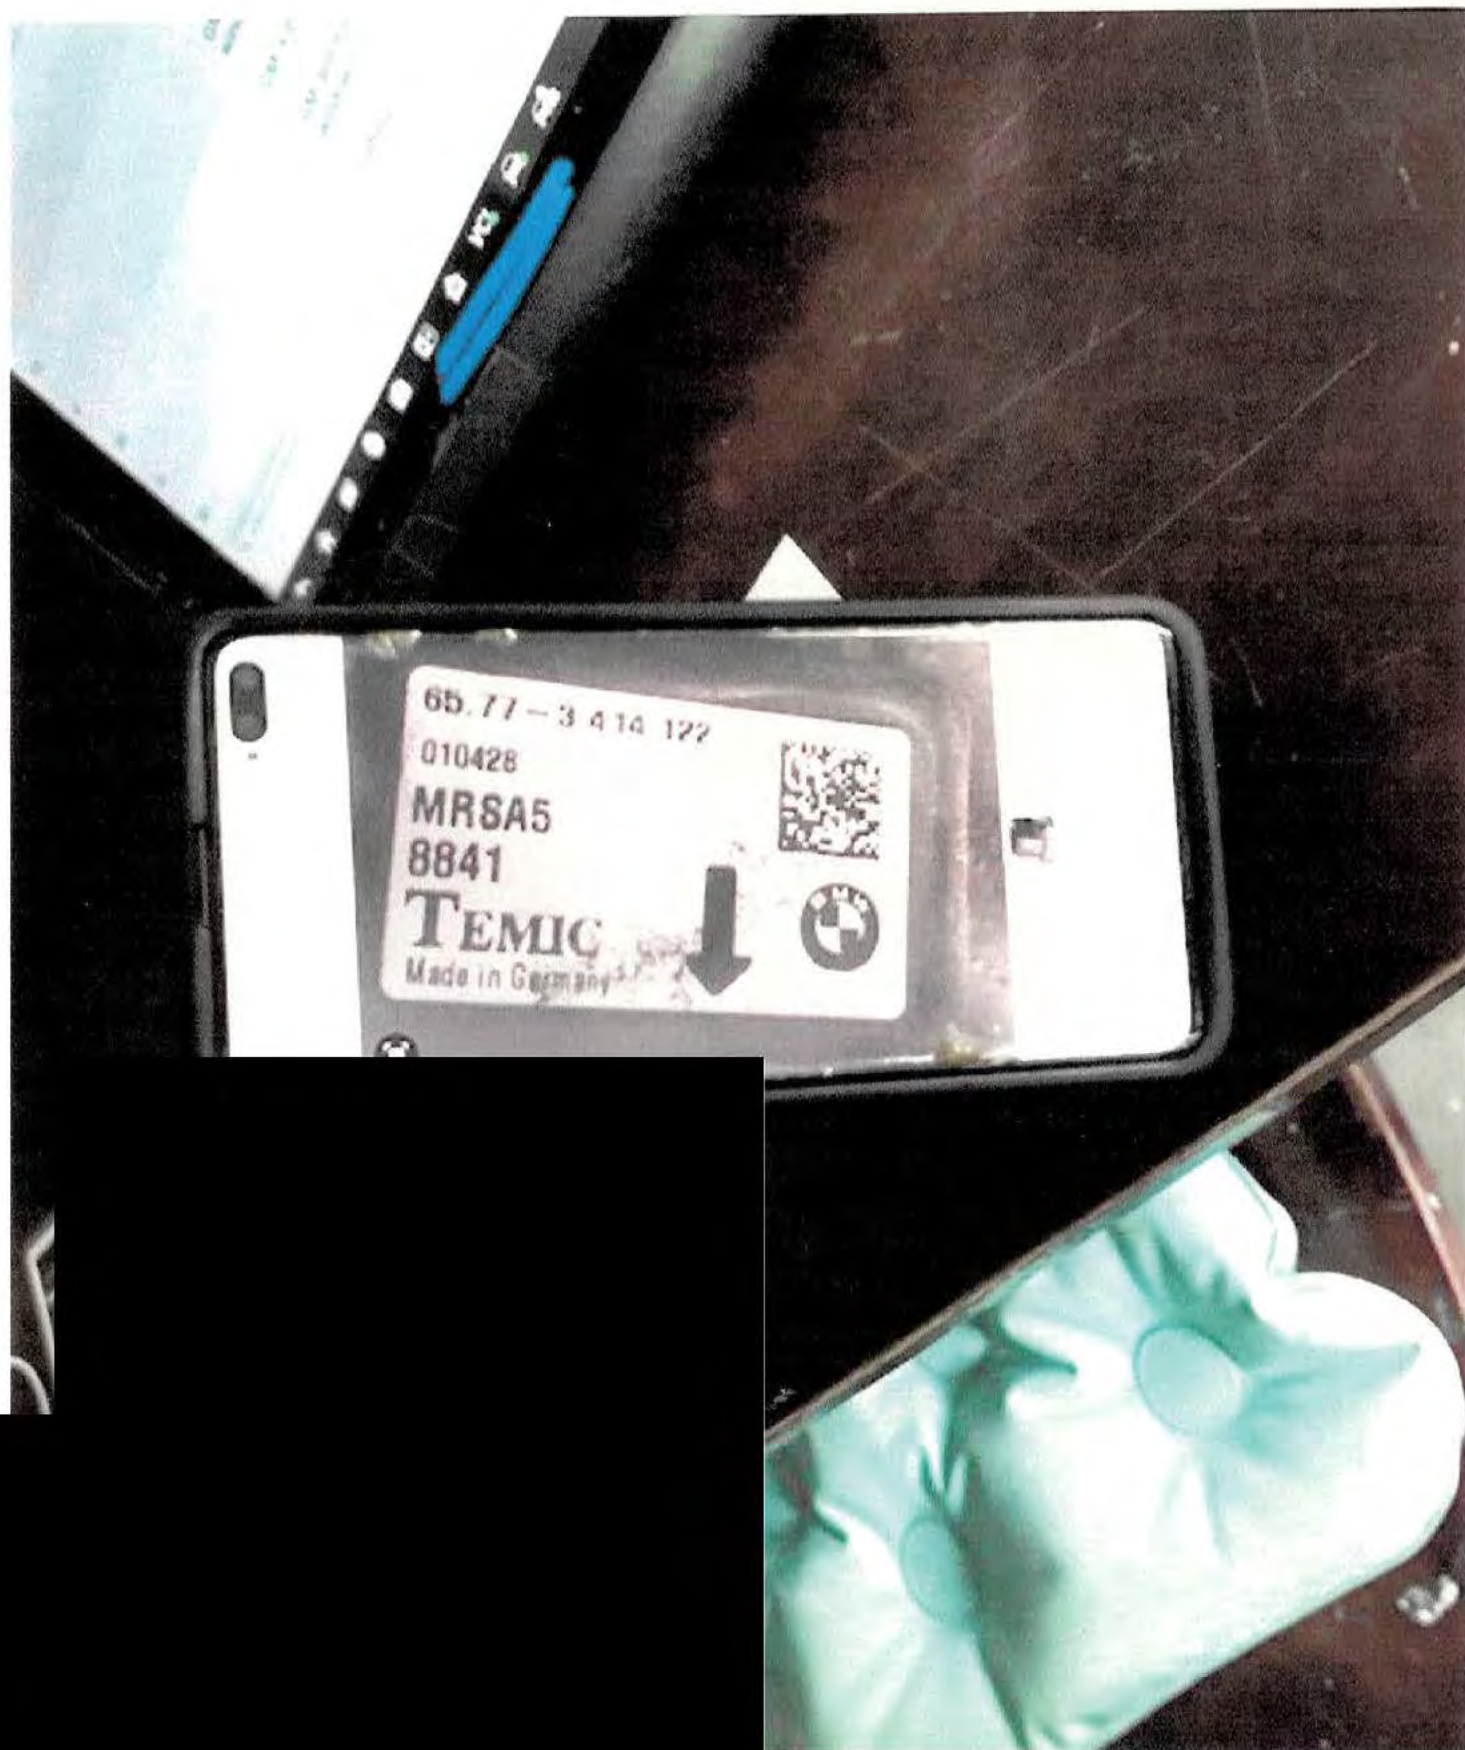
Alleged recalled and  
replaced airbag serial  
numbers.
