**COMPLAINT # 11343867**

Re: Recall on 1985 Mercedes 380SL Sub-Frame  
VIN Number: WDBBA45C7FA [REDACTED]

Vehicle Component Codes: 020000 SUSPENSION, 161100 STRUCTURE: FRAME AND MEMBERS: UNDERBODY SHIELDS

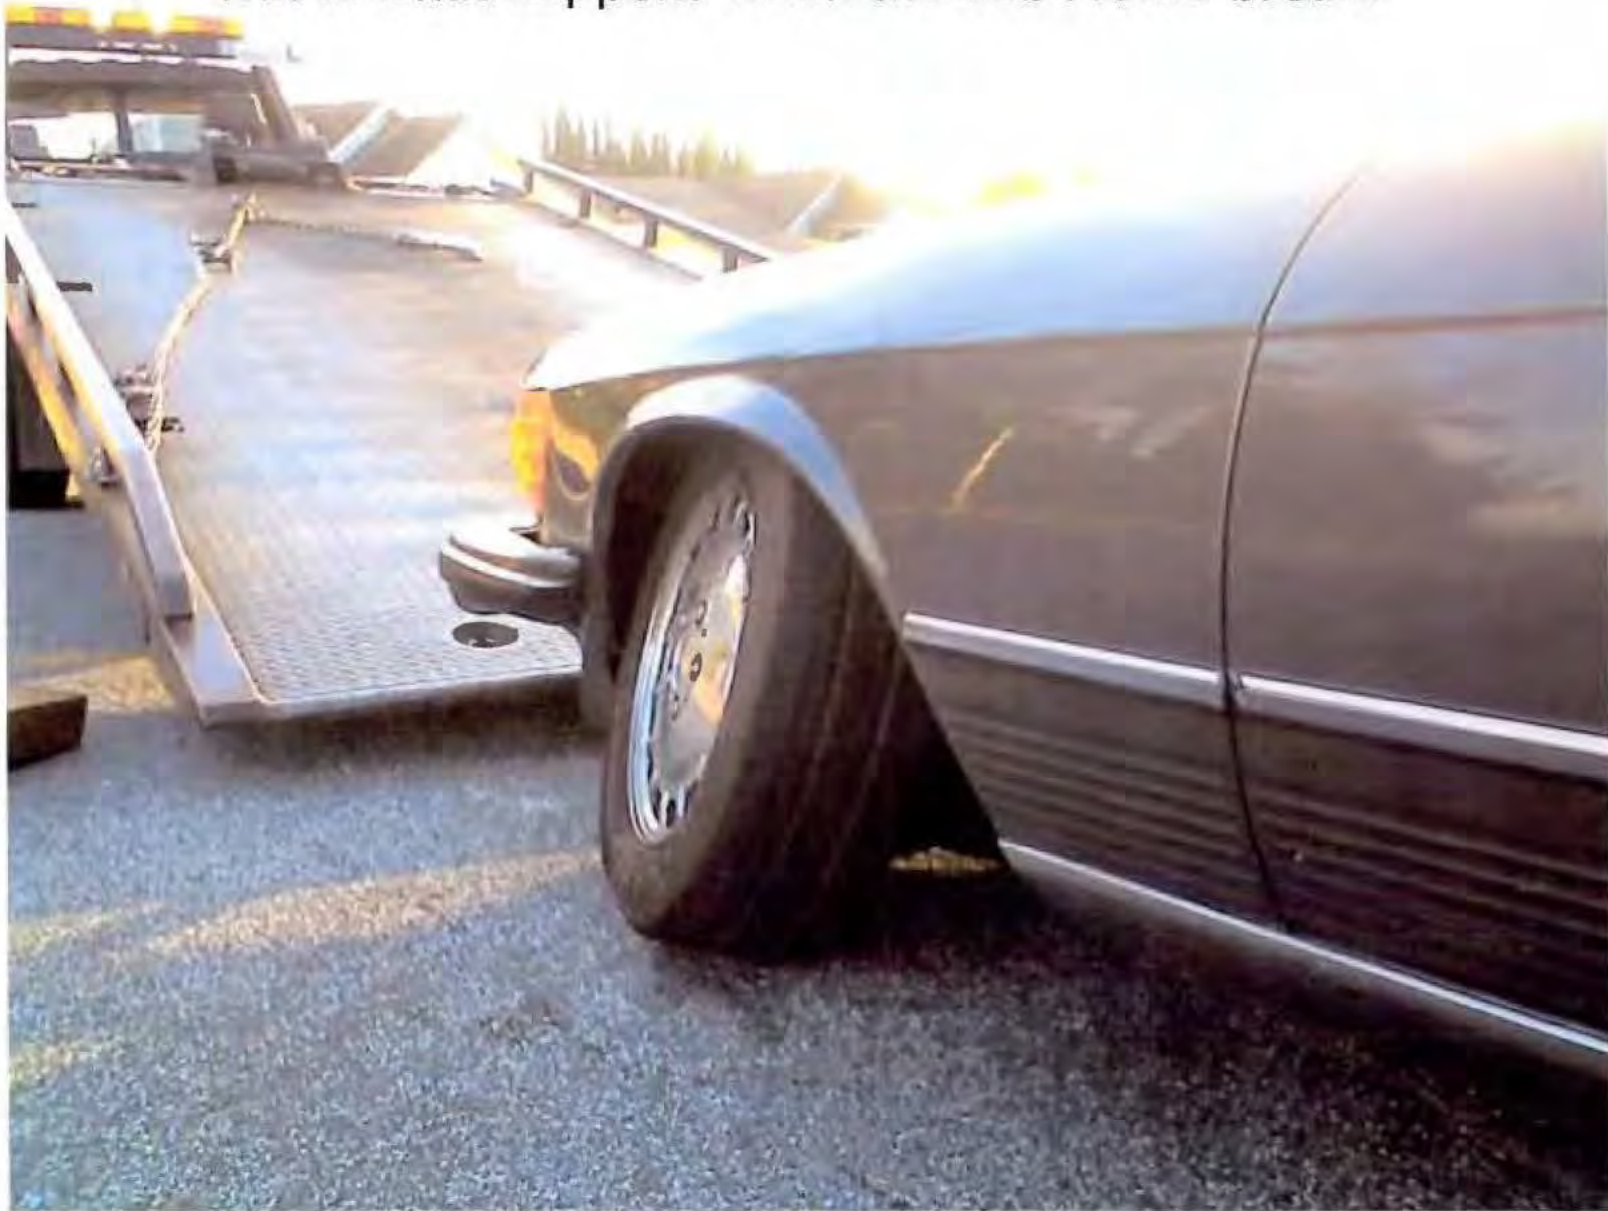
I was very lucky that the owner of Roy's Auto Service noticed the broken Sub Frame otherwise I could have a very bad accident. (See picture enclosed)

This is what happens when the Sub Frame breaks

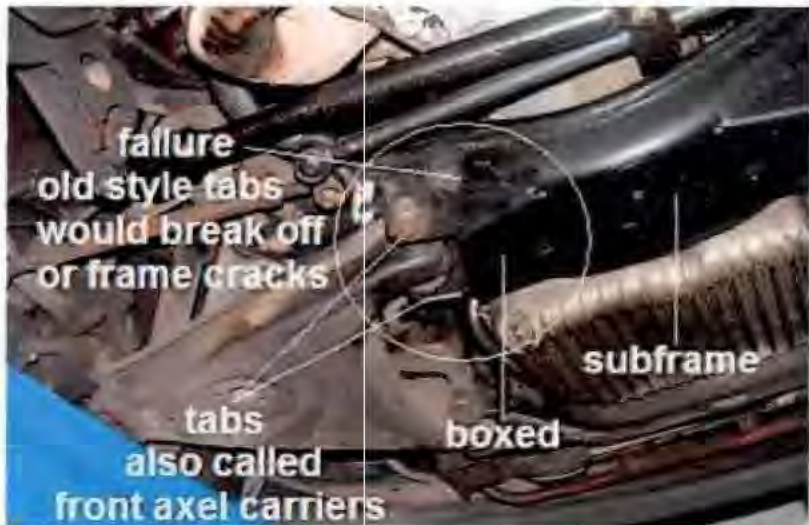
This is the newer boxed unit. (The original lower control arm attachment points on the rear of the subframe didn't have the boxed area at all). They only had the tabs projecting down,

and no side reinforcements at all, so if the car was curbed the tabs would break off. It would be pretty easy to box the front tabs also, and would probably be a good idea for your project. The whole front subframe began with the 114 cars, in fact my '82 has a 114 subframe under it right now. I had thought I remembered the boxing of the rear lower control arm tabs on the '79 going right under the arms, but after
