I am writing you to make you aware of a problem I experienced with my 2002 Chevy Express 3500 Van.

2002 Chevy Express Van, VIN 1GCHG35RX2 [REDACTED]

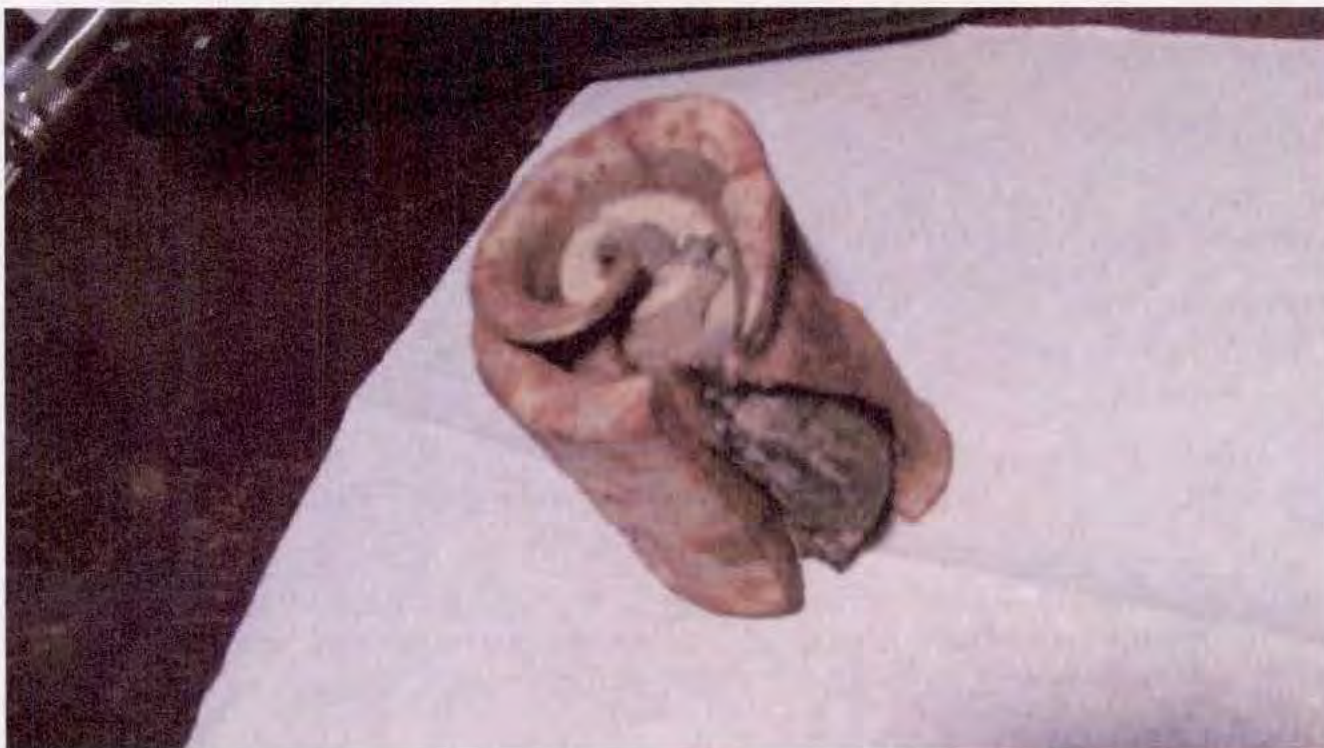
After a pot-hole broke my driver's side rear leaf spring, I discovered that the spring had been incorrectly installed at the factory. The bolt that holds the spring to the frame had been put in so that it was holding the spring down, but was not running through the eye loop. It was just laying on top of the top spring leaf.

The bolt should have run through the rubber grommet, but never did. It was just laying over the area where the break occurred. I have retained this part should you want to examine it.

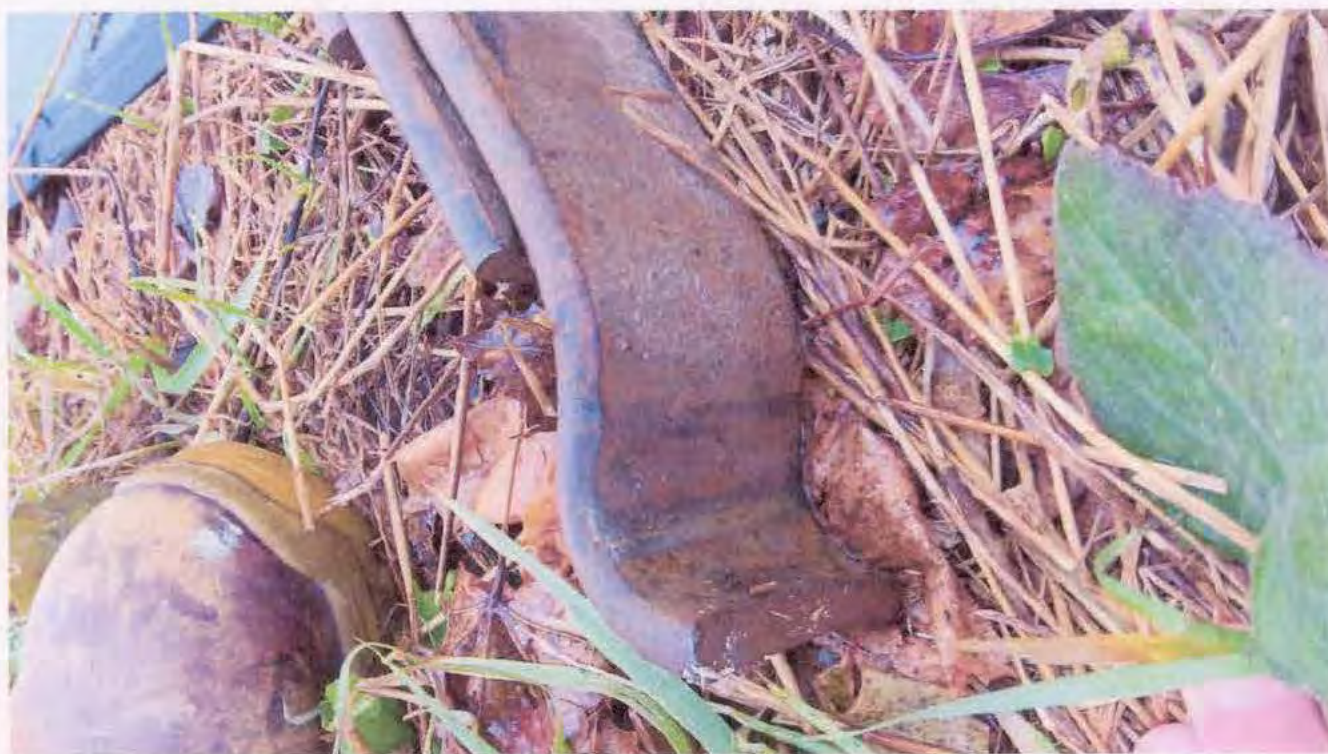
This is the end of the spring leaf where the break occurred. I have since recycled all of the leaves.
