From: [DataQuality, DataQuality \(NHTSA\)](#)
To: [EVOQ \(NHTSA\)](#)
Subject: FW: Follow up reply to ODI -- 11404496
Date: Monday, April 19, 2021 8:12:39 AM
Attachments: [REDACTED]

From: [REDACTED]
Sent: Saturday, April 10, 2021 8:19 AM
To: DataQuality, DataQuality (NHTSA) <DataQuality@dot.gov>
Subject: Follow up reply to ODI -- 11404496

17 digit Vehicle Identification Number Located at bottom of windshield on driver's side 5YJ3E1EB5LP		Make TESLA	Model MODEL 3	Model Year 2020
Date Purchased 06/12/2020	Dealer's Name and Telephone Number Tesla, 310-473-8337		Engine: No: Cylinders	Fuel Type: (Electric)
Original Owner Ron Harris (lessee)	Dealer's City Los Angeles	State CA	Zip Code 90025	
Transmission Type	<input checked="" type="checkbox"/> YES Antilock Brakes <input checked="" type="checkbox"/> YES Cruise Control	Powertrain	Multiple Failure:	Incident Date(s) 01-NOV-2020

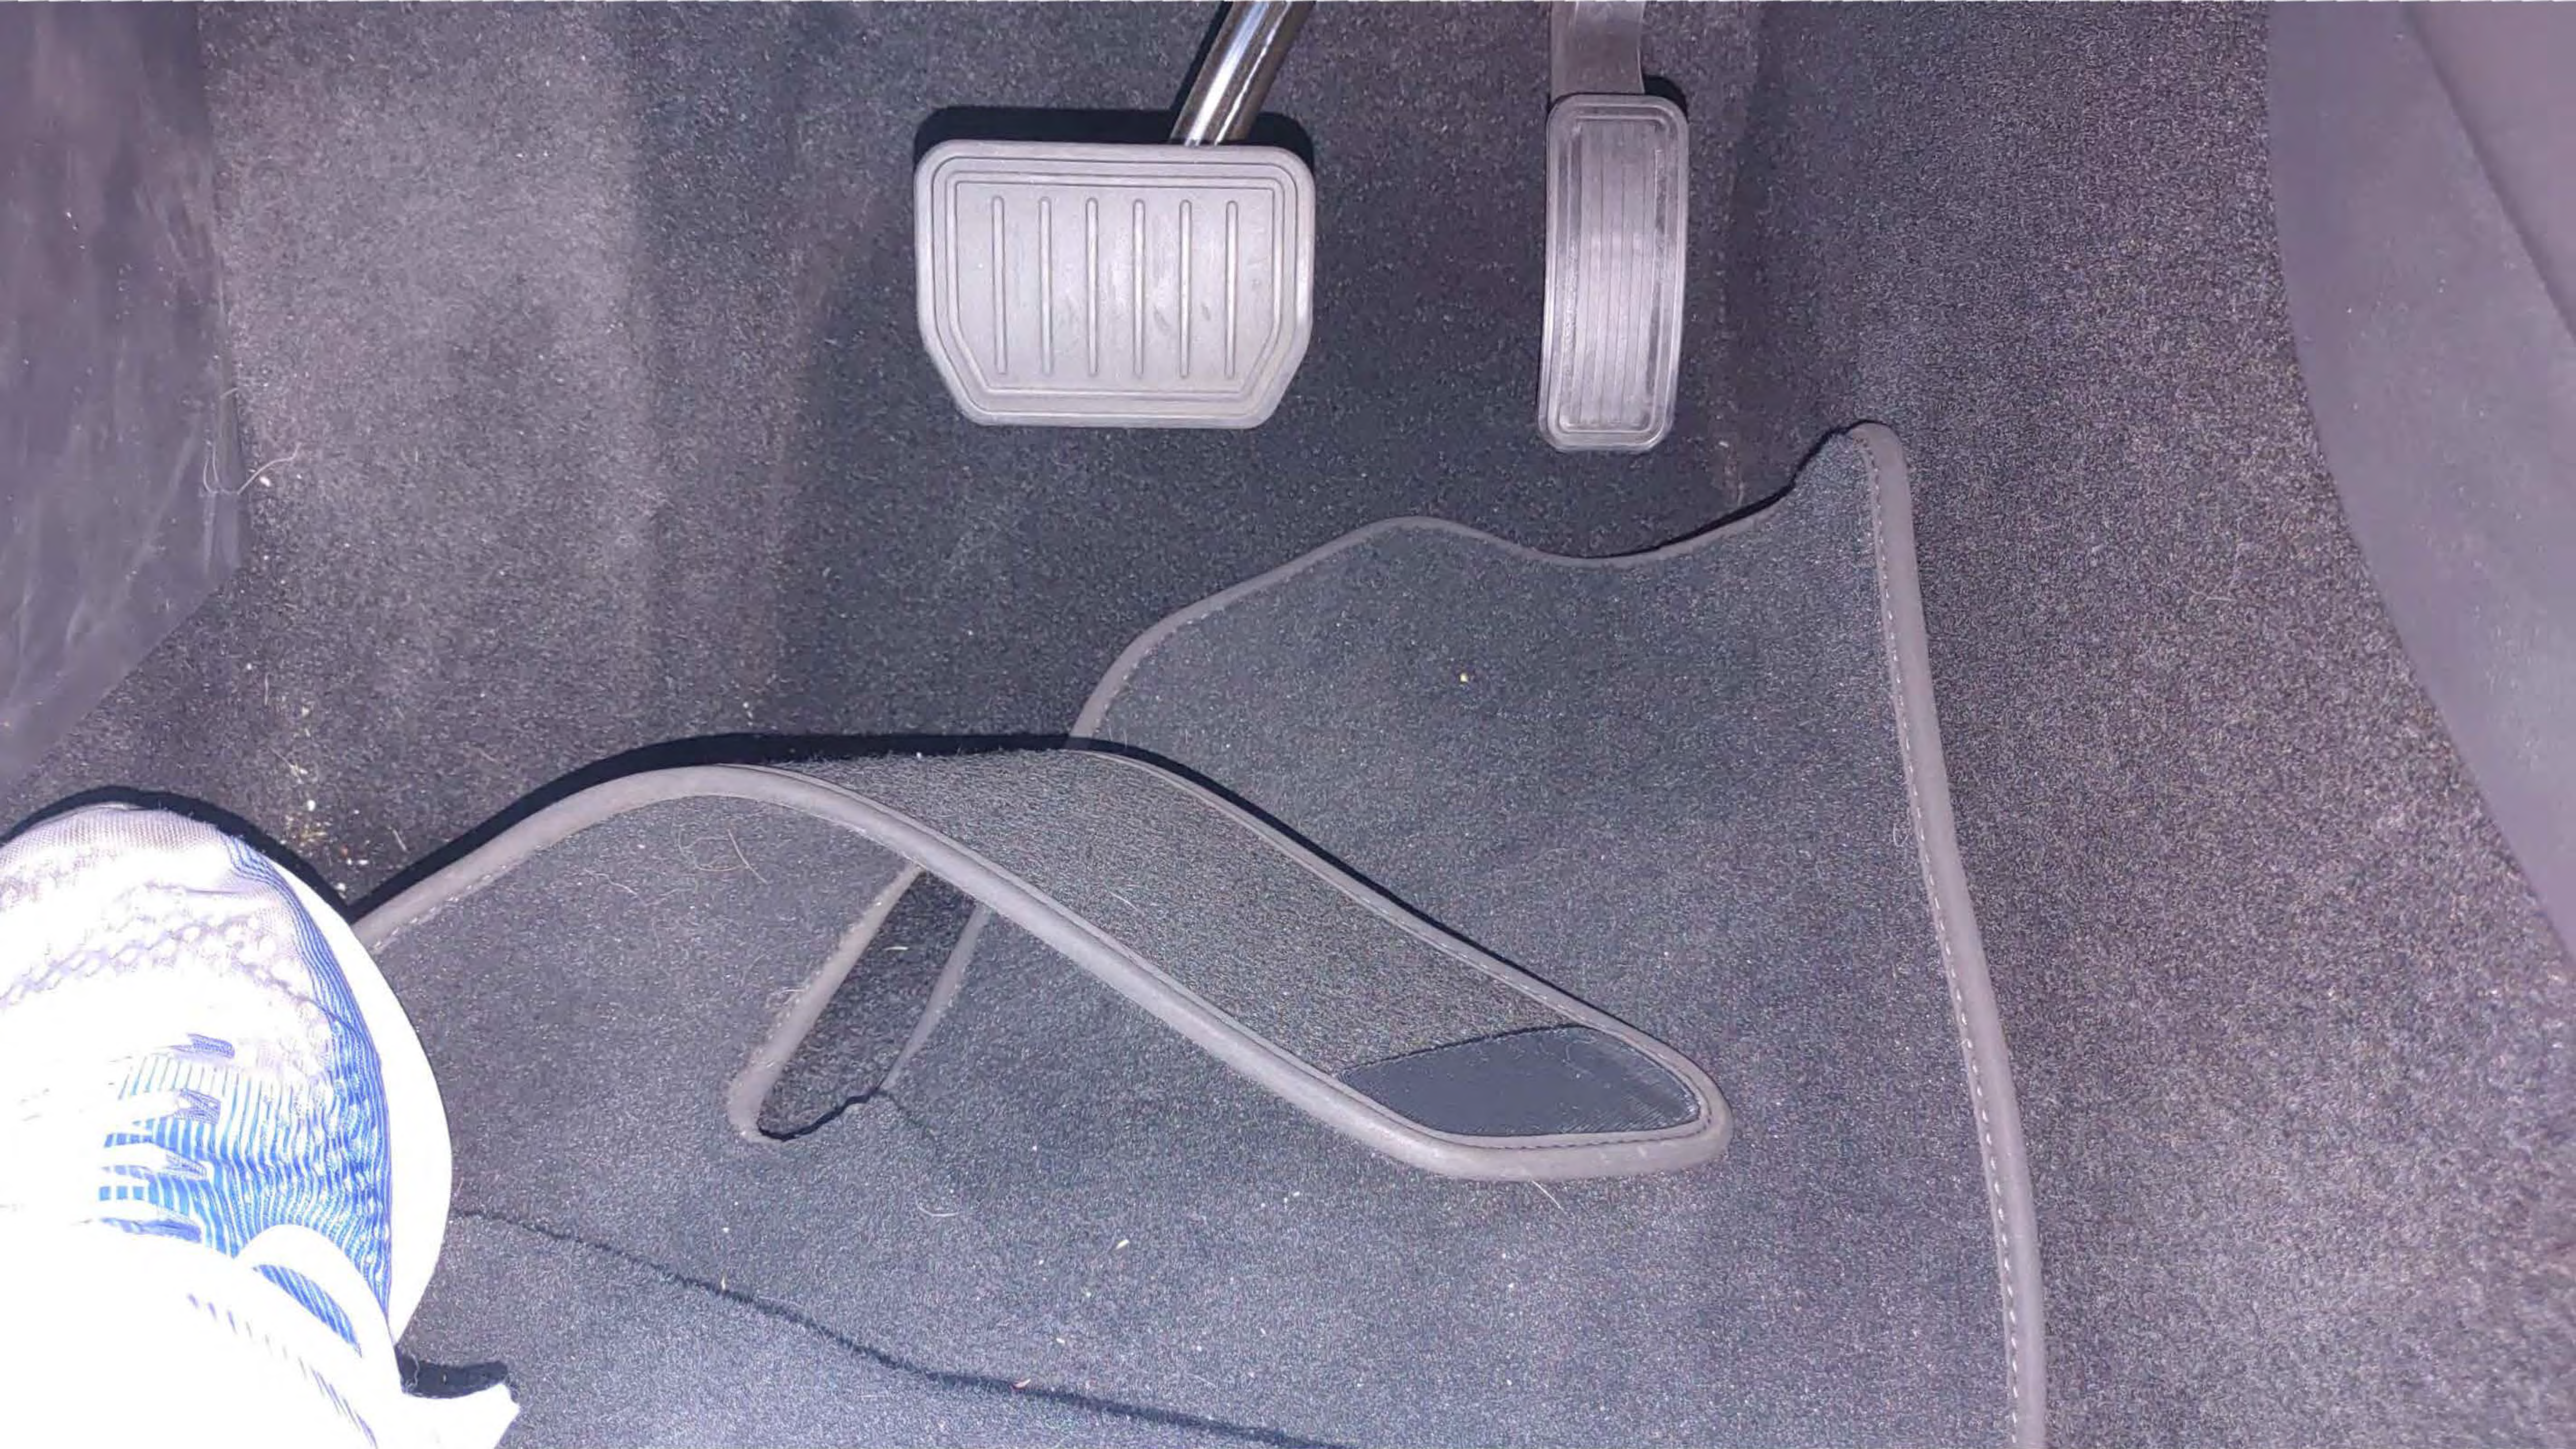
This is the only thing that holds this piece of carpet to the floor. (It is the mat that came with the Tesla.)

TL* THE CONTACT OWNS A 2020 TESLA MODEL 3. THE CONTACT STATED THAT WHILE OPERATING THE VEHICLE, THE DRIVER'S SIDE FLOOR MAT FOLDED OVER WHILE ATTEMPTING TO DEPRESS THE PEDALS. ON ONE OCCASION THE FAILURE CAUSED THE DRIVER TO LOSE CONTROL OF THE VEHICLE AND THE VEHICLE STRUCK THE CURB. THE CAUSE OF THE FAILURE WAS NOT YET DETERMINED. THE MANUFACTURER AND TESLA SERVICE CENTER LOCATED AT 11163 SANTA MONICA BLVD, LOS ANGELES, CA 90025 WERE NOTIFIED OF THE FAILURE. THE FAILURE MILEAGE WAS 600.

The Tesla Service Center replaced the mats (at no charge), but the same problem occurs. They claim the Velcro adheres firmly, but neither the original nor the replacements will stay in place.
