NHTSA Attachment for Complaint 11417805

National Highway Traffic Safety Administration – 5/19/21

We are reporting a series of problems which we think could be posing significant risks to motor vehicle safety which exist in 2016 Volvo XC90 T6 SUVs and which could also exist in previous years and more current Volvo models.

The following is a summary of issues we encountered in our 2016 Volvo XC-90 Vin# YV4A22PK2G [REDACTED], which we purchased new from Bill Pierce Motors (Authorized Volvo Dealer) in Reno Nevada 06/24/2016. (A certificate of title is attached to this complaint.)

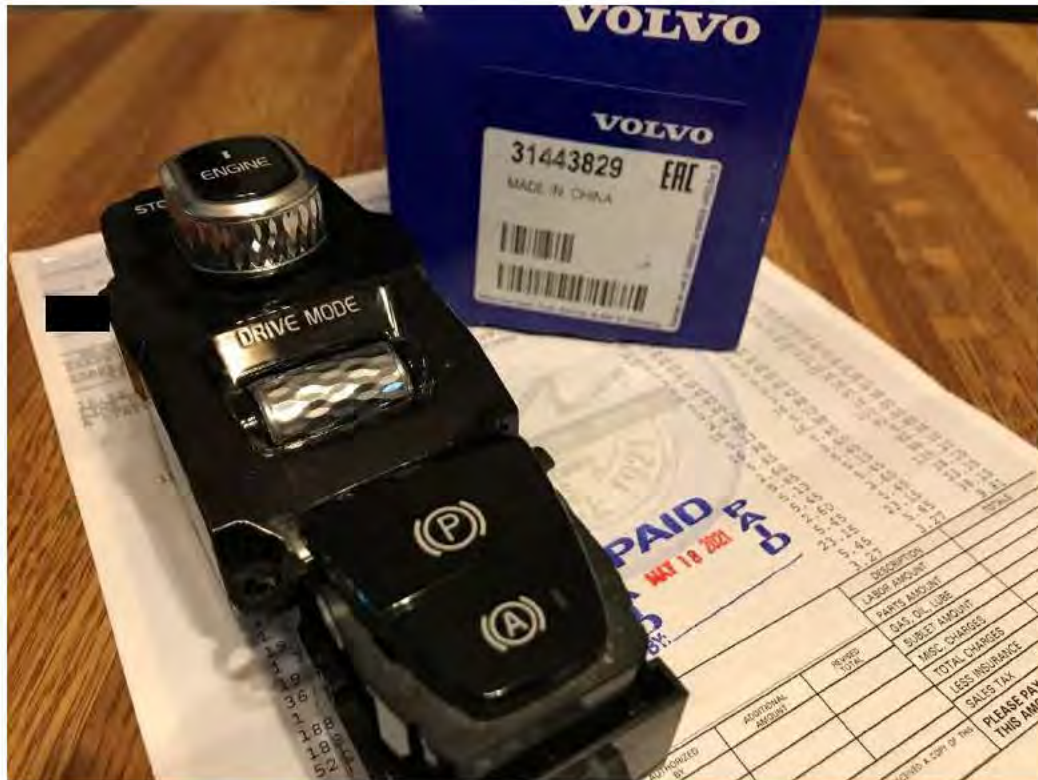
2. Neillo Service performed the Diagnosis and determined that the Stop/Switch component was defective and they requested my approval to replace it for an additional \$813.25 plus tax. I have retained this switch assembly. (See Picture of this switch.)

I approved the replacement of this switch. I noted from the Service Technician's notes that they found that the switch was actually shutting the vehicle down when turned to the "Start" position. So, I have to include the Switch Assembly as another Safety Concern which poses a risk to motor vehicle safety which when under certain situations not understood, may leave the operator unaware of which direction to turn the knob. It is fairly large component combining a number of additional functions including Driver Mode, Parking Brake, and what appears to be a holding brake function. There is no evidence of mechanical, broken parts or liquid caused damages. The part is stamped made in China. This is the only (in vehicle) engine on/off control that I am aware of. The vehicle uses no conventional keyed ignition switch and this functionality depends entirely on a proximity connection from a wireless fob to enable the start function. It is also unknown to me whether the other functions of this switch assembly were negatively impacted or affected. This assembly is mounted in a raised console behind the Gear Shift Lever between the Driver and Passenger seats.

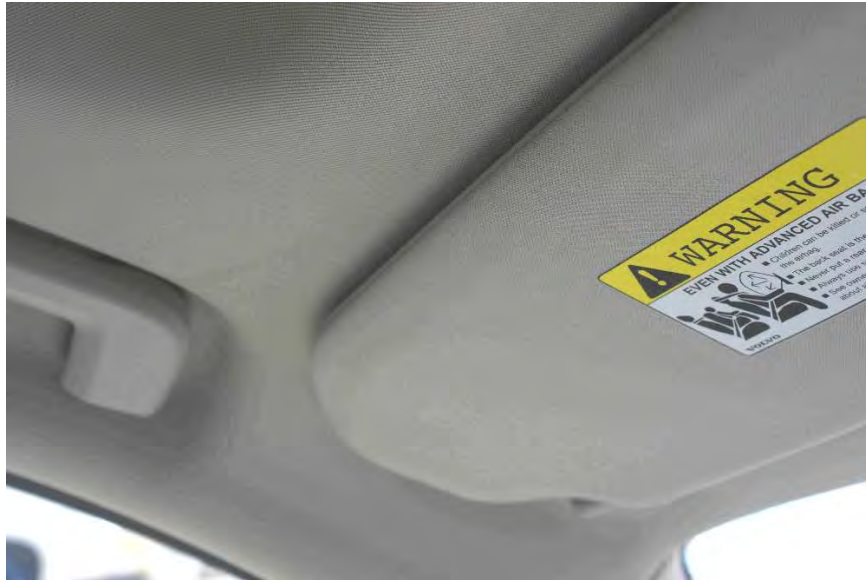
later when the Insurance Company made an observation of a dried water spot under the Driver's sun visor. (See Photo)

Now I was being told that there are Sunroof Drains which when clogged cause water to seep into the automobile's frame and leaks down the windshield posts to pool under the floorboards. I was totally unaware of these drains and never received any owner/user information regarding their maintenance. There is no mention of these in the owner's manual.

I found it significant that some of the class action suits were stalled because no one had shown how the water got into the vehicle. **From the Neillo Service Technician's notes they "-cleared out the sunroof front drains which was the cause of the water intrusion".**

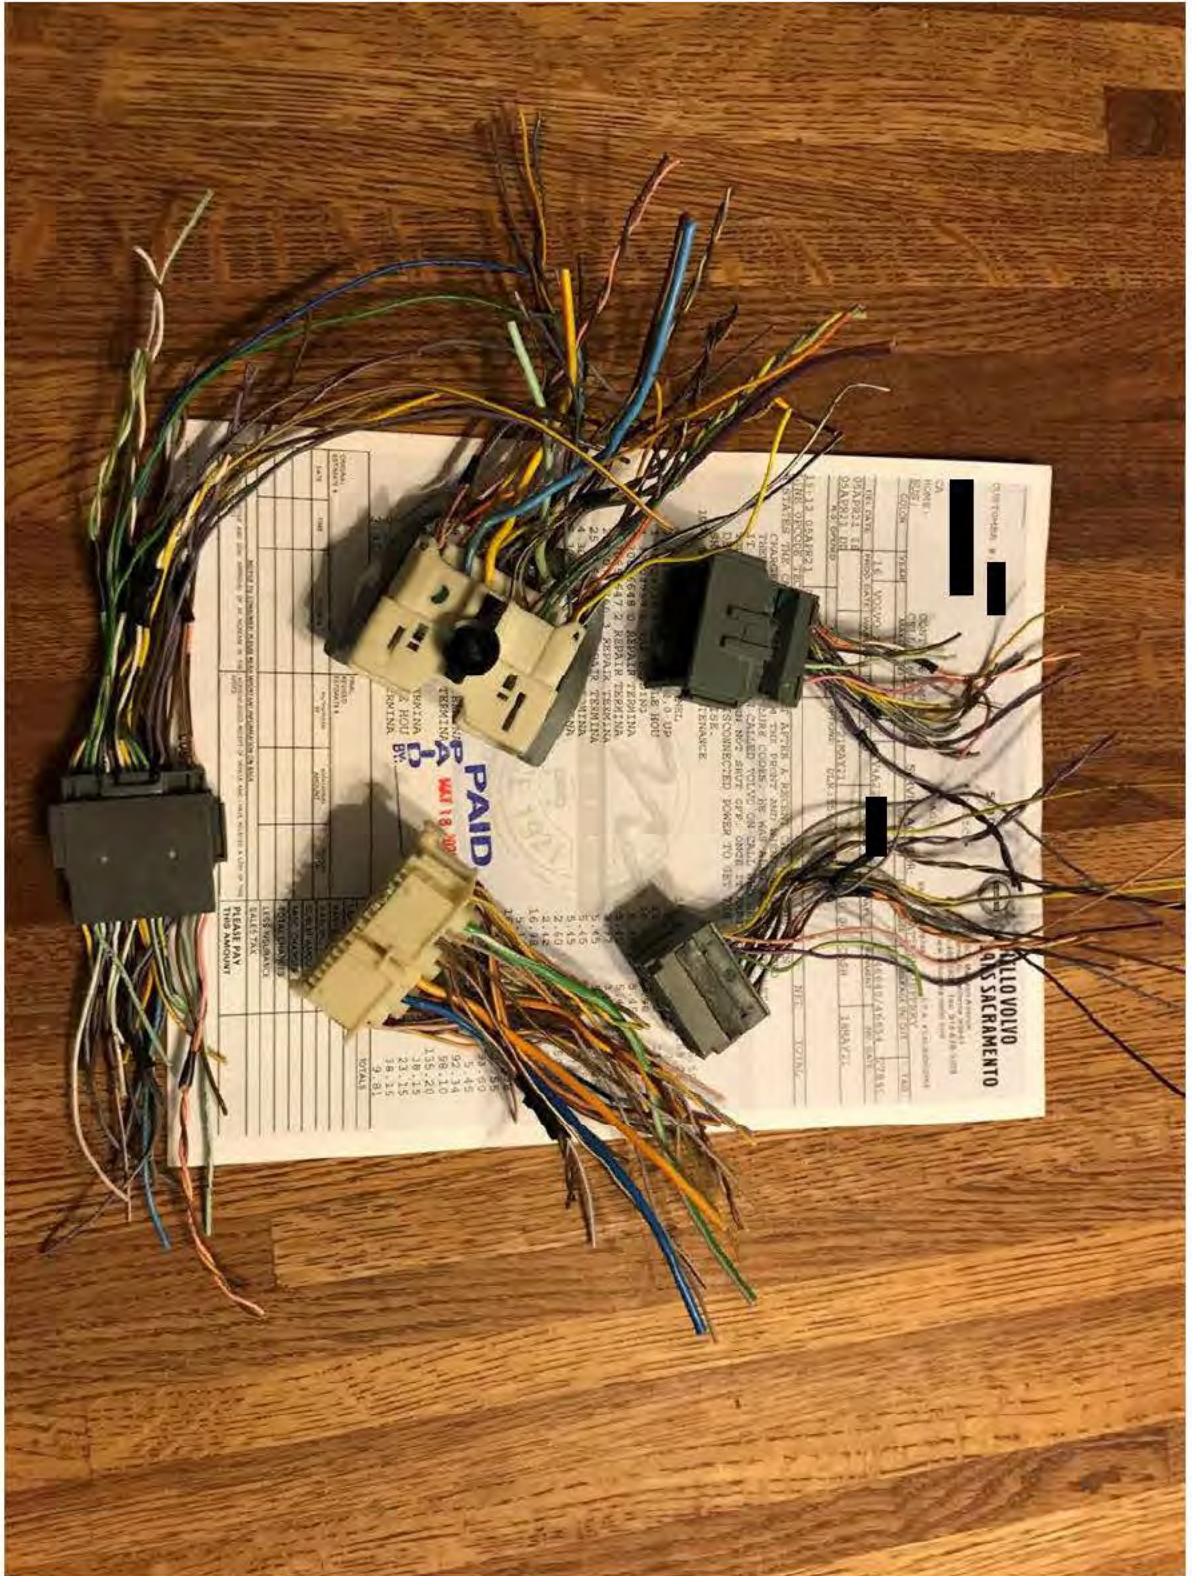
3. During this next phase, Neillo Volvo Service removed the Driver's side floor boards and discovered several inches of water. Three large electrical cable connections were found submerged and corroded. To us, this represented significant manufacturers' Safety Related Defects – water entering the vehicle while hidden from view, unnoticeable, while compromising electrical connections which lead to a cascading failure of various computers. This compromised the operation of the vehicle and totally deprived the operator of specific key safety information while rendering operator control to zero. I have a problem with all of this happening without a single blown fuse. (See attached Neillo parts listing and notes 2 – pages)

I cannot be certain how the repairs were completed, but the Service Advisor told me that there were no bare wires under the floor board and that new connectors were spliced into the existing cables. There were a lot of splices that must have been made which are evident from the number of wires cut on the old connectors. I found myself having to make a significant financial investment to get my car back while the manufacturer did not seem to care. I also find it equally disturbing that the manufacturer appears to be totally ok with leaving the dealer with the potential liability to myself and others from a failure of automated safety maneuvering features or any one of the computer cluster controls affected in the splicing. (See Photo of retained connectors)

Neillo Service made another estimate for the repair \$5,357.07 plus tax. With my vehicle being out of service for almost a whole month, I authorized the repair. The bulk of the effort was to replace the three cable connections.

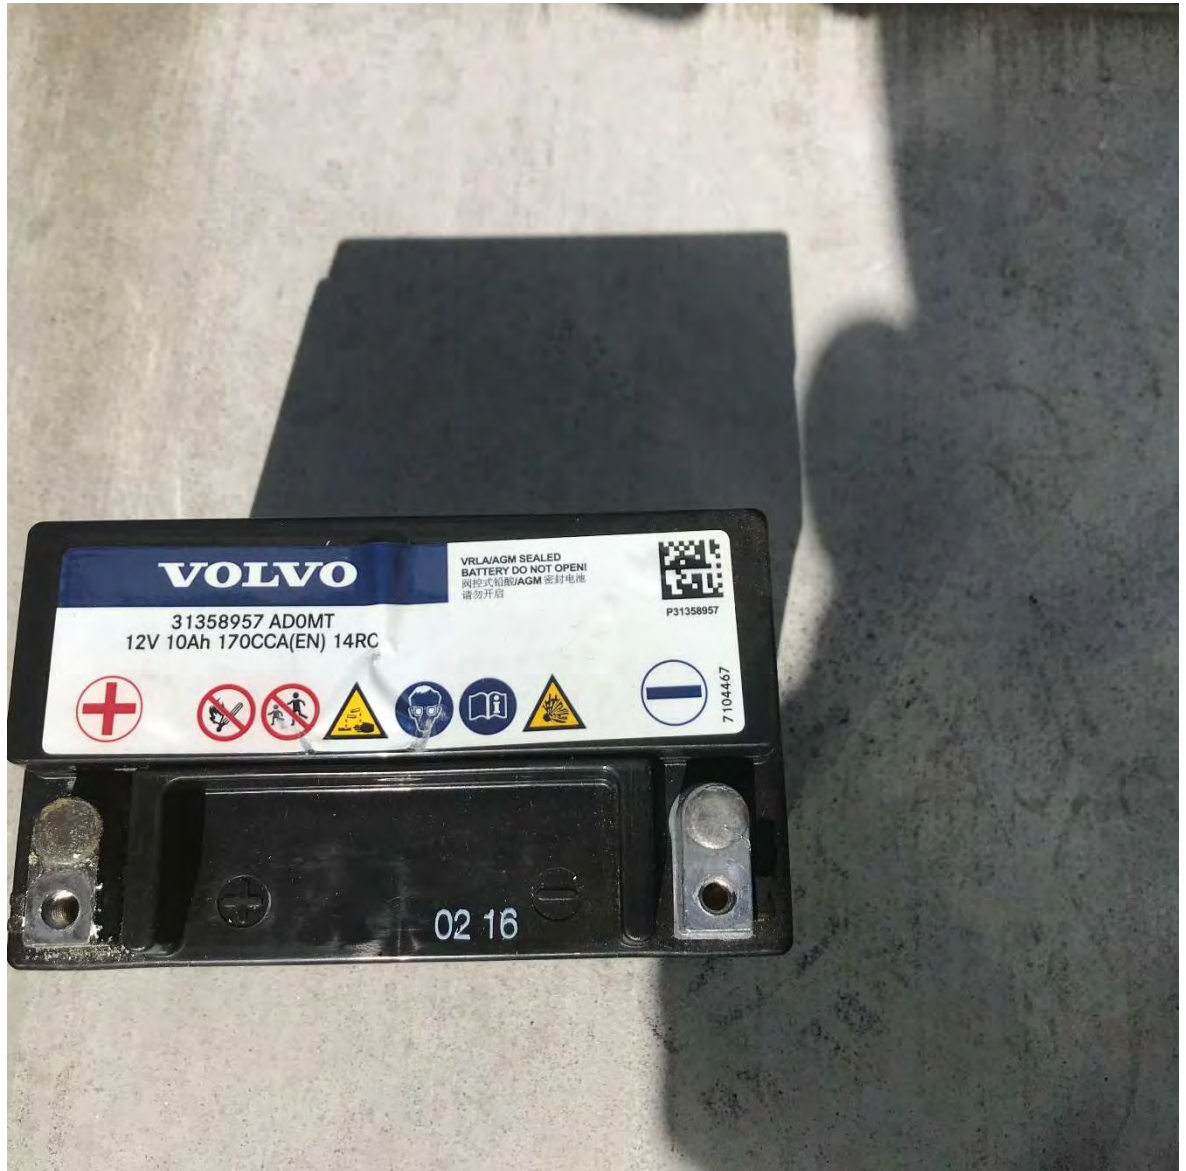
4. During the above diagnosis, a Support Battery was found to be defective. A Support Battery appears to be a small 12 volt lead acid sealed cell unit. (See Photo)

I would suggest that a failed "Support Battery" which is not referenced in the owner's manual and which is installed behind panels in the Engine Compartment out of visual sight of an owner looking under the hood represents another unacceptable safety risk. Hidden inside the vehicle, much like the sunroof drains, leakage or corrosion or failure is not apparent or even made known to the owner/operator in time to be proactive. Lead Acid Batteries are in themselves a hazardous waste item and inherently a fire hazard. Hidden lead acid batteries in a vehicle could be potentially catastrophic for first responders responding to collision accidents or other forms of emergencies. The owner's manual even failed to provide information as to the location of the main vehicle battery. It is discouraging that the manual explains to the owner how to replace a headlight but has no
