NHTSA - Additional Attachment for Complaint 11417805

6/17/2021 - Document #2 - - Addendum to NHTSA Complaint 11417805 filed 5/19/2021

Additional Issues noted after receipt of the vehicle after Sunroof Clogged Drains Water Damage was repaired at Customer Cost of \$5,357.07 (+tax) on 5/21/2021.....

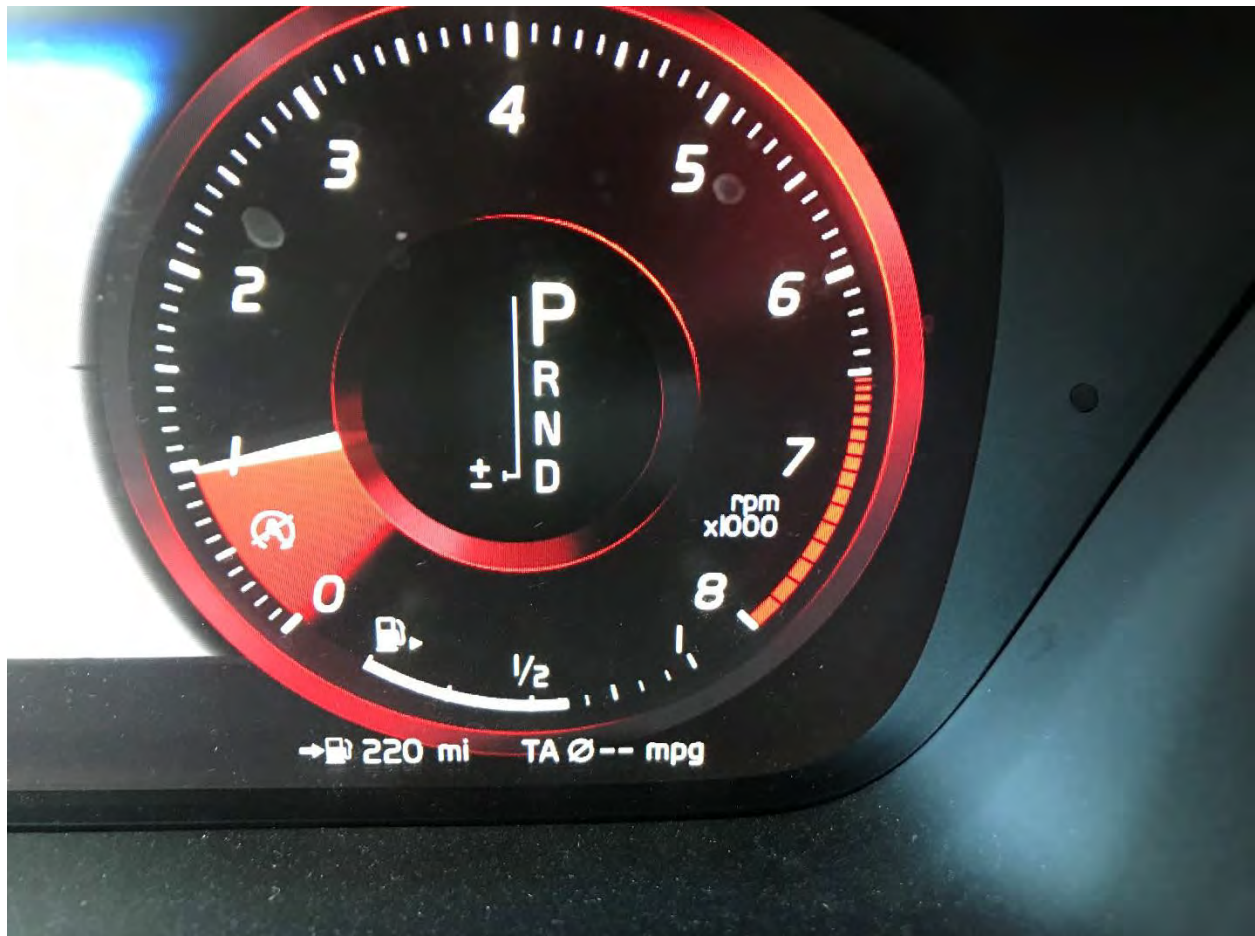
1. Driver Display now shows that the **Automated Stop/Start feature is no longer functional.**  
(Shown in picture below between the 0 and 1)

This feature provided for a fuel saving engine shutdown at prolonged stops such as traffic signals and an automated engine restart when the traffic movement resumed.

I was told by the Service Advisor on 6/7/21 when I returned the vehicle to the Dealership to have this checked, The car's computers make a number of decisions using sensors before enabling this function, (things like Voltage/Air Temperature). He advised that I should drive it around to see if the condition clears. As of 6/16/21, it had not cleared and I have set up another Diagnostic Appointment for 7/1/21.

It is not understood at this point whether this problem is a result of the damaged cable connectors (150+ wire splice repairs), the support battery replacement, software updates in Volvo Version 2, replacement of the Start/Stop Switch, or more worrisome, some additional problem for which I might be billed.
