**From:** [DataQuality, DataQuality \(NHTSA\)](#)  
**To:** [EVOO \(NHTSA\)](#)  
**Subject:** FW: Case #11425477 requested additional information  
**Date:** Monday, September 13, 2021 10:17:40 AM  
**Attachments:** [REDACTED]

Please find the additional requested information attached as a PDF file regarding the faulty Vanos bolts failure of my 2011 BMW 328i e91 wagon.

2011 BMW 328i e91 Sports Wagon  
Broken and Faulty Vanos bolts in N52k Engine  
VIN: WBAUT9C59BA [REDACTED]  
(Exhaust Cam Vanos)

**Recall Campaign 14V-176: N51, N52K and N52T Engine – Replace VANOS Gear Bolts**

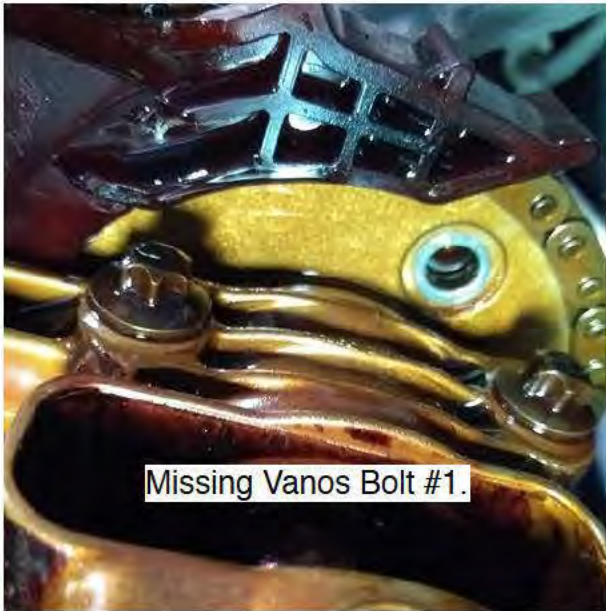
Missing Vanos Bolt #1.

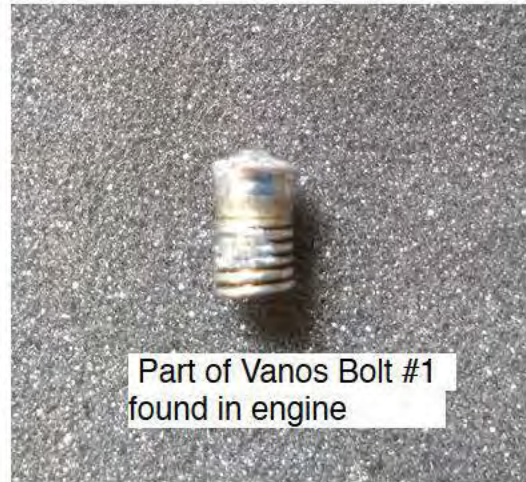
Part of Vanos Bolt #1  
found in engine

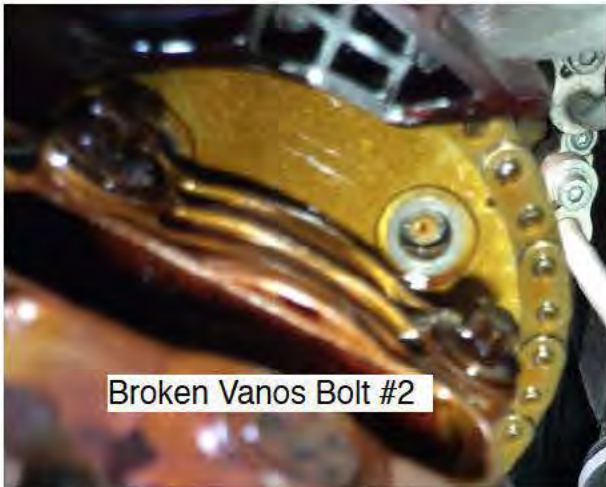
Broken Vanos Bolt #2

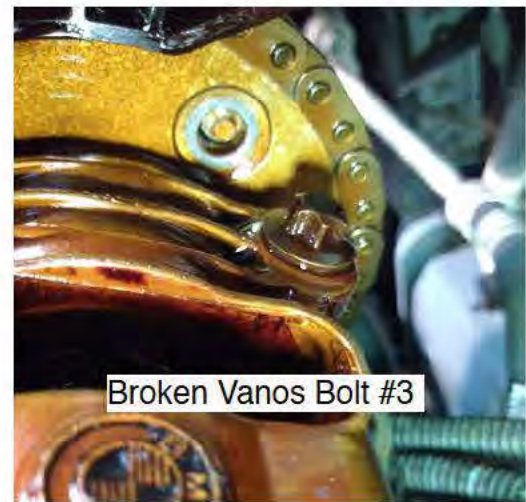
Broken Vanos Bolt #3

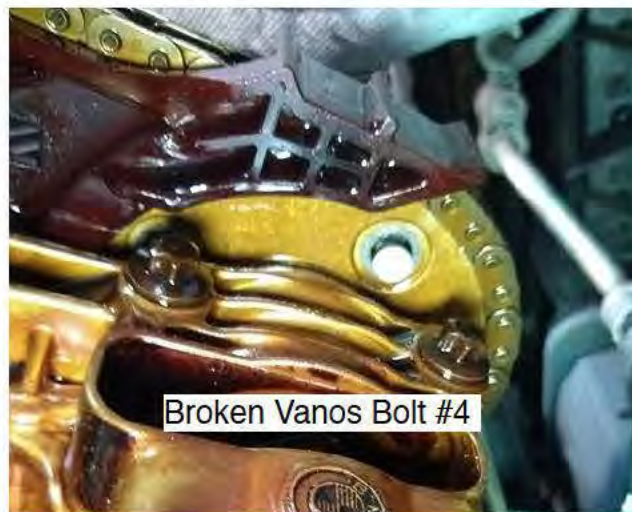
Broken Vanos Bolt #4

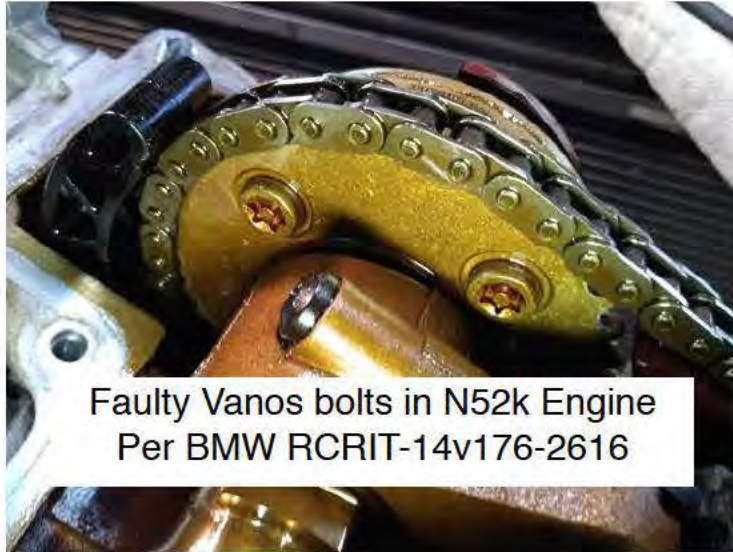
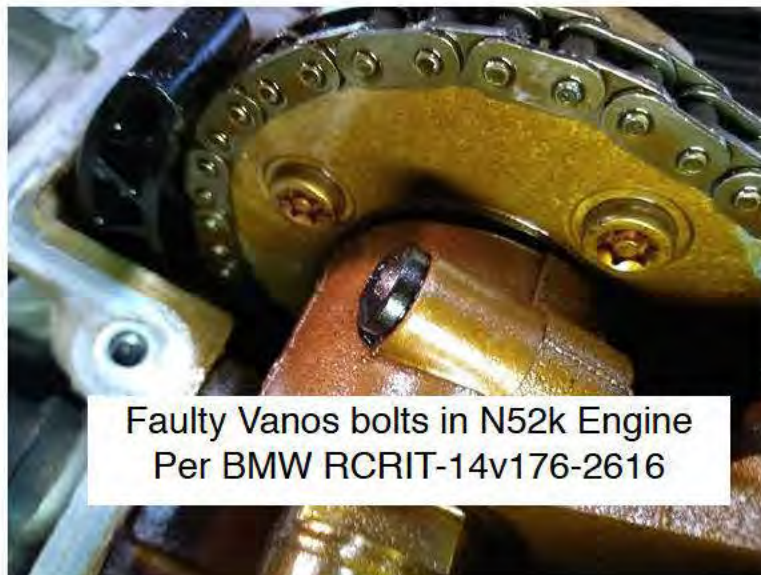
2011 BMW 328i e91 Sports Wagon  
Faulty Vanos bolts in N52k Engine  
VIN: WBAUT9C59BA [REDACTED]  
(Intake Cam Vanos)
