MAKE  
MAZDA

Model  
MAZDA6

Model Year  
2010

### ODI Complaint 11426631

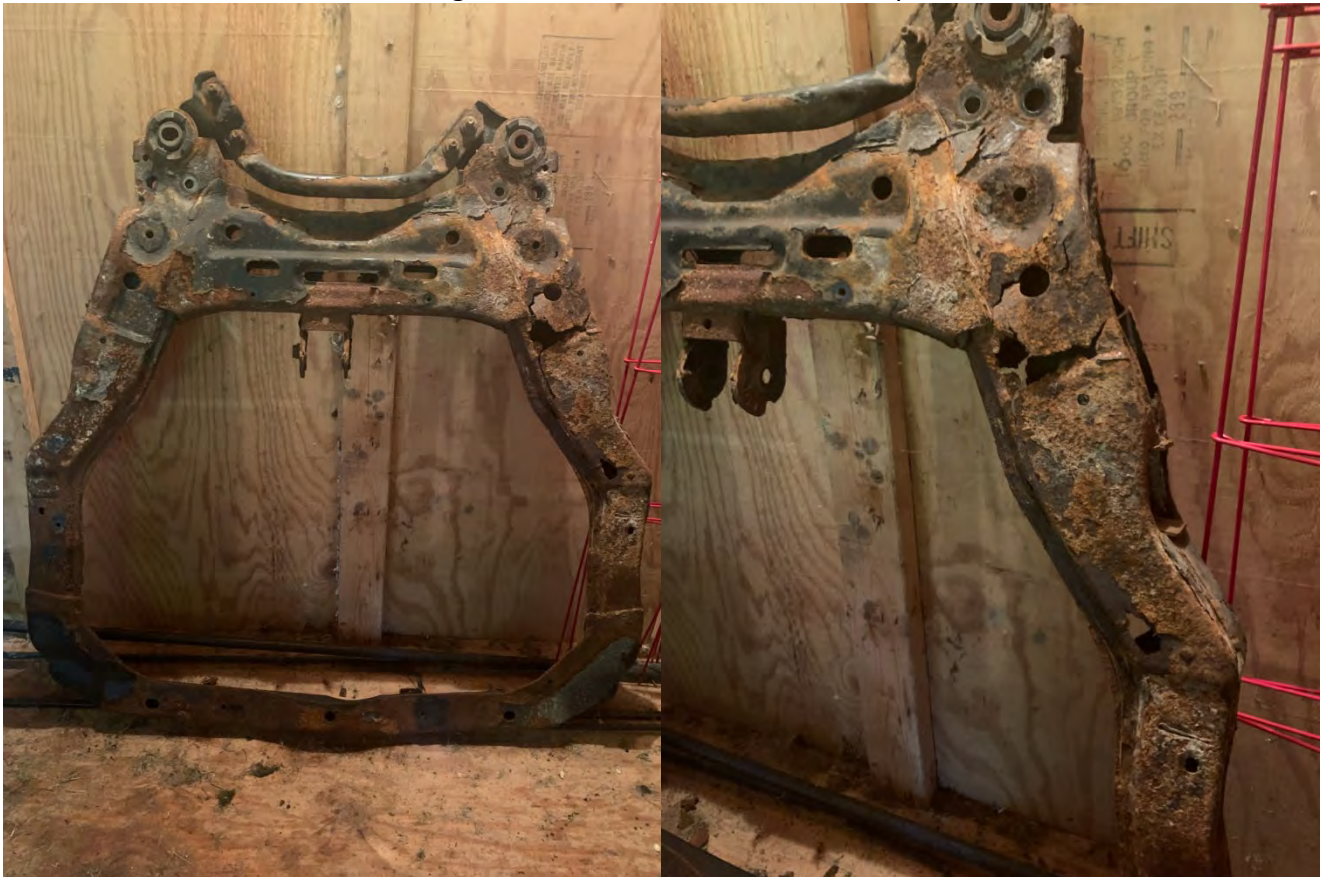
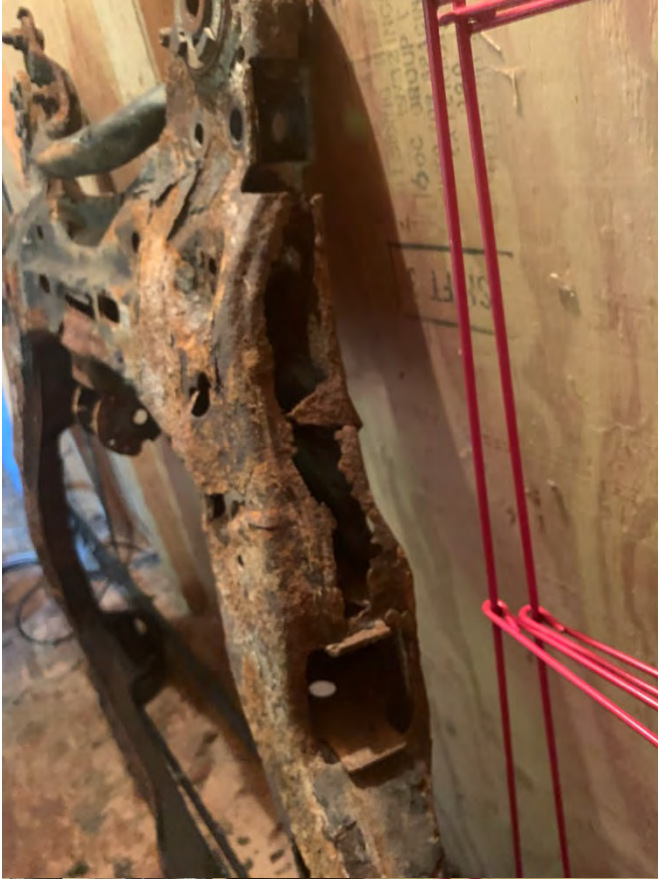
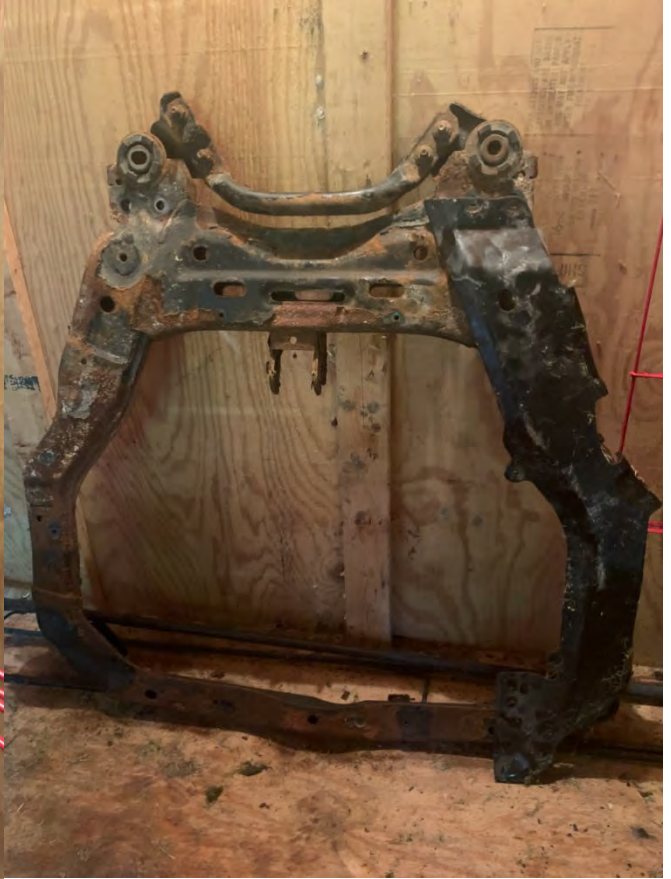
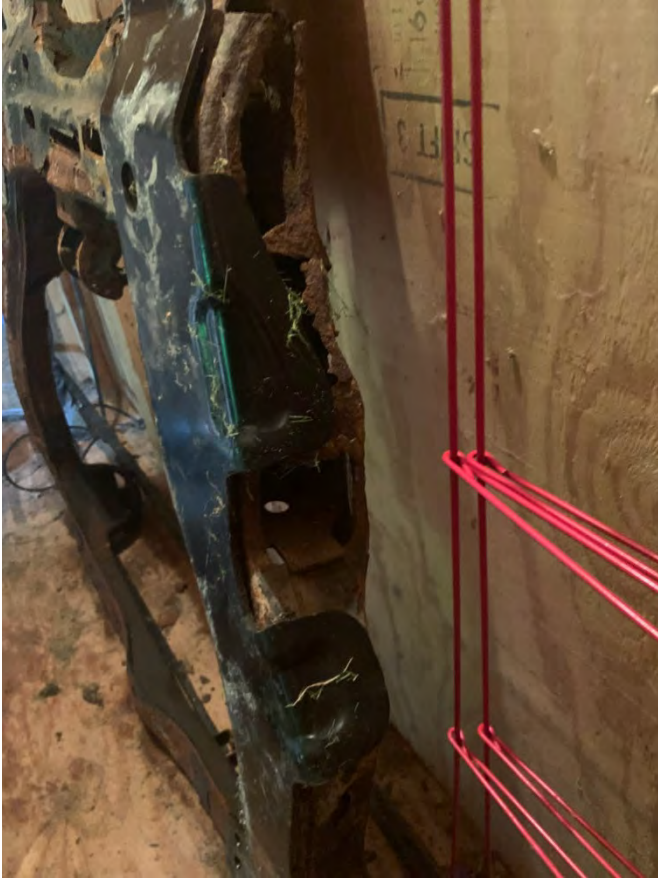
This issue resulted from a poorly repaired recall (NHSTA campaign ID: 18V-631000) initiated on September 18, 2018. The safety risk from Mazda's website specifically states *"Continued use of the vehicle with such condition may allow the perforation to progress, and the support of the right lower control arm front bushing to decrease. This may result in a change of the right front wheel alignment. The driver may experience a heavy pull to the right, and in some cases, it is possible that the steering control may become difficult."* The solution Mazda used DID NOT solve this dangerous issue, specifically with the right lower control arm. Rust was significantly worse on the right versus left side of the frame and especially where the control arm attaches. My mechanic noted that Mazda's recall repair only served to keep the car from splitting apart, but it in no way resolved the control arm issue. As a result my car was unexpectedly swerving all over the road and was difficult to control. That was with the control arm still somewhat attached, though extremely loose. I can only imagine how bad this could've been if this had completely loose. There's a good chance I'd be injured, dead or have injured someone else.

The Mazda recall also notes *"In severe cases the front cross member will be replaced along with the A/C drain hose instead of the side member."* Perhaps the dealer didn't adequately assess the corrosion on my vehicle and instead went the cheaper route of repair; however, this left me eventually driving a dangerous vehicle and it cost me approximately \$1,200 to fix what should've been fixed for free a few years ago. The last two photos are shown with the replacement part from the recall, which held the frame together but didn't address the real problem.
