RE: Consumer vehicle defect worthy of a recall

PIP5558 Clutch Pedal Stays On The Floor - Pedal Does Not Return To Top Of Travel Or Pedal Returns Slowly

PIP5558A Clutch Pedal Stays On The Floor - Pedal Does Not Return To Top Of Travel Or Pedal Returns Slowly

# Product Safety Recall: Astra Diesel with manual transmission Reference Number 18-C-120 (E1811803130)

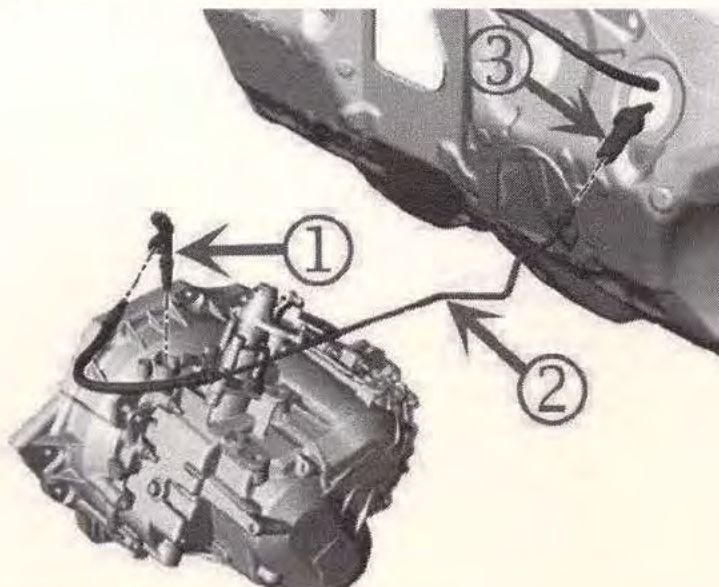
Item number 1 in the picture below has a small orifice internally that fluid passes through. If small pieces of debris in the fluid get pushed to or through the orifice then it will restrict oil flow. The debris may restrict the orifice then the pedal return will be affected. Customer may notice any of the following concern: Pedal stays on the floor, pedal does not return to top of travel or pedal returns slowly.

Engineering is currently investigating and a bulletin will be published when a repair is validated.

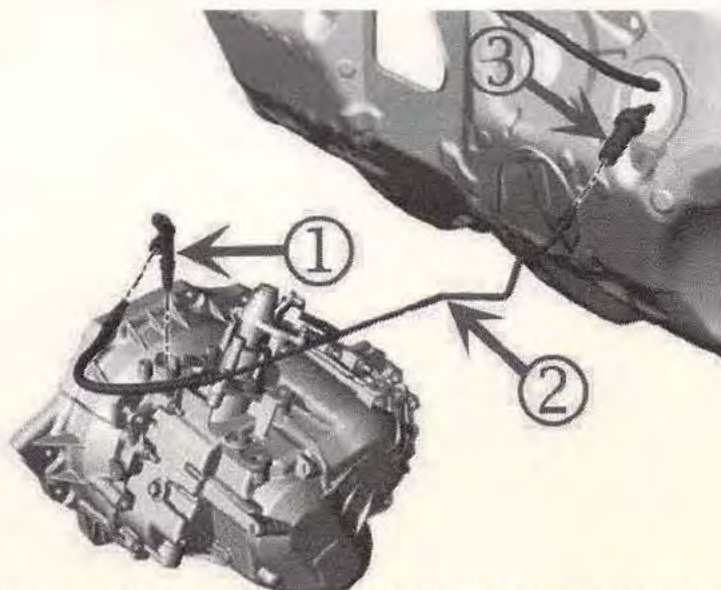
Item number 1 in the picture below has a small orifice internally that fluid passes through. If small pieces of debris in the fluid get pushed to or through the orifice then it will restrict oil flow. The debris may restrict the orifice then the pedal return will be affected. Customer may notice any of the following concerns: Pedal stays on the floor, pedal does not return to top of travel or pedal returns slowly.

The source of the debris is the dampener in the high pressure line (3).

FOR GASOLINE ENGINE equipped vehicles: Replace the Line, Elbow, Sleeve and slave cylinder with kit p/n 24295457. The new parts in the kit are not interchangeable with the original parts in the vehicle due to hydraulic connection variation between the parts.

FOR DIESEL ENGINE equipped vehicles: Replace the line and elbow with parts currently available in the parts catalog. Diesel equipped vehicles were originally built with the FTE parts so current part inventory will interchange.
