**From:** [DataQuality, DataQuality \(NHTSA\)](#)  
**To:** [EVOQ \(NHTSA\)](#)  
**Subject:** FW: Follow up to ODI Complaint ---11503483  
**Date:** Monday, February 27, 2023 8:03:03 AM  
**Attachments:** [REDACTED]

**Re: Recall Campaign  
VANOS Assembly Bolts  
Model Year 2010-12 BMW 1 Series, 3 Series, 5 Series, 5 Series Gran  
Turismo, 6 Series, X3 SAV, X5 SAV, X6 SAV, Z4**

**Subject:** Camshaft Housing Bolts May Loosen causing Stall

My 2011 328i Xdrive stalled in heavy traffic suddenly and without warning. Since that time, it has been in a "crank / no start" condition with Check Engine Light on and throwing 2A9A and 2A9E error codes. After closely checking the engine, I was surprised to discover that all 4 of the vanos housing bolts on the intake camshaft had sheared off. The vanos housing bolts are of the type that are known to be defective and are addressed by the 14V-176 recall. Note that these defective bolts are of a soft, silver-colored aluminum and have a tamper-resistant torx head, in contrast with the sturdier replacement bolts (BMW part #11368602263) which are black in color and have a regular torx head. I have checked with both the manufacturer (BMW US Headquarte

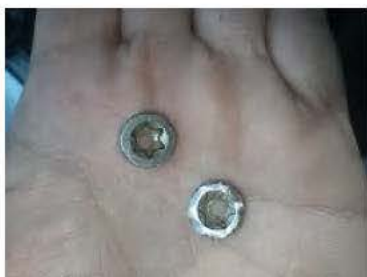
5) sheared off intake vanos bolt heads (2 of 4) found in upper engine (under valve cover).jpg  
430K

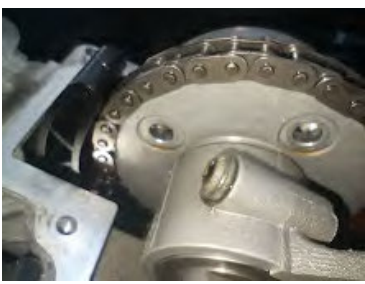
**4) intake vanos gear (all 4 bolts are broken).jpg**  
490K

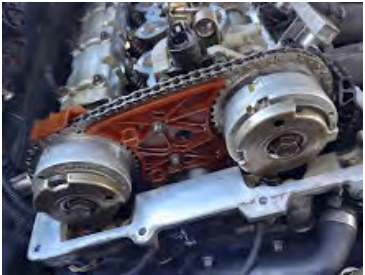
**2) timing chain and vanos gears (looking backward).jpg**  
3213K

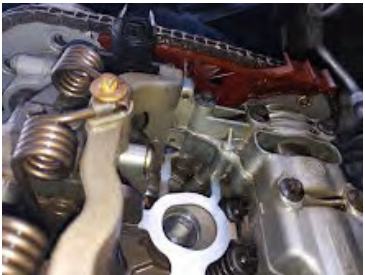
**3) timing chain and vanos gears (looking forward).jpg**  
3598K
