Motor Vehicle Defect Petition to Recall All Tesla Vehicles Due to Sudden Unintended Acceleration

How Brakes Can Fail During a Sudden Acceleration Incident

27 November 2024

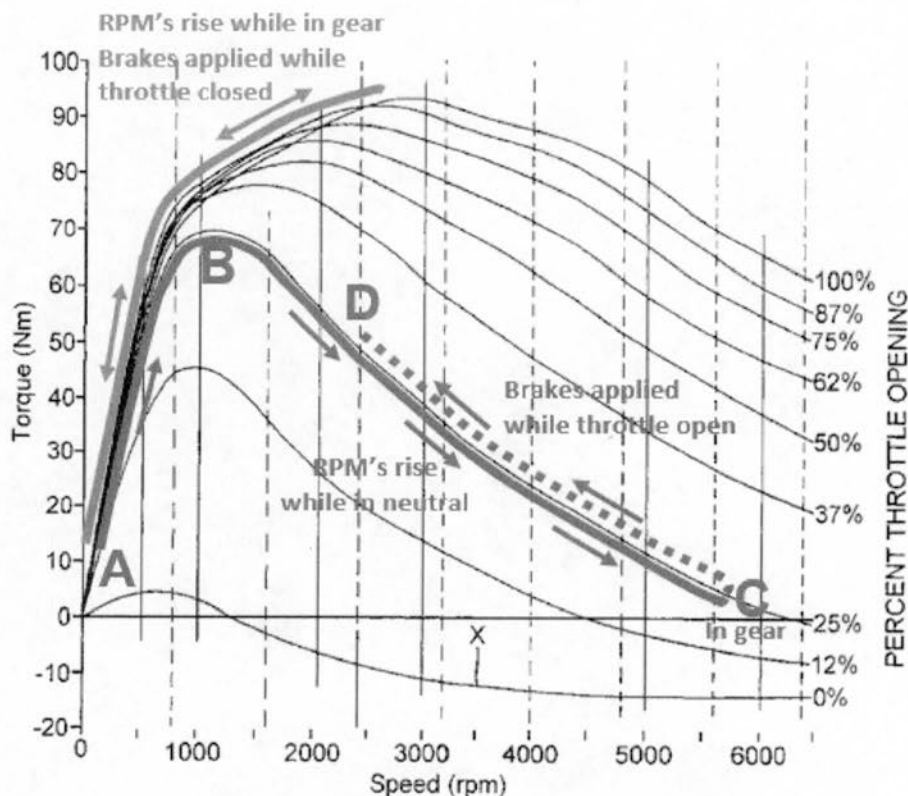
Figure 1. Engine torque versus engine speed for an ICE vehicle. During normal operation the engine follows the green curve to the left of the maximum points in the throttle opening curves. The engine torque increases as the engine RPM's increase and decreases as the engine RPM's decrease while braking with the accelerator pedal released and the throttle closed. During sudden acceleration, the engine RPM's increase rapidly following the red curve while the transmission remains in neutral due to delayed engagement. At point C the transmission drops into the lowest gear to begin vehicle motion. When the brakes are applied during sudden acceleration, the engine torque increases as the engine RPM's decrease because of the increased load on the engine produced by the brakes as a result of the engine operating to the right of the maximum torque position while the throttle remains open. The resulting increase in engine torque counters the braking torque, giving the driver the impression that the brakes are failing. In vehicles with engines that produce a lot of torque the driver may even perceive that the vehicle speeds up as the driver presses on the brake pedal during sudden acceleration.

When the driver applies the brakes to try to stop the sudden acceleration, the load on the engine increases further, causing the engine RPM's to decrease. But as the engine RPM's decrease, the engine torque increases as a result of operating between points C and D to the right of the curve maximum where the curve slopes upward with decreasing engine RPM's. If the increase in the engine torque is low, then the increase in engine torque opposes or neutralizes the applied braking torque, causing the driver to perceive that the brakes are less effective or have failed completely. If the increase in the engine torque is higher than the applied braking torque because of a powerful engine, then the increase in engine torque causes the vehicle to accelerate as the driver applies the brakes. This is the reason many drivers involved in sudden acceleration incidents say that the brakes have failed or that pressing on the brake pedal caused the vehicle to accelerate. It is the perception of the driver-- resulting from the vehicle acceleration-- that the brakes are failing, and not the actual failing of the brakes. This perception of brake failure is correct because while the engine is operating to the right of the maximum RPM value, the engine torque increases as the engine RPM's decrease when the brakes are applied. This increase in engine torque counters the applied braking torque, making the driver perceive that the brakes are ineffective. The harder one presses on the brake pedal, the faster the engine RPM's decrease and the faster the engine torque increases to oppose the brake torque or to cause the vehicle to accelerate.

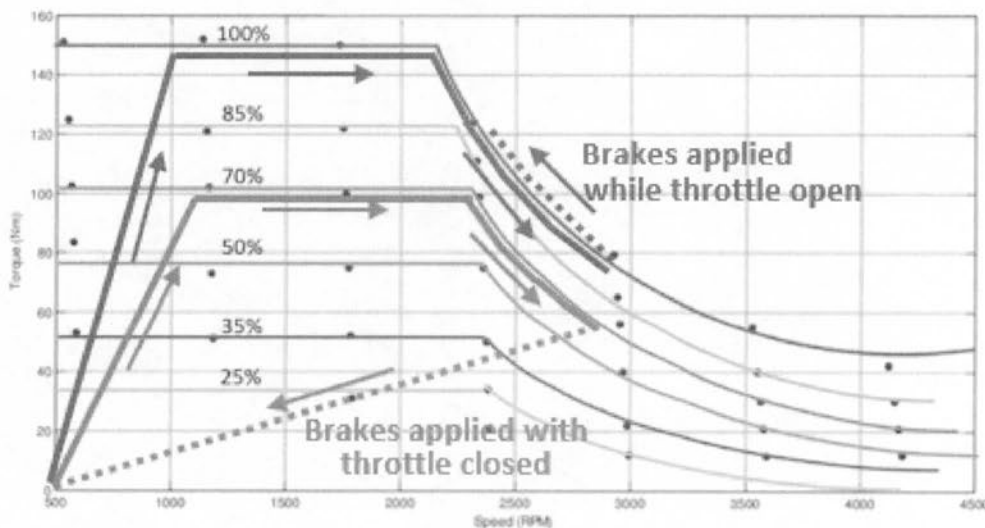
In vehicles powered by electric drive motors, the motor torque varies with motor RPM as shown in Figure 2. The torque in the base region varies with the battery current as controlled by the driver pressing on the accelerator pedal, and remains constant as the motor RPM's increase up to the base speed of around 2000 RPM. At motor RPM's higher than the base speed the drive motor torque decreases with increasing motor RPM's.

Figure 2. Motor torque versus motor speed for the drive motor of an electric vehicle. During normal operation the drive motor follows the green curve, causing the motor torque to decrease as the motor RPM's decrease while braking with the accelerator pedal released and no current applied to the motor. During sudden acceleration the motor follows the red curve, causing the motor torque to increase as the motor RPM's decrease while braking as current continues to be applied to the motor.^[Endnote 1] The increased motor torque counters the braking torque, giving the driver the impression that the brakes are failing.

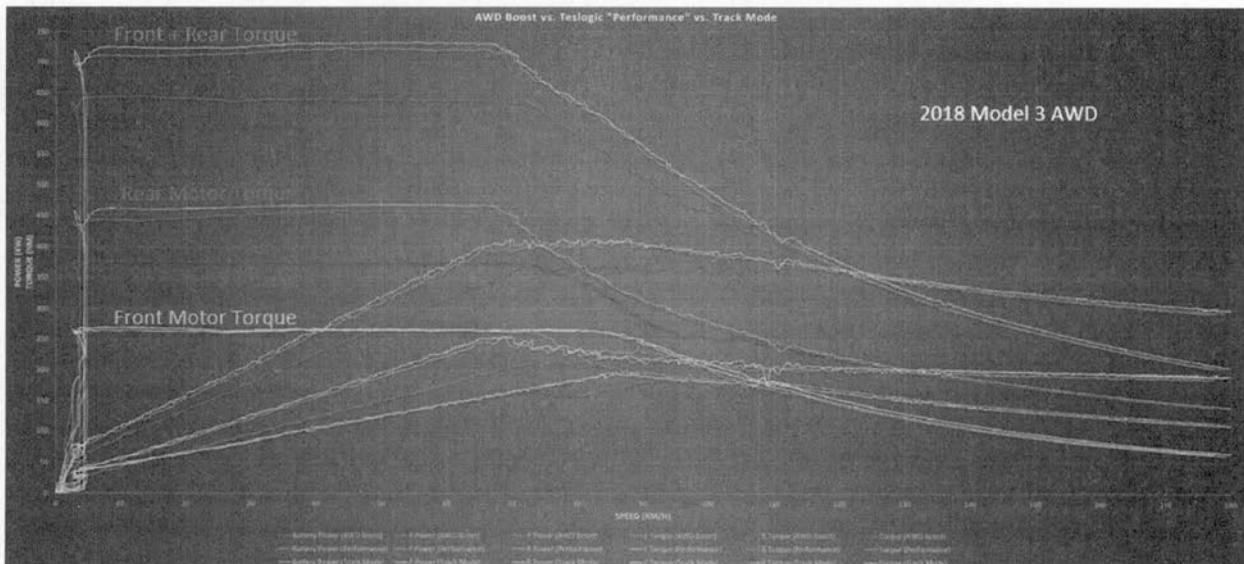
In some electric vehicles the drive wheels are directly connected to the drive motor without a geared transmission. In these vehicles, the vehicle speed is directly proportional the motor RPM as shown in Figure 3. This difference in drive train design causes the following differences between ICE vehicles and electric vehicles during sudden acceleration:

Figure 3. Motor torque versus vehicle speed for the two drive motors of a 2018 Model 3 Tesla with AWD. Only the maximum torques (100% throttle) are shown. Lower torques are obtained by using lower accelerator pedal settings that apply proportionally lower currents to the motors.

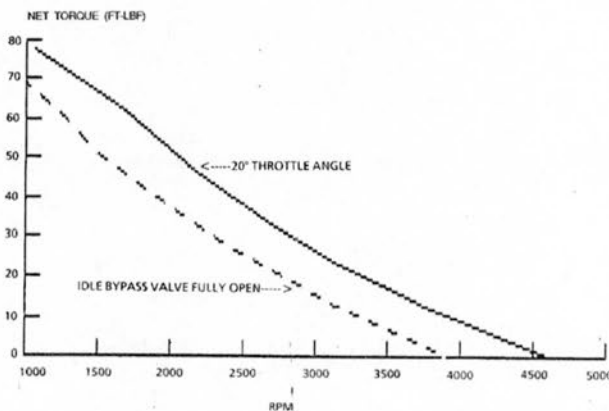
FIGURE B-4. NET ENGINE TORQUE (WARM)

Note that the engine torque in this figure decreases with increasing RPM's, implying that the engine is operating in the red region of Figure 1 when the idle stabilizer valve is fully open. This figure would be more recognizable if it did not omit the 0 to 1000 RPM region in which the engine torque increases with increasing RPM's, which includes the green region of Figure 1. It should also be noted that a turbocharger causes the peak RPM value to decrease compared to the peak RPM value of a non-turbocharged Audi 5000 engine.
