From: [DataQuality, DataQuality \(NHTSA\)](#)
To: [EVOO \(NHTSA\)](#)
Subject: FW: 11567348
Date: Friday, February 23, 2024 10:53:54 AM

From: [REDACTED]
Sent: Friday, February 23, 2024 9:50 AM
To: DataQuality, DataQuality (NHTSA) <DataQuality@dot.gov>
Subject: 11567348

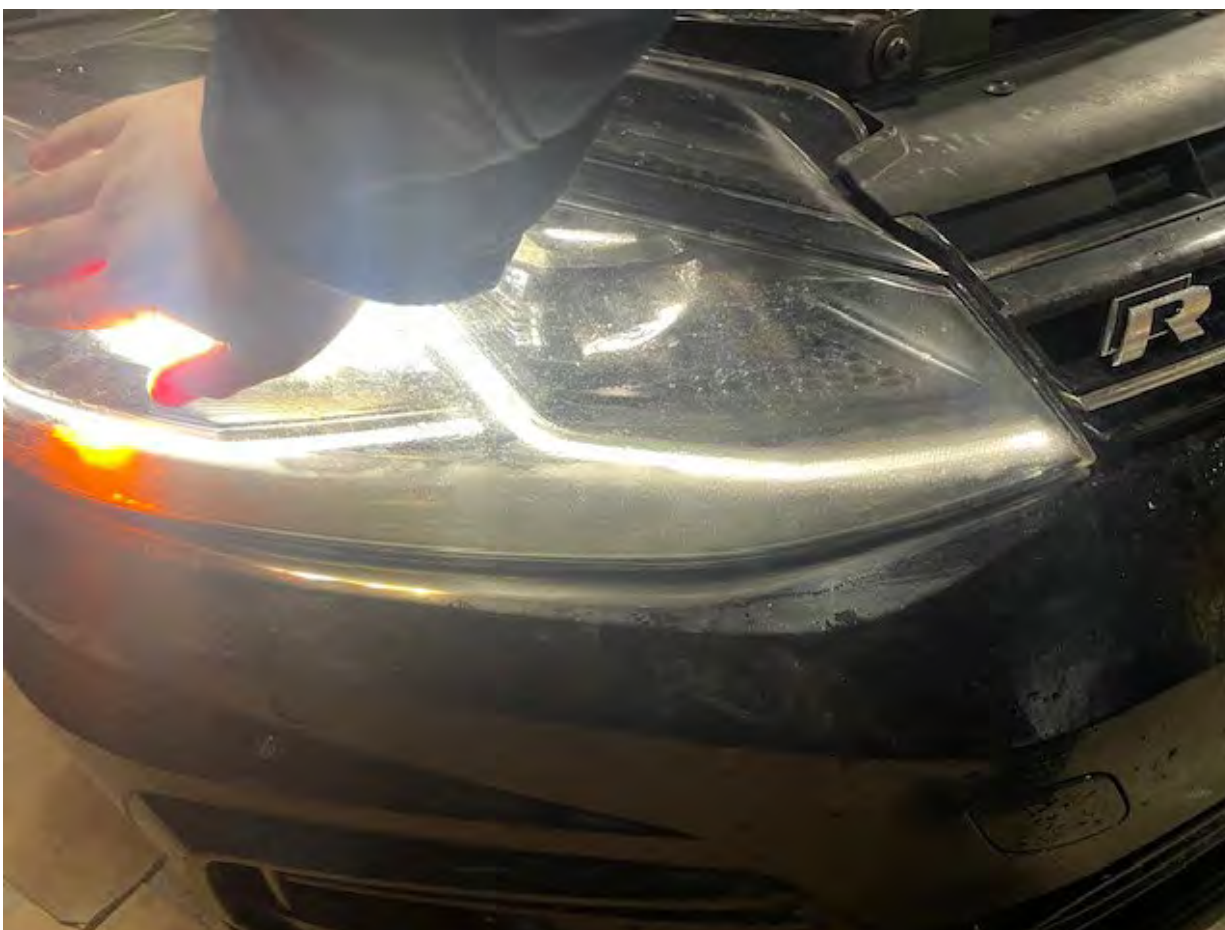
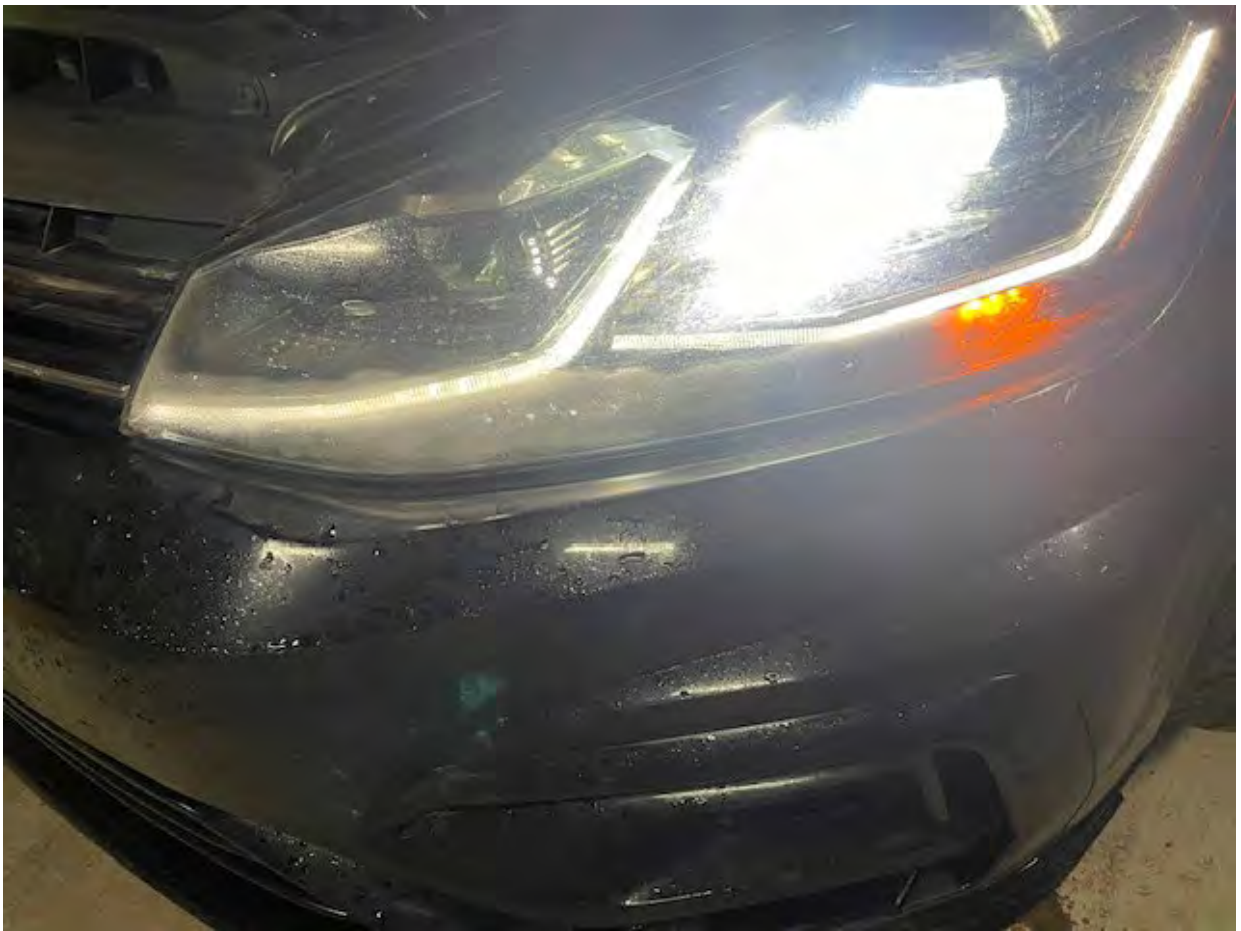
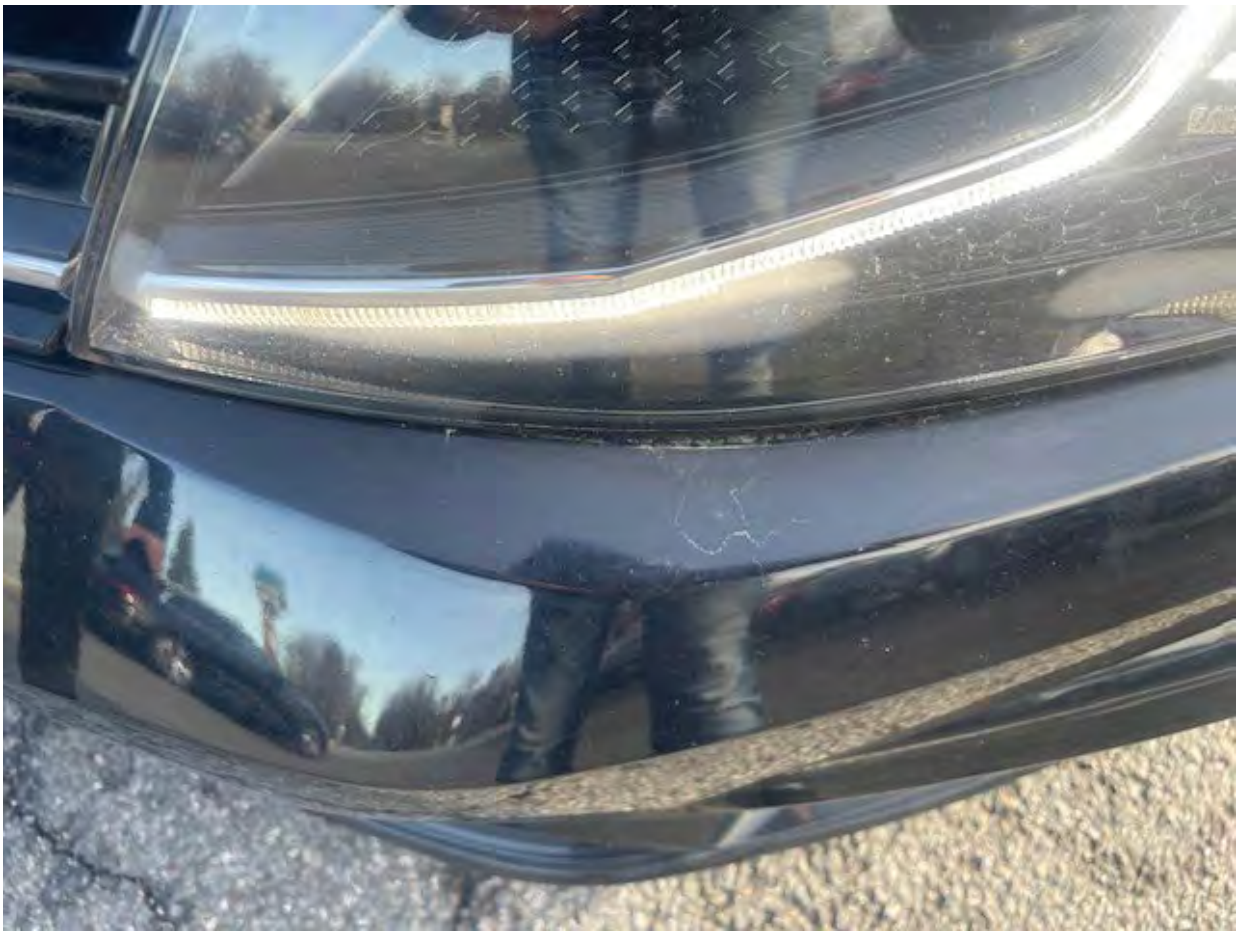
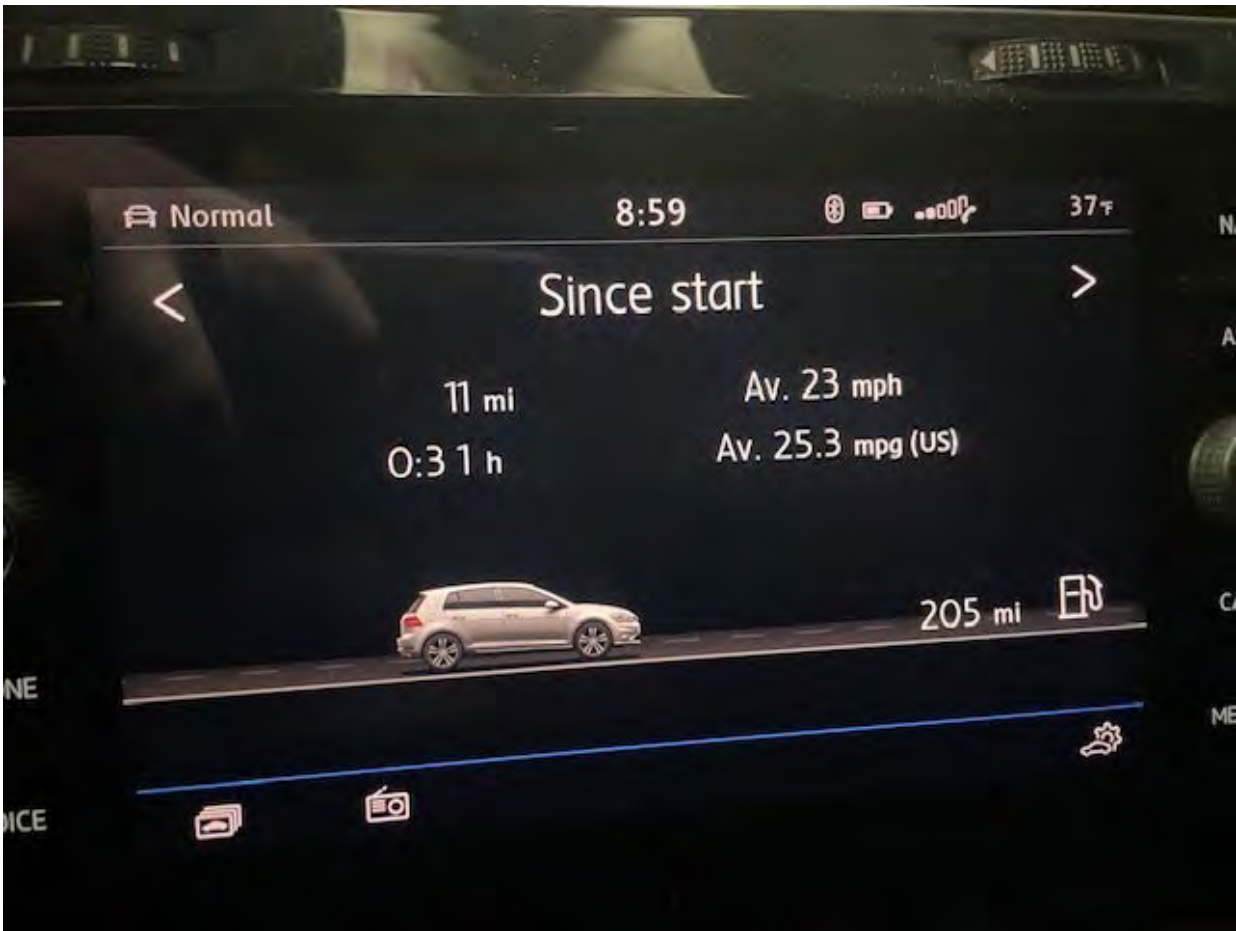
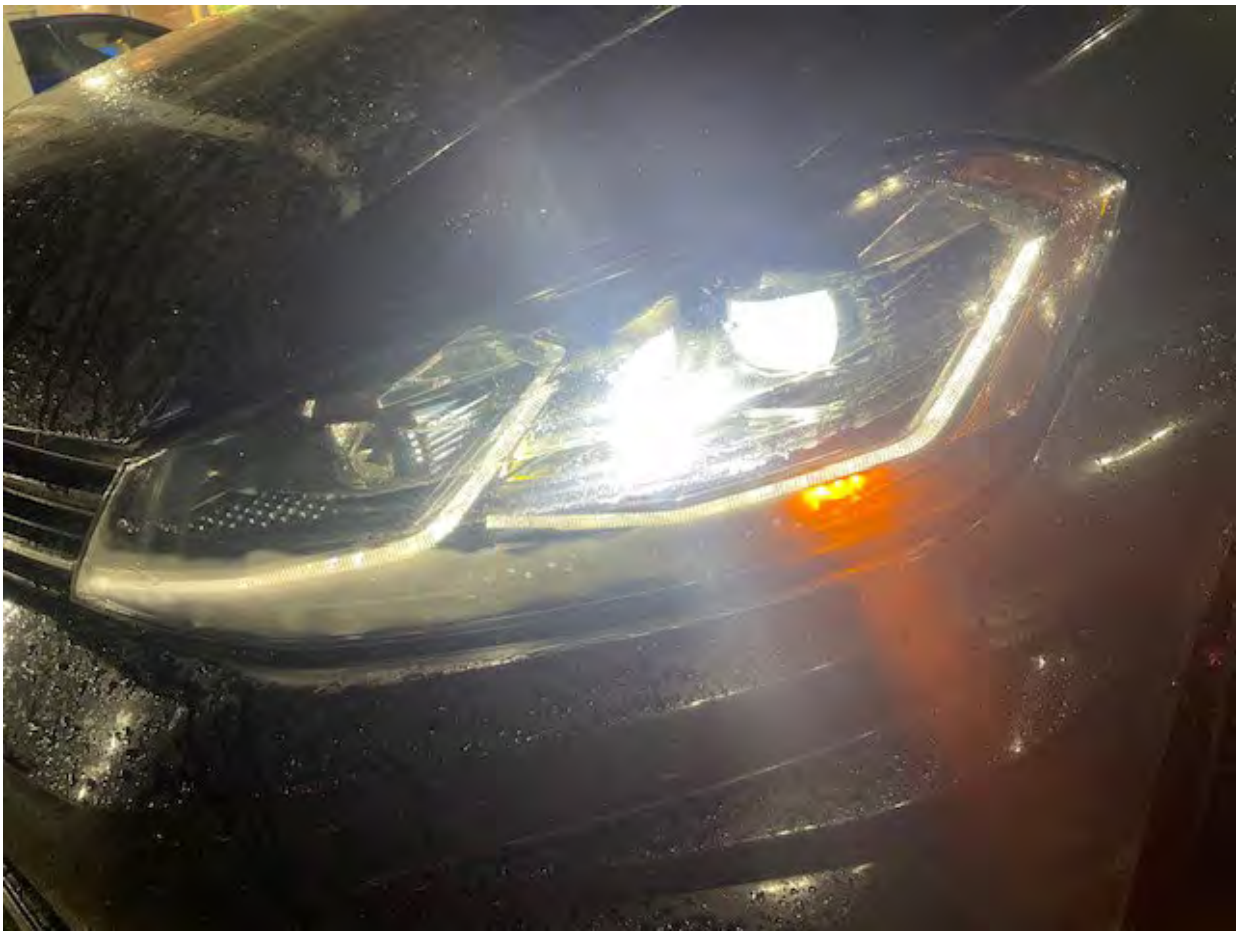
Issue is with safety of not being able to see the road at night, this is a common issue on the bi-xenon head lights on Volkswagen golf's 2015-2023 Volkswagen group of America is aware of the issue and is issued a tsb advising customers To let their car run with their headlights on for 30 minutes for them to clear in an excuse to not have to replace the defective units with this being unreasonable and putting drivers at risk of causing accidents let alone they are not warranty them even if after 30 minutes of supply out, I have already done this with the dealer and they still will not warrantee my headlights and the water will get to the point where it covers the inner lens and light can get out or it is extremely scattered.
