From: [Ambrose, Ann-Marie L](#)
To: [EVOQ \(NHTSA\)](#); [Robertson, Faithia \(NHTSA\)](#); [Lewis, Brenton](#)
Cc: [NHTSA ODI CED](#); [Strasser-King, Marion C](#)
Subject: ODI- 11571902
Date: Thursday, February 22, 2024 10:41:51 AM
Attachments: [REDACTED]

Subj: Volta Alternator Cable Routing Defect in Winnebago Travatos

There is a problem with Winnebago Travatos equipped with the Pure3 Volta system (GL & KL models).

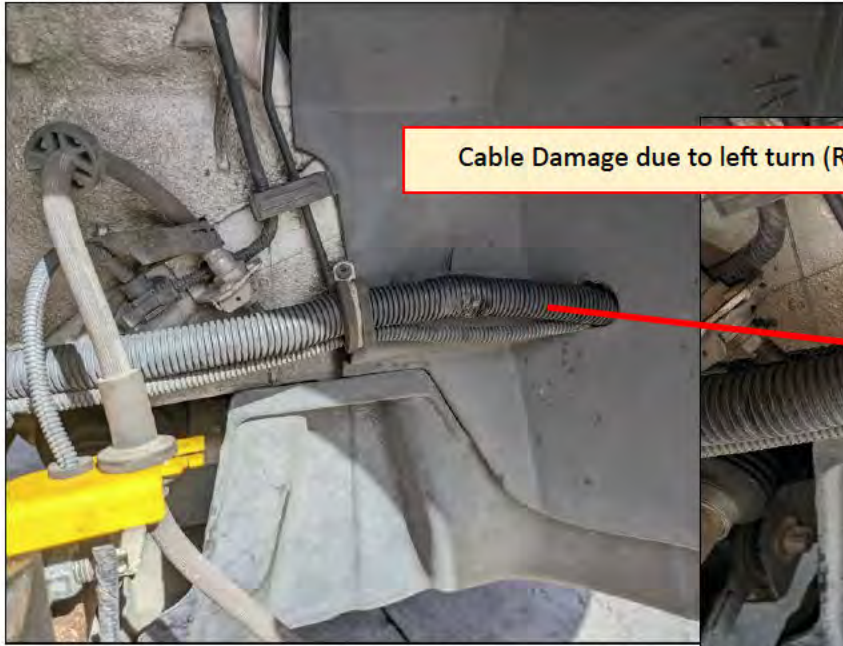
I recently discovered that the outer protective conduit has been damaged by the tire rubbing against it.

In my situation, the rubbing occurs if the steering wheel is turned all the way to the left.

Cable Damage due to left turn (Rene Cote's 2020GL Travato)

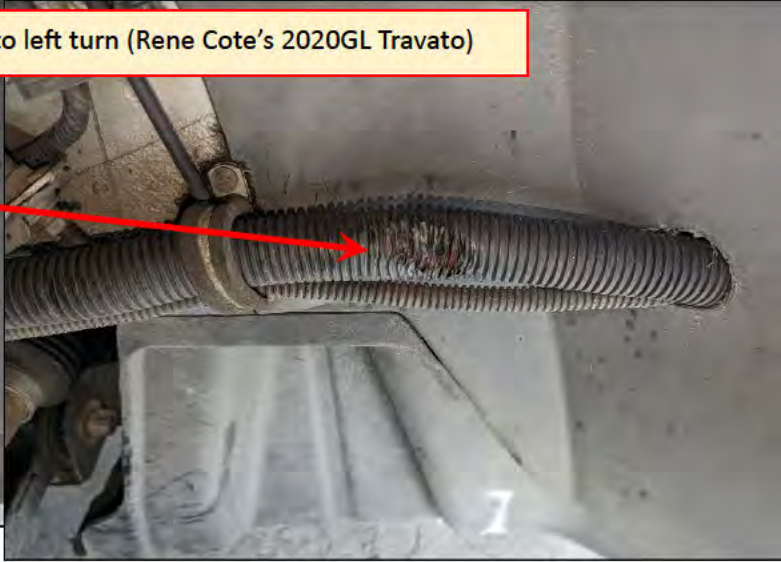
Thanks to those who posted about this issue - I just checked, and the tire has been rubbing one of the Volta cables in the passenger side wheel well on our 2022KL. I sent the photos to Volta, and they said it looked like a ground wire, which could be shrink-wrapped and repaired. I'm applying some liquid electric tape now and, after a few coats, I'll wrap it with tape for now. Then I'll try to move it up and out of the way before we depart on a 5-week trip in 10 days. Maybe I... [See more](#)

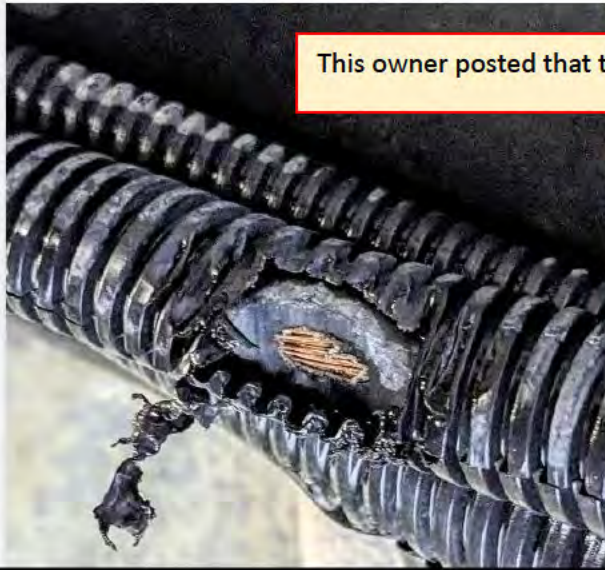
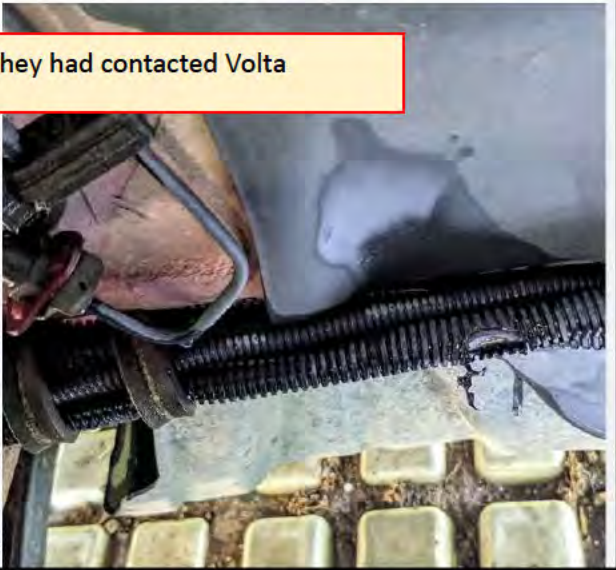
This owner posted that they had contacted Volta

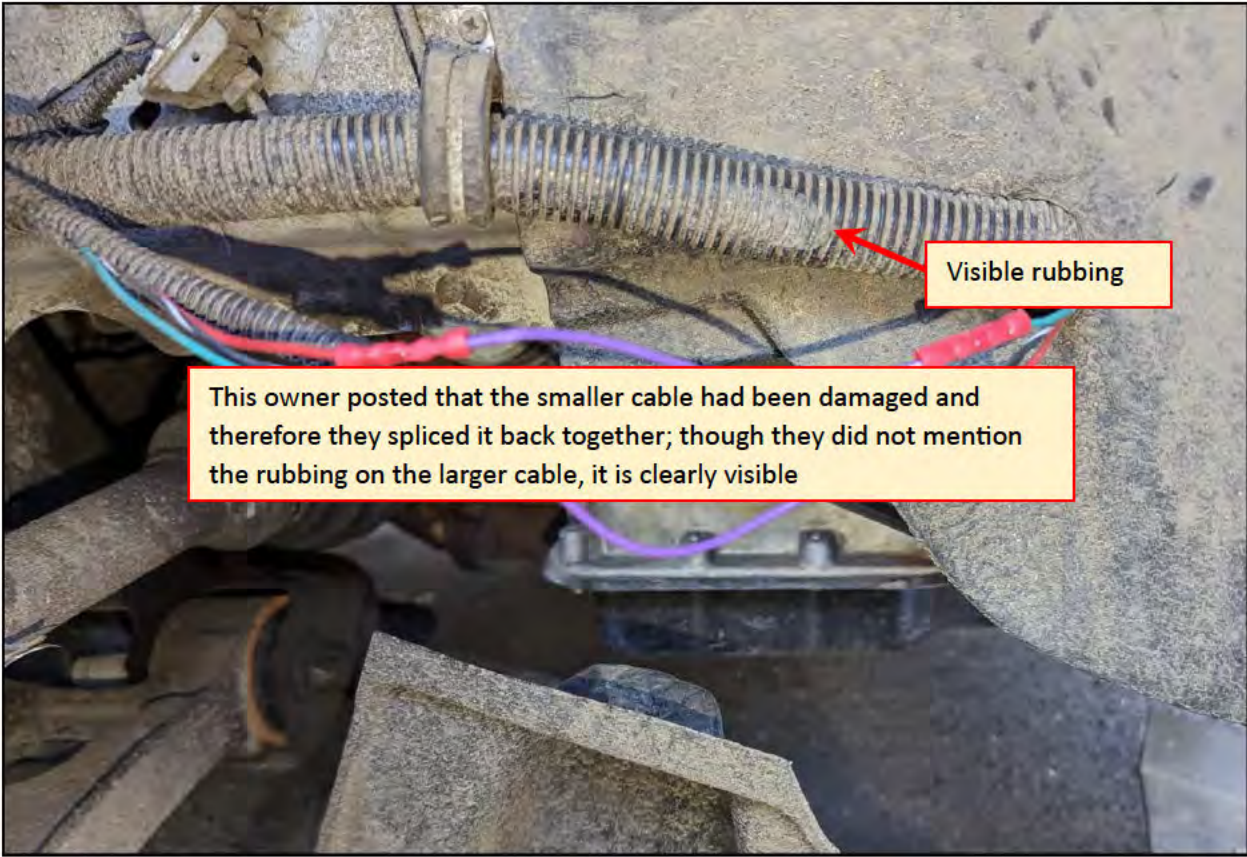
This owner posted that the smaller cable had been damaged and therefore they spliced it back together; though they did not mention the rubbing on the larger cable, it is clearly visible

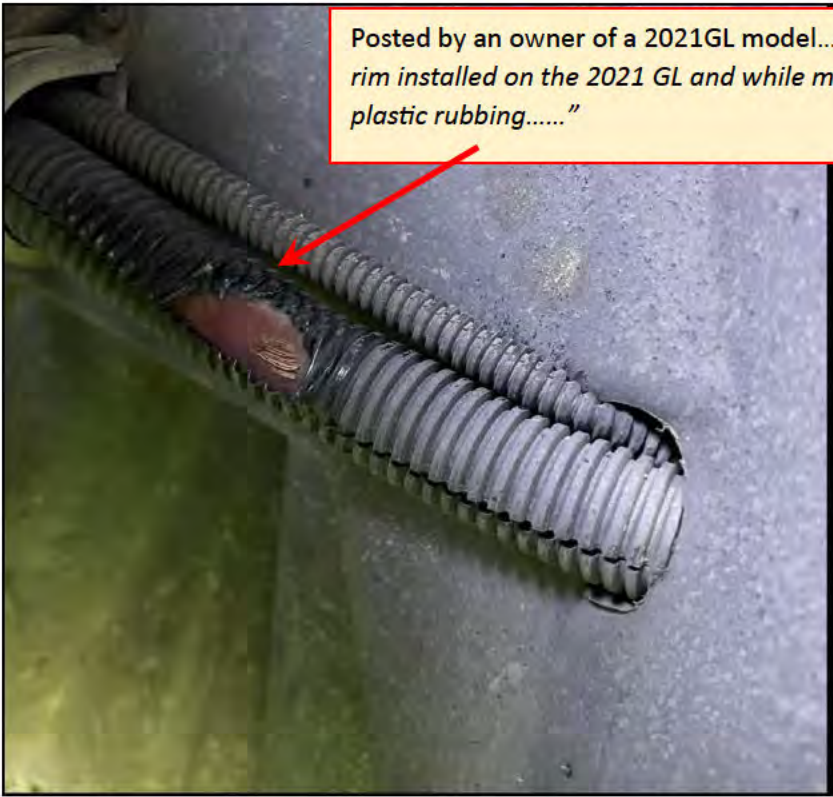
Posted by an owner of a 2021GL model... *"We had the National Park Edition tires and rim installed on the 2021 GL and while making a 5 point turn the other day heard plastic rubbing....."*

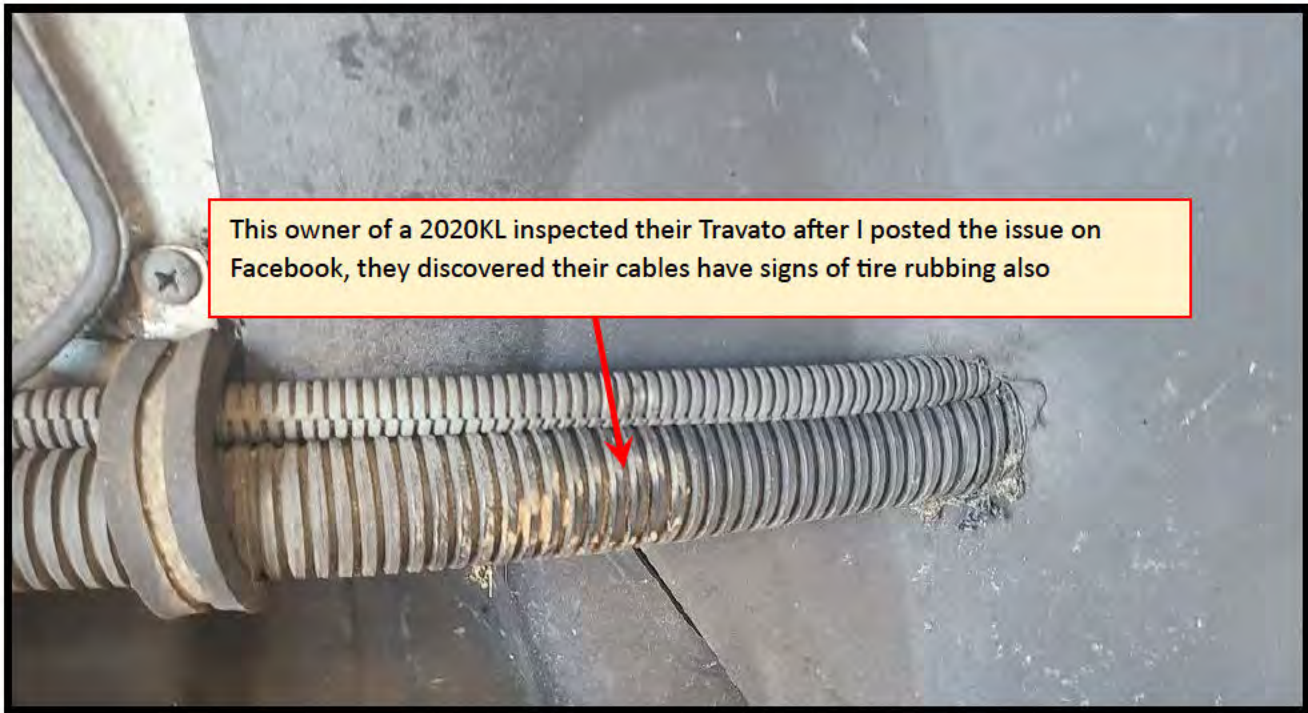
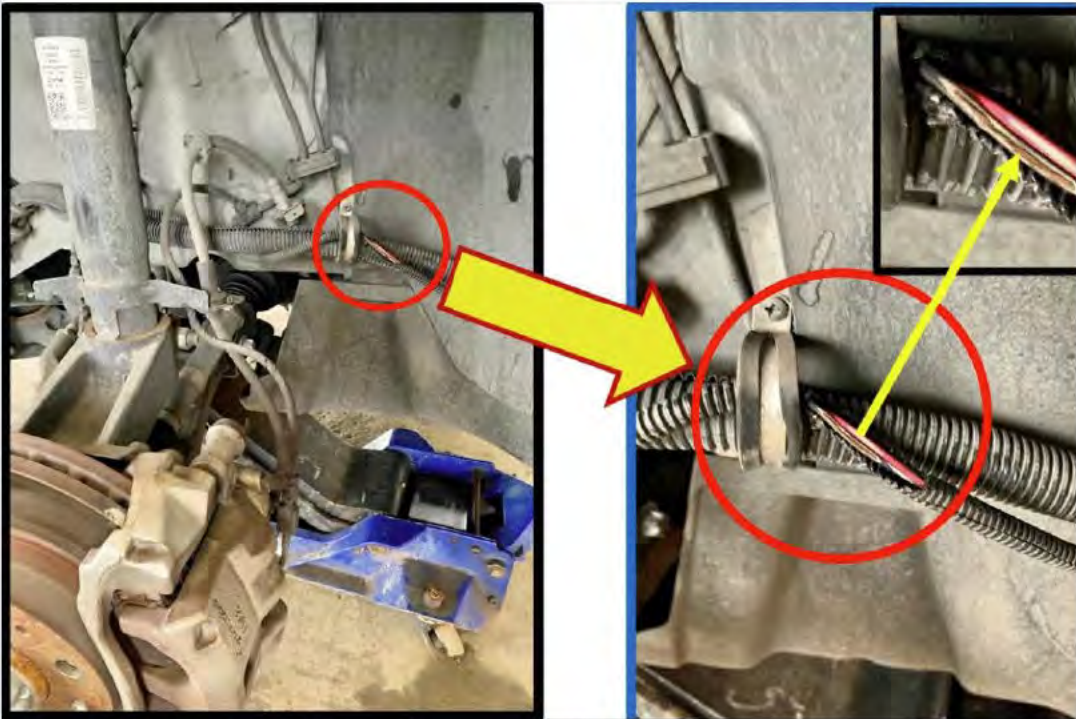
A post from an owner of a 2021GL

Do you know what this bare wire connects to behind passenger side wheel well of a 2021 Travato GL (photos with red circles)? An apparent rubbing of the tire (on sharp turns?) has exposed the wire we just discovered during a tire rotation. The tire change technician attempted to mitigate further exposure by electric taping and zip tying wire closer to wheel well (second image). Will this do or should we seek a better solution. Thoughts appreciated. Thanks!
