From: [REDACTED]
To: [EVOQ \(NHTSA\); DataQuality, DataQuality \(NHTSA\)](#)
Subject: Re: Follow up to ODI Complaint ---11576642
Date: Monday, April 8, 2024 3:02:57 PM
Attachments: [REDACTED]

Automobile Status Report

2017 Lincoln MKC

Multi-Point Inspection Form

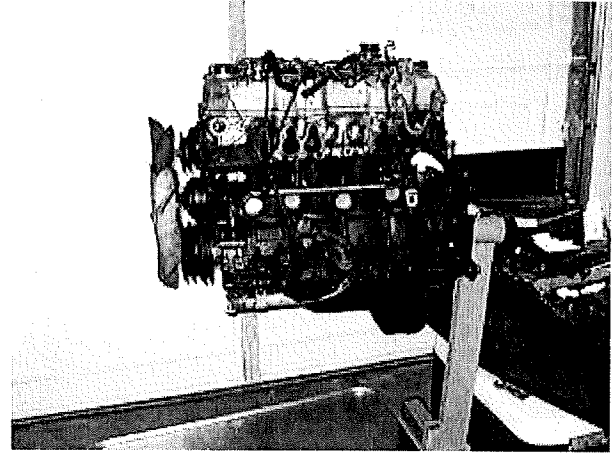
Engine Rebuild/Replace: VERIFIED CONCERN, CK AND INSP VEHICLE OF EXTERIOR COOLANT LEAKS NONE FOUND. RUN EEC SELF TEST HAS CODE P0301 AND P0316 CYL 1 MISFIRE. SUSPECT COOLANT INTRUSION ON CYL 1, REMOVE SPARK PLUGS 1 AND 2. PRESSURE TEST COOLING SYSTEM FOUND CYL 1 COMPROMISED COOLANT LEAKING INTO THE CYLINDER CAUSING MISFIRE AND CHECK ENGINE LIGHT TO COME ON. ENGINE LONG BLOCK REPLACEMENT IS NEEDED. DIAGNOSE/REPLACE LONGBLOCK

Without replacing or rebuilding a damaged engine, the car will not be able to function and will be left useless.
