On Aug. 5, Saturday, my husband and I, along with our two sons who are [REDACTED] years old and [REDACTED] years old, were driving on [REDACTED] at 75 miles per hour at approximately 5 pm when we heard and felt a whoosh sound, and the air dam fell off completely, rolled under our vehicle, and beneath several vehicles behind us, including semis that ran over the air dam because they could not swerve around it. This is a congested two-lane highway between Oklahoma and Texas. When it ripped off, it sounded like it first came from the front drivers side, which is reinforced by other complaints posted onto [REDACTED]

2020 highlander air dam fell off

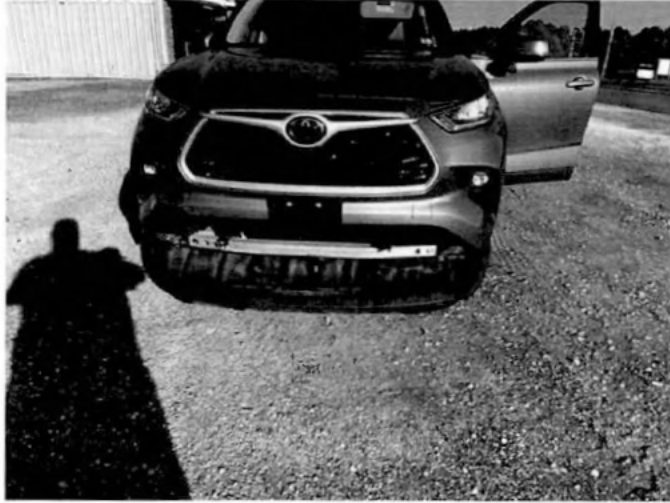
We were driving to work. All of a sudden we hear scrapping coming from the front of the car. I stopped and found this. I did not hit anything. What exactly is this called?

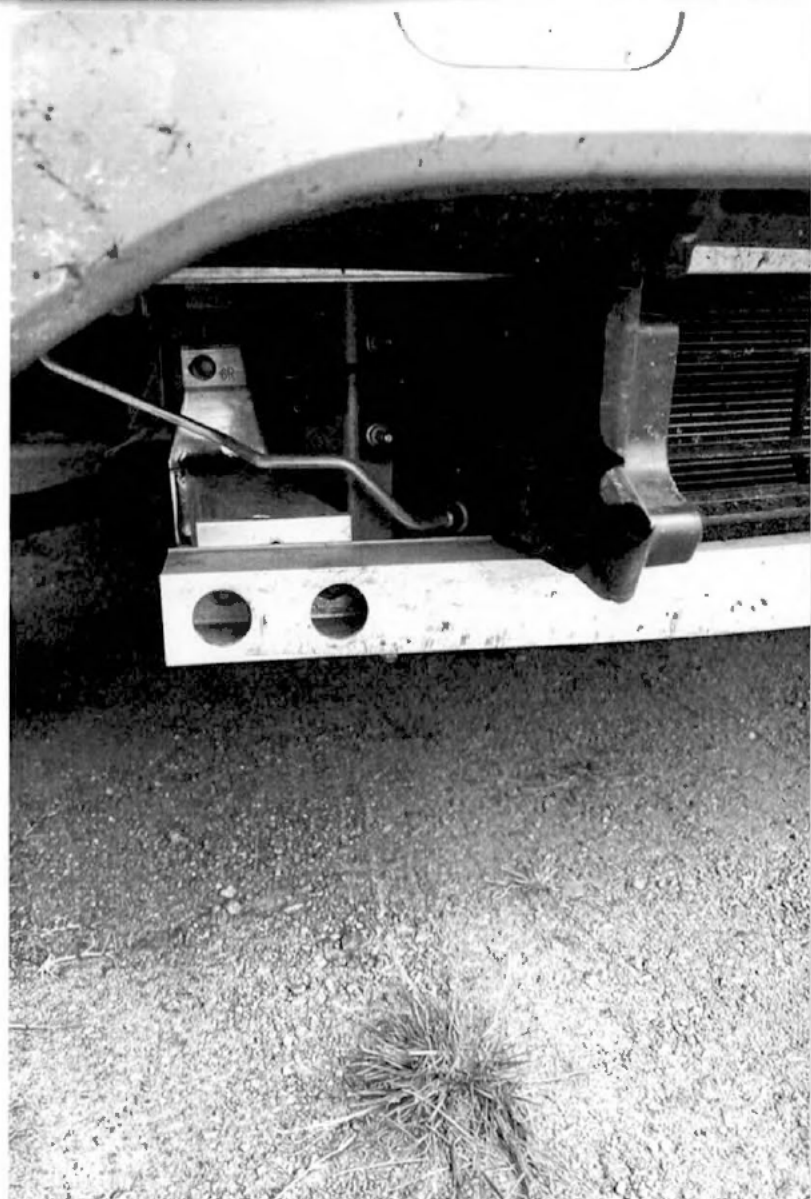
On Saturday Jan 21, 2023 while driving 70 mph on i75 between [REDACTED] florida the lower bumper fell off. We didn't hit anything on the road. I was driving and my wife was in the car and witnessed the incident. We pulled off onto the shoulder of the highway. Our quick response saved not only the lower front bumper from going under the front tires but also avoided a major accident. We had to tie the bumper to the grill and went to the nearest Toyota dealer. He put it up on the lift, showed us how plastic plugs securing the lower bumper had failed. He secured the bumper with zip ties so we could proceed on our journey.

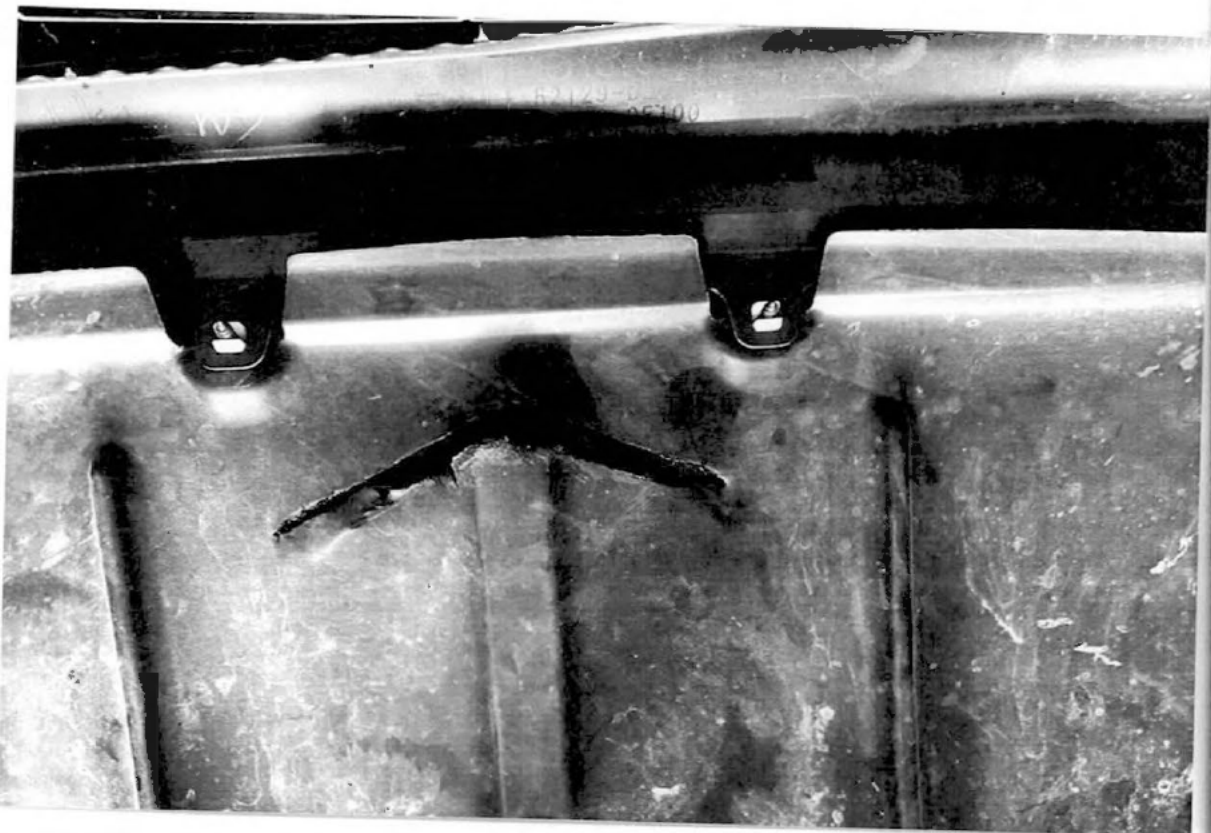
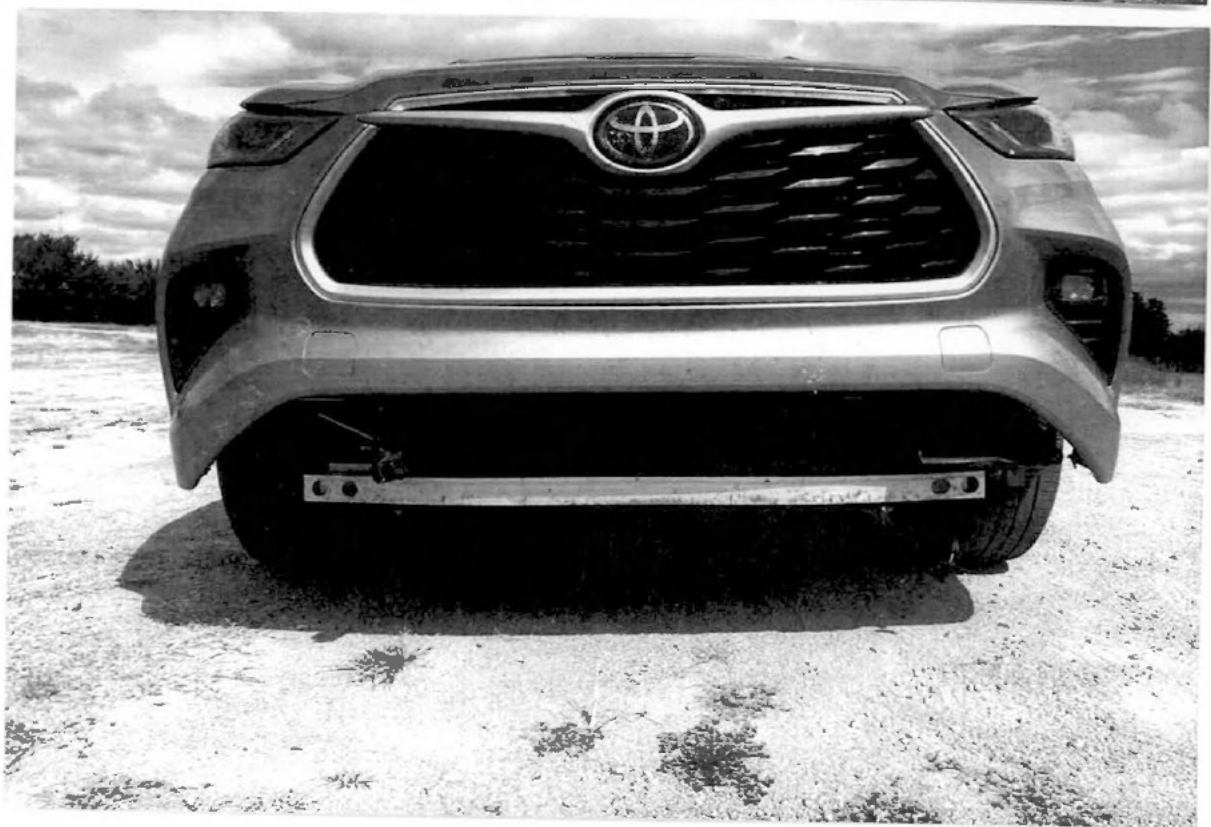
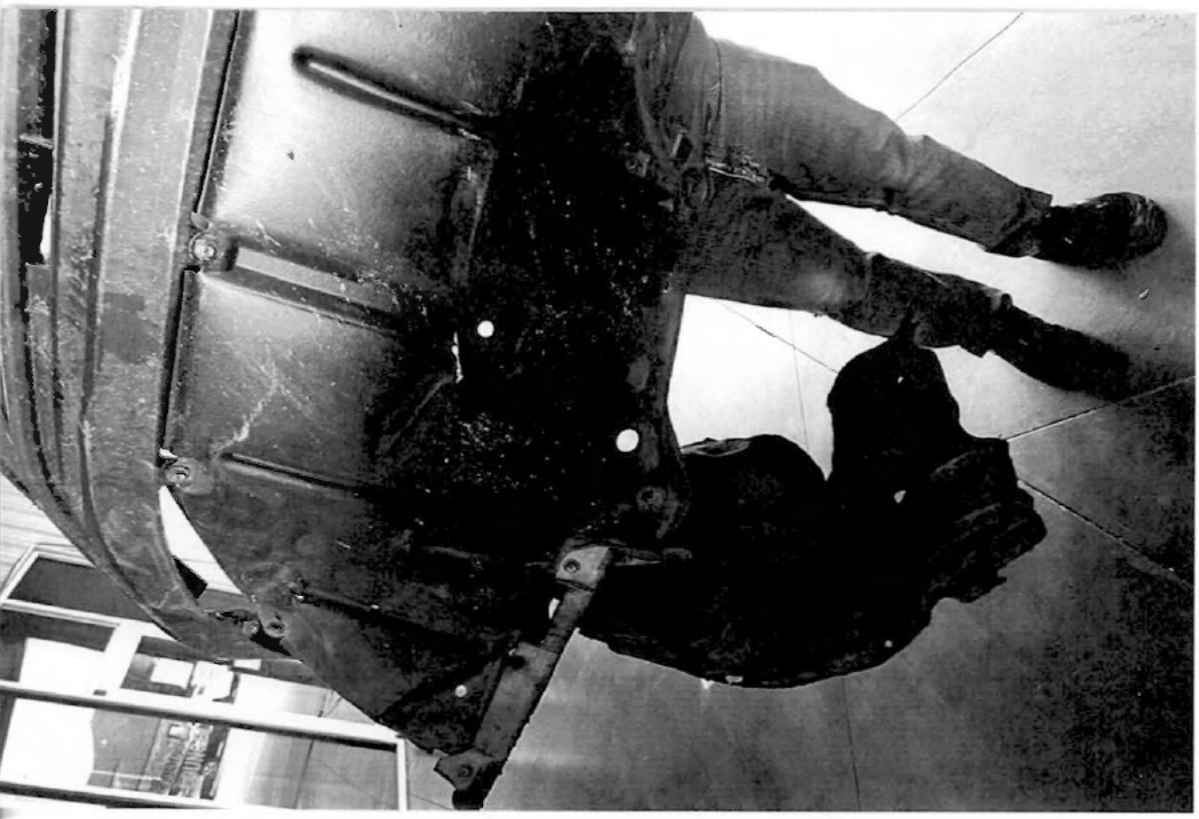
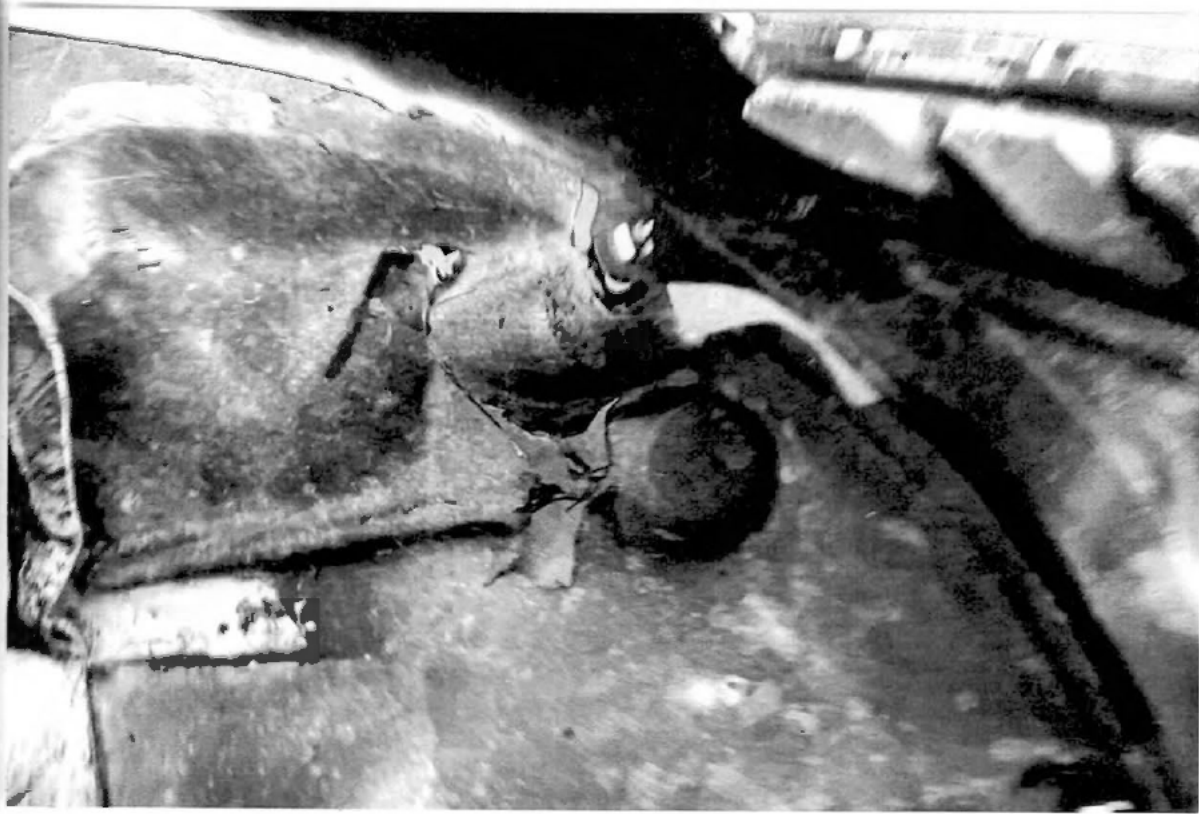
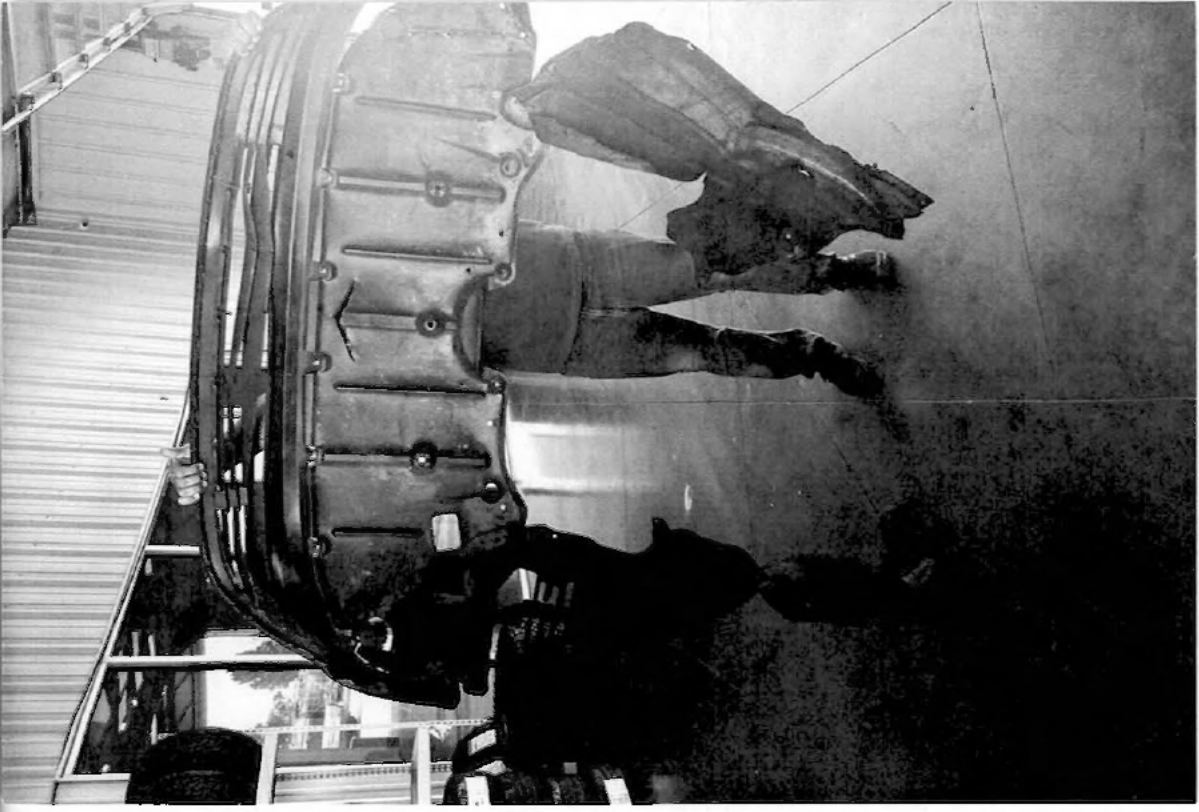
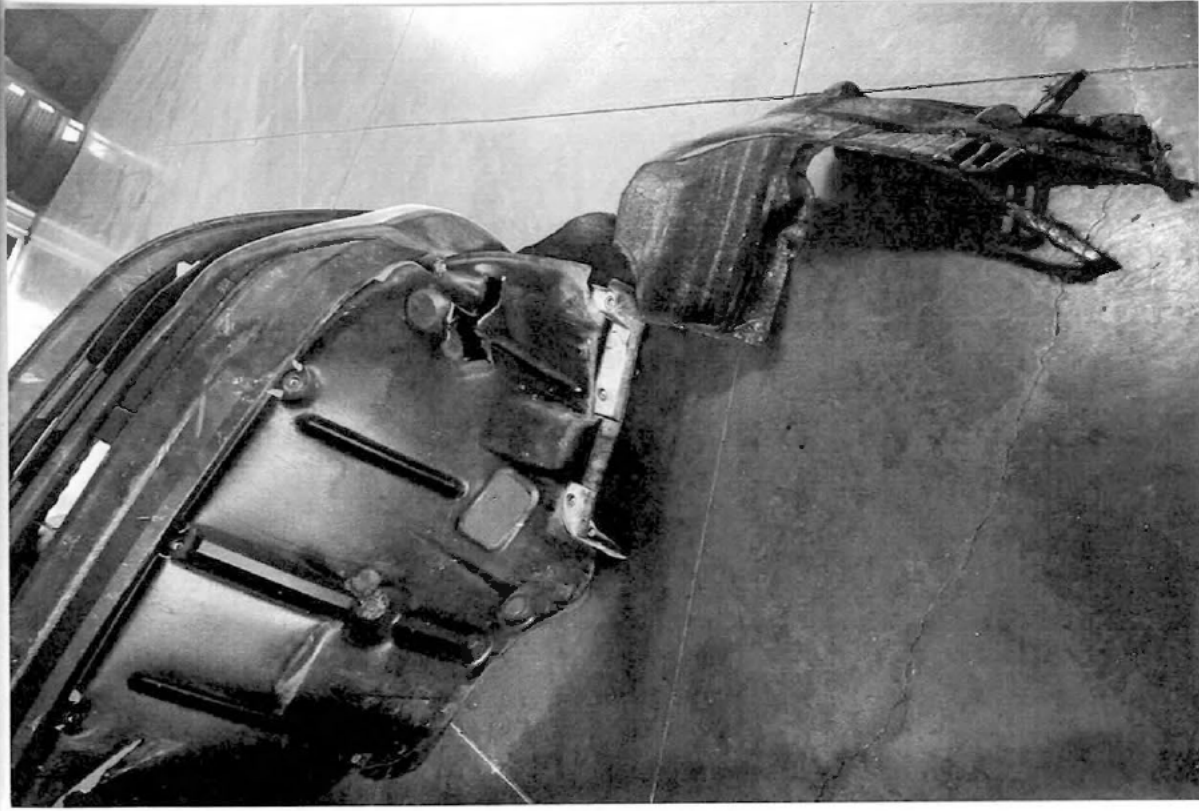
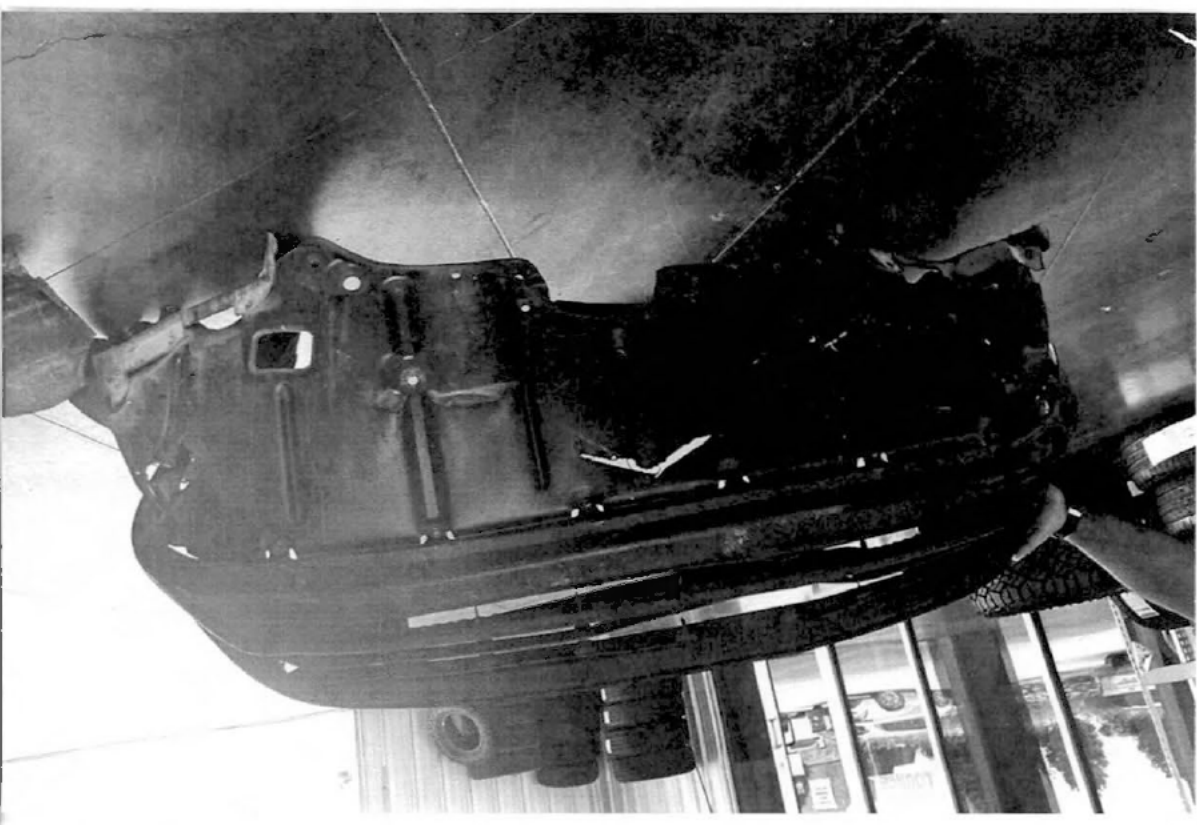
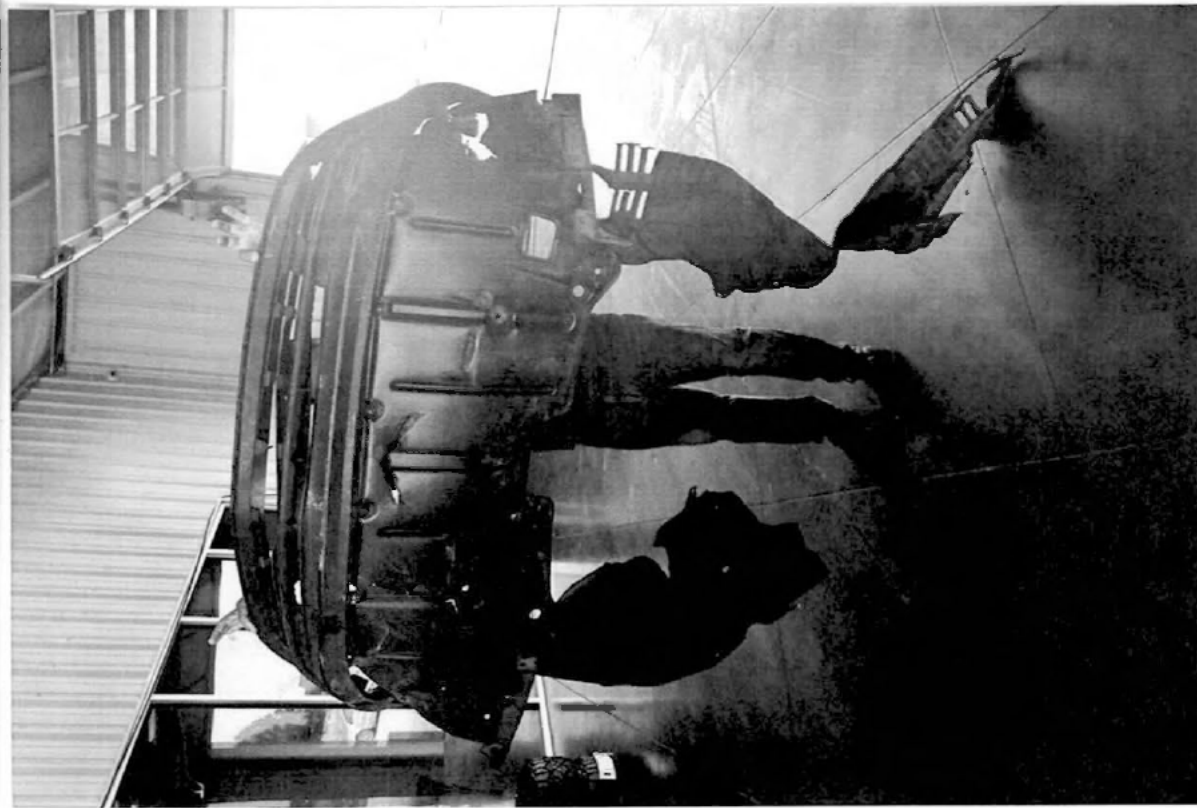
Unfortunately, like others, our complaint is going unheard with service workers at the dealership claiming "air dams don't just fall off" and pointing at rips to claim we "must've hit something", completely disregarding that we were on a busy highway, and several vehicles, including semis, hit the air dam as it flew down the road. They are also ignoring that there are zero impact marks on our vehicle itself, and that the rips are at three opposing spots across the air dam, which reinforces the veracity of what we are saying: several vehicles hit this air dam at high speed. You can imagine what that does to flimsy plastic. Weather conditions were sunny and clear. We did not hit anything. There was no reason for the air dam to fall off. We believe there might be a design flaw, which should be investigated and rectified. The dealership requested to keep our air dam. You can retrieve this evidence at the Toyota Ardmore location in Ardmore, OK.

In this correspondence, we have included several photos of the vehicle, air dam, and fellow complaints regarding the same part on the same model. Thank you for your time and regard in this matter.
