Re: Toyota file: [REDACTED]  
2004 Toyota Sequoia – VIN 5TDBT44A84S [REDACTED]  
Structural Chassis Corrosion Degradation

Re: 2004 Toyota Sequoia – VIN 5TDBT44A84S [REDACTED]  
This Letter Replaces my August 21<sup>st</sup> letter with an incorrect VIN: 5TDBT44A84S [REDACTED]  
Approximately 270,000 miles – Toyota Motors Sales USA, Inc. case number [REDACTED]  
Structural Chassis Corrosion Degradation

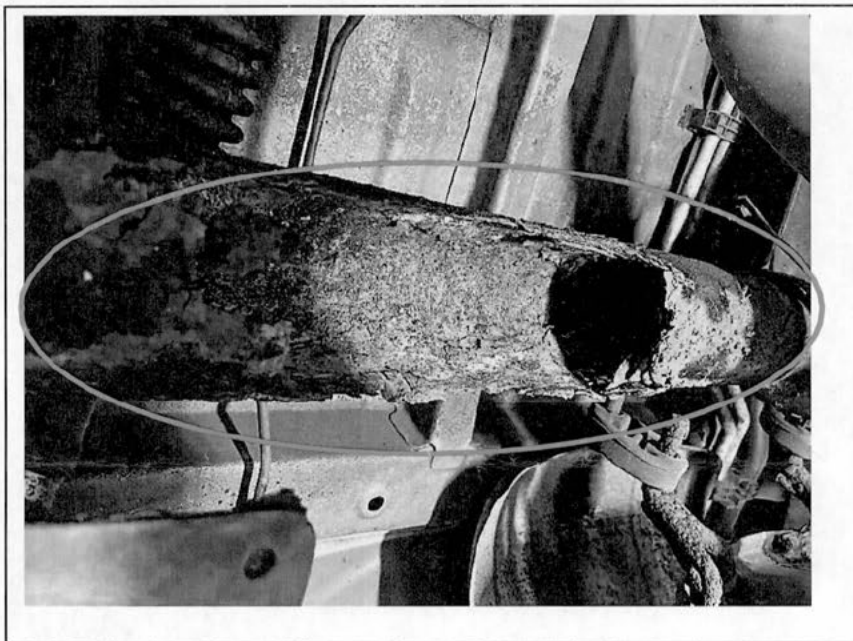
Image 1:

1. Looking upward toward the rear connector tube - about two feet of the bottom half of the center of the tube has disintegrated. The rear connector tube (ID of ~3 1/8" and approximately 4 1/2 feet long) joins the left and right rear sides of the chassis.
2. Looking laterally at the left chassis side, just behind the left front wheel – see an approximately 1-inch diameter perforation adjacent to a welded seam.
