Subject: Formal Complaint – Engine Failure, Repeat Misfire, and Warranty Concern –  
2020 Chevrolet Tahoe 6.2L, VIN# [REDACTED]

I am writing to formally report ongoing engine-related issues with my vehicle, a 2020 Chevrolet Tahoe RST equipped with a 6.2L V8 engine.

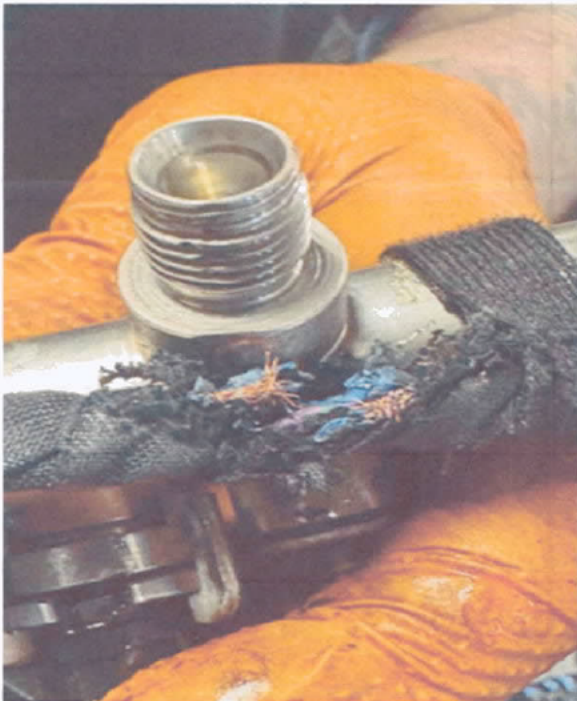
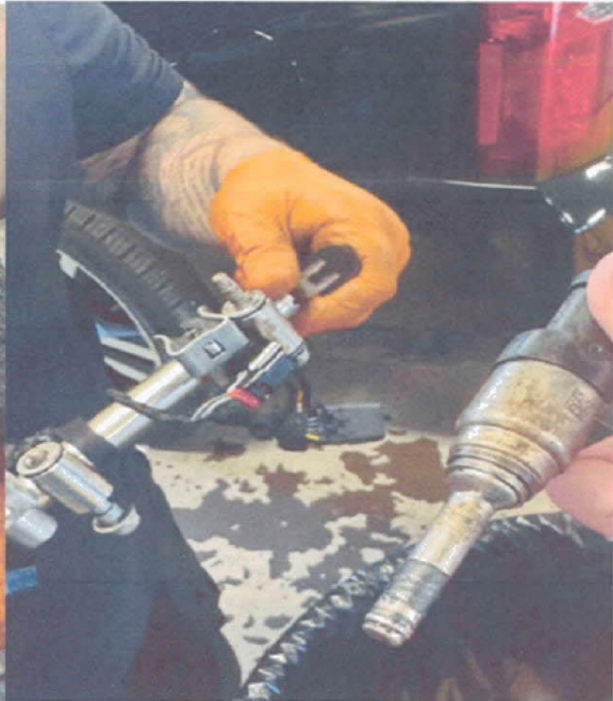
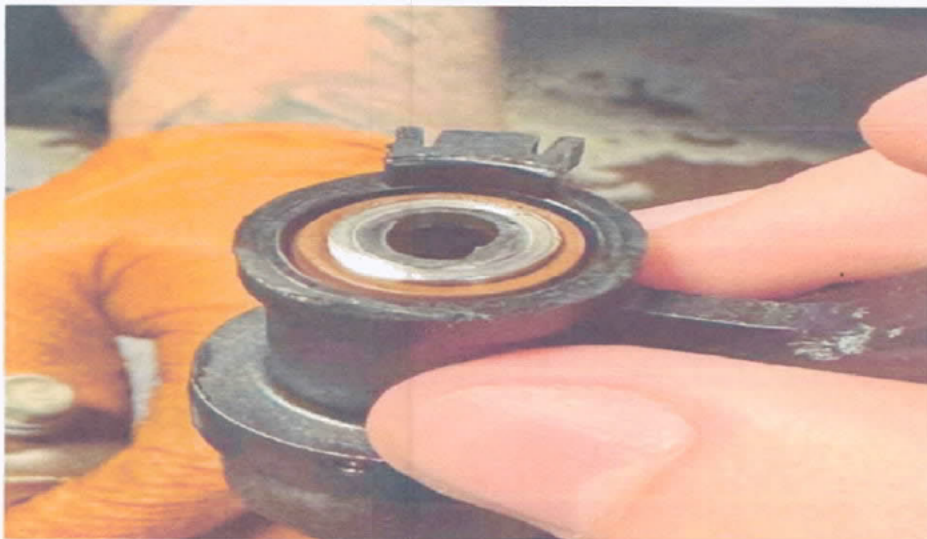
I have included the dealership repair sheet documenting that, upon further examination, the fuel rails were damaged and all 8 fuel injectors required replacement, supporting the diagnosis and extent of the engine failure. In addition, I am including photographs of several of the removed fuel injectors and fuel rails to document the condition of the components at the time of replacement. While not every individual injector is pictured, the images demonstrate visible damage consistent with the failure that led to the repairs.

52190 Verified customer concern. Vehicle DTC P0206 P0300 P0306 found. disassembled intake to inspect fuel injectors, harness, and rails and found we need to replace all fuel injectors, rails, and harness due to internal parts failure causing misfires. Visible failure to fuel injectors when disassembled, old fuel injectors seized to fuel rails, and connector harnesses are loose causing intermittent connection issues. Replaced all fuel injectors, fuel rails, and fuel injector harnesses. Verified ok at this time
