### **TABLE OF CONTENTS**

**Vehicle Information:** 2012 Hyundai Genesis  
**VIN:** [REDACTED]  
**Mileage:** 234526

**Subject: Safety Defect Complaint – Coolant Reservoir Pressure Eruption**

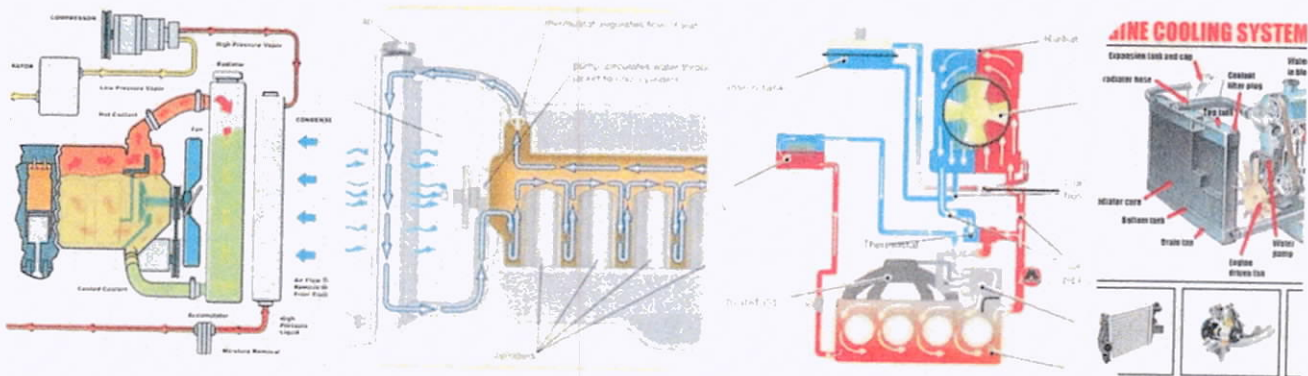
### Printable Diagram — Pressurized Coolant System

The 2012 Hyundai Genesis uses a **pressurized coolant reservoir**, meaning the reservoir is part of the active cooling loop and can hold **15–20 psi** during normal operation. The reservoir cap is a **snap-on design with no warnings**, creating a misleading appearance of a non-pressurized overflow tank.

- Coolant heats as the engine runs.
- Pressure increases as temperature rises.
- The reservoir becomes part of the **pressurized loop**.
- The snap-on cap does **not** warn of pressure buildup.
- Opening the cap while hot causes **instant pressure release**.

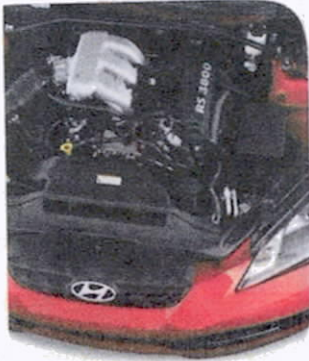
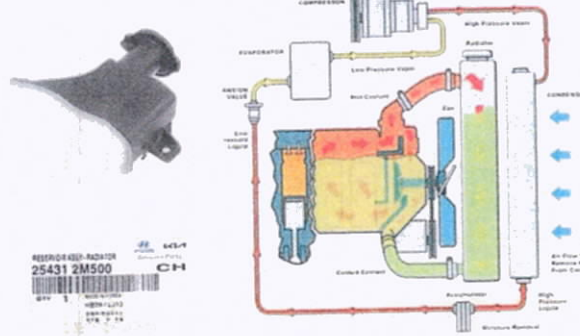
## Pressurized Coolant System

The coolant reservoir in this model is **not a passive overflow tank**. It is part of the **active pressure loop**, meaning it holds the same pressure as the rest of the system.

Because the Genesis reservoir uses a **non-threaded snap-on cap**, pressure can release **instantly and vertically** when opened while hot.

Below is a visual reference showing the pressure loop and reservoir location.

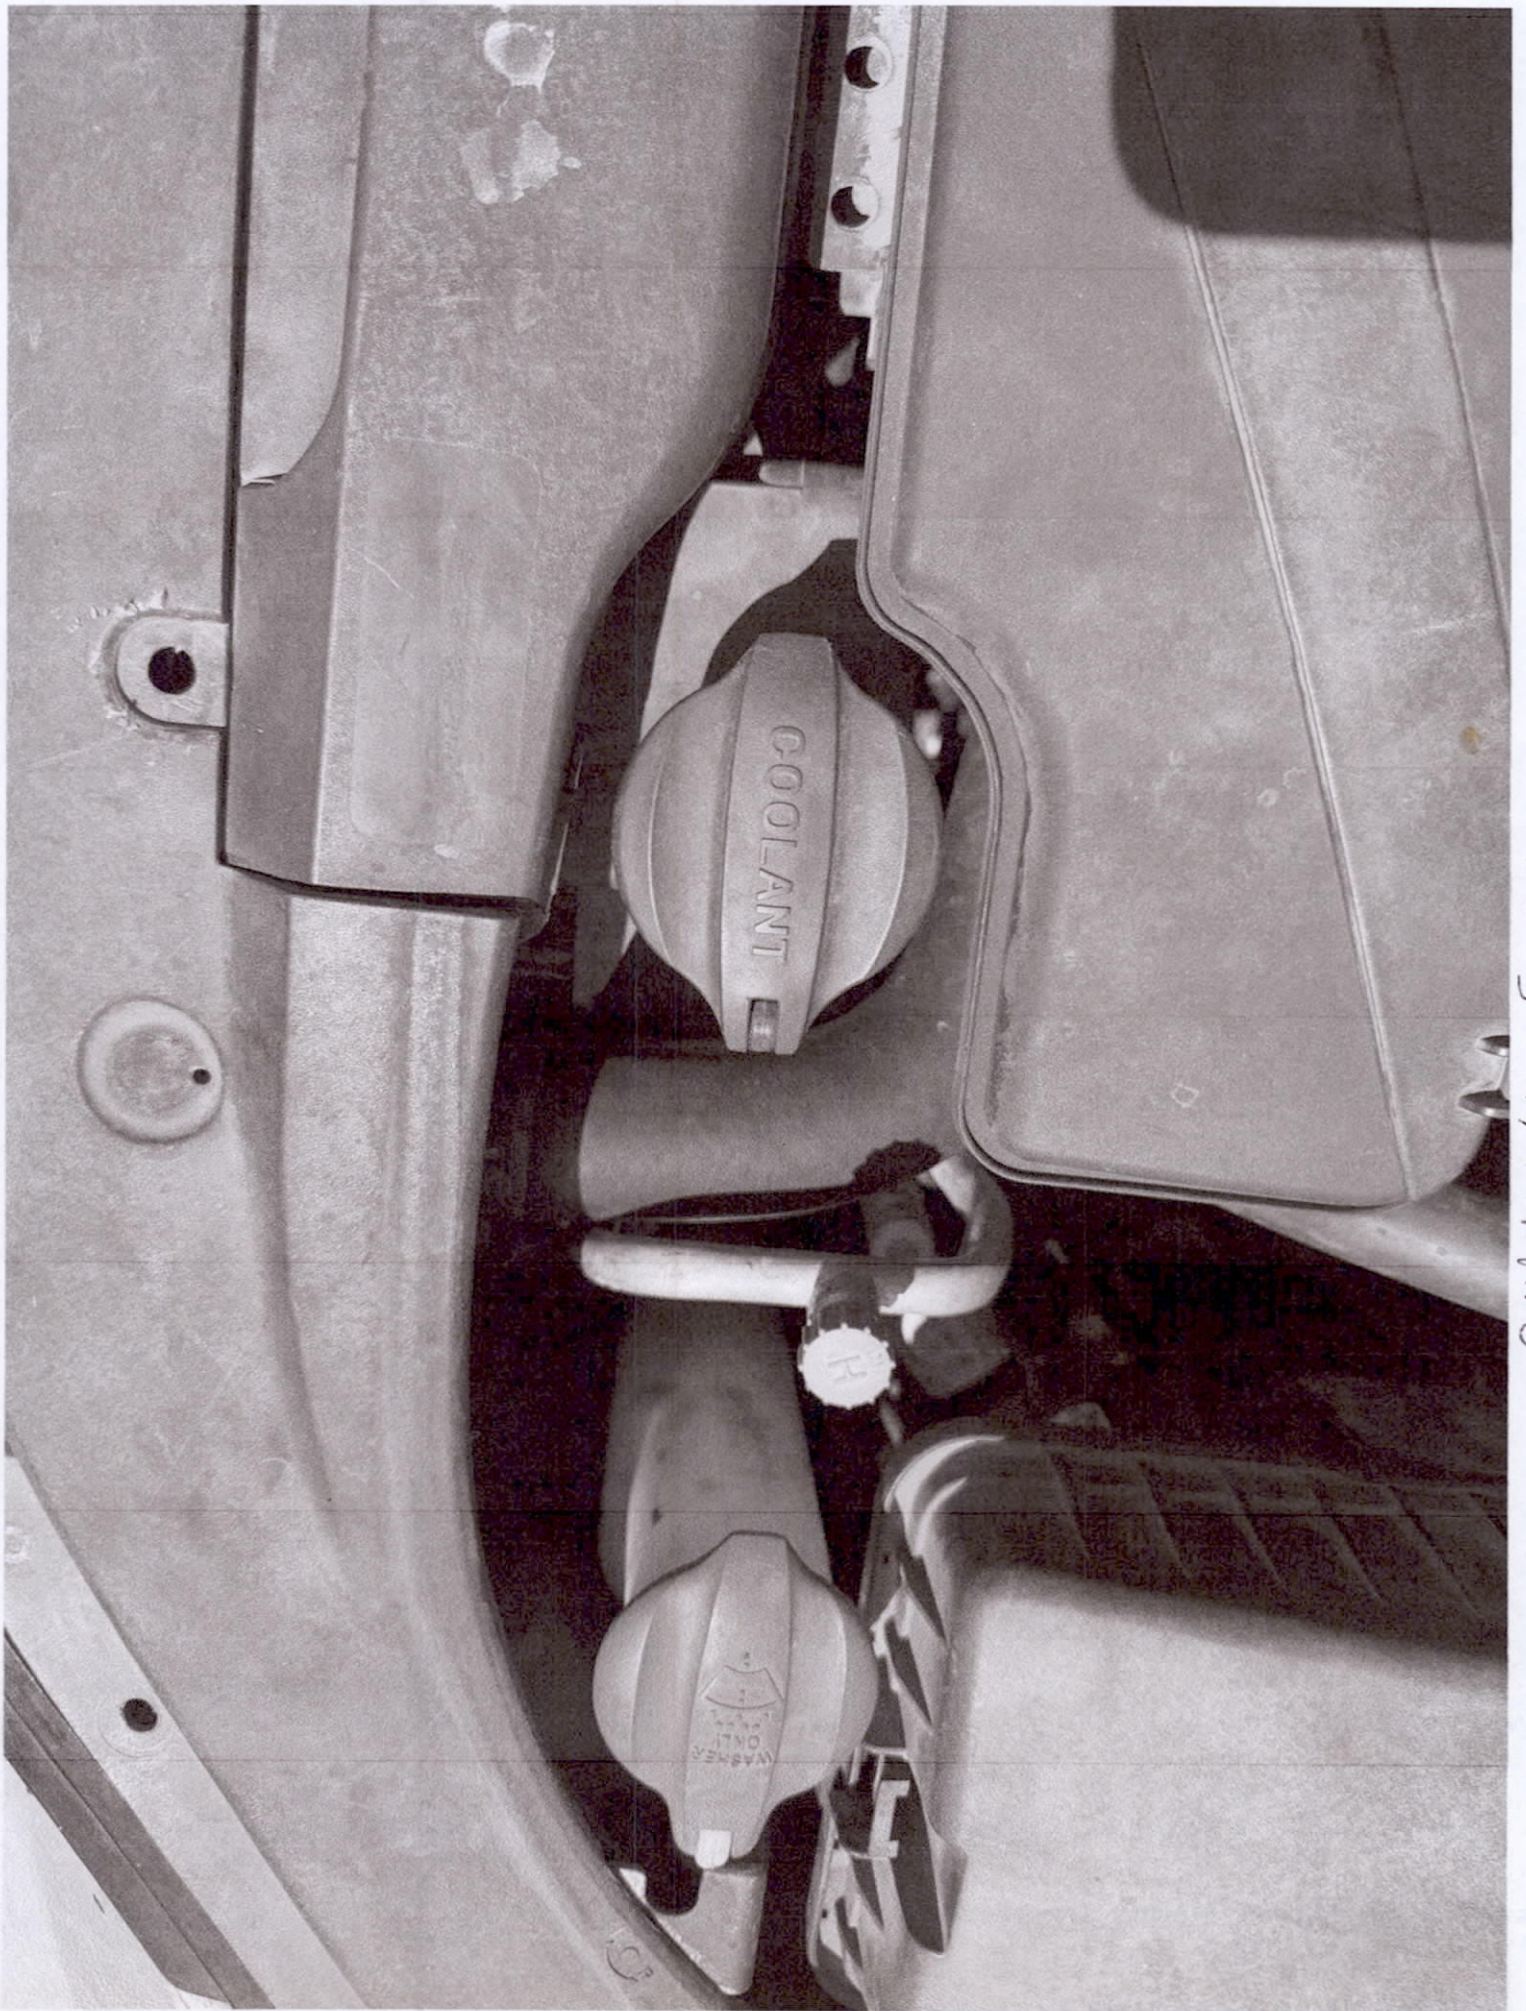
## Reservoir Cap Hazard

**Description:** Photographs of the **snap-on coolant reservoir cap**, showing **no warning labels**, no pressure rating, and no “Do Not Open When Hot” markings.

**Purpose:** To demonstrate the misleading appearance of a non-pressurized overflow tank despite internal pressure buildup. The **snap-on, non-threaded plastic cap** used on the 2012 Hyundai Genesis coolant reservoir. This is the style that looks like a harmless overflow tank but can actually hold **15–20 psi** of pressure. Here is a **clear visual reference** showing the *exact type of coolant reservoir cap* that caused Mark’s injury — the **snap-on, non-threaded plastic cap** used on the 2012 Hyundai Genesis coolant reservoir. This is the style that looks like a harmless overflow tank but can actually hold **15–20 psi** of pressure.

- Smooth snap-on cap
- No pressure markings
- No "Do Not Open When Hot" warning
- No threads or locking mechanism
- Appears similar to a washer-fluid cap

This design **misleads users** into believing the reservoir is non-pressurized, despite being part of a high-pressure system.
