VEHICLE OWNER'S QUESTIONNAIRE

DODGE

D360

Subject: DODGE MODEL-350 1993 YEAR FRONT SUSPENSION

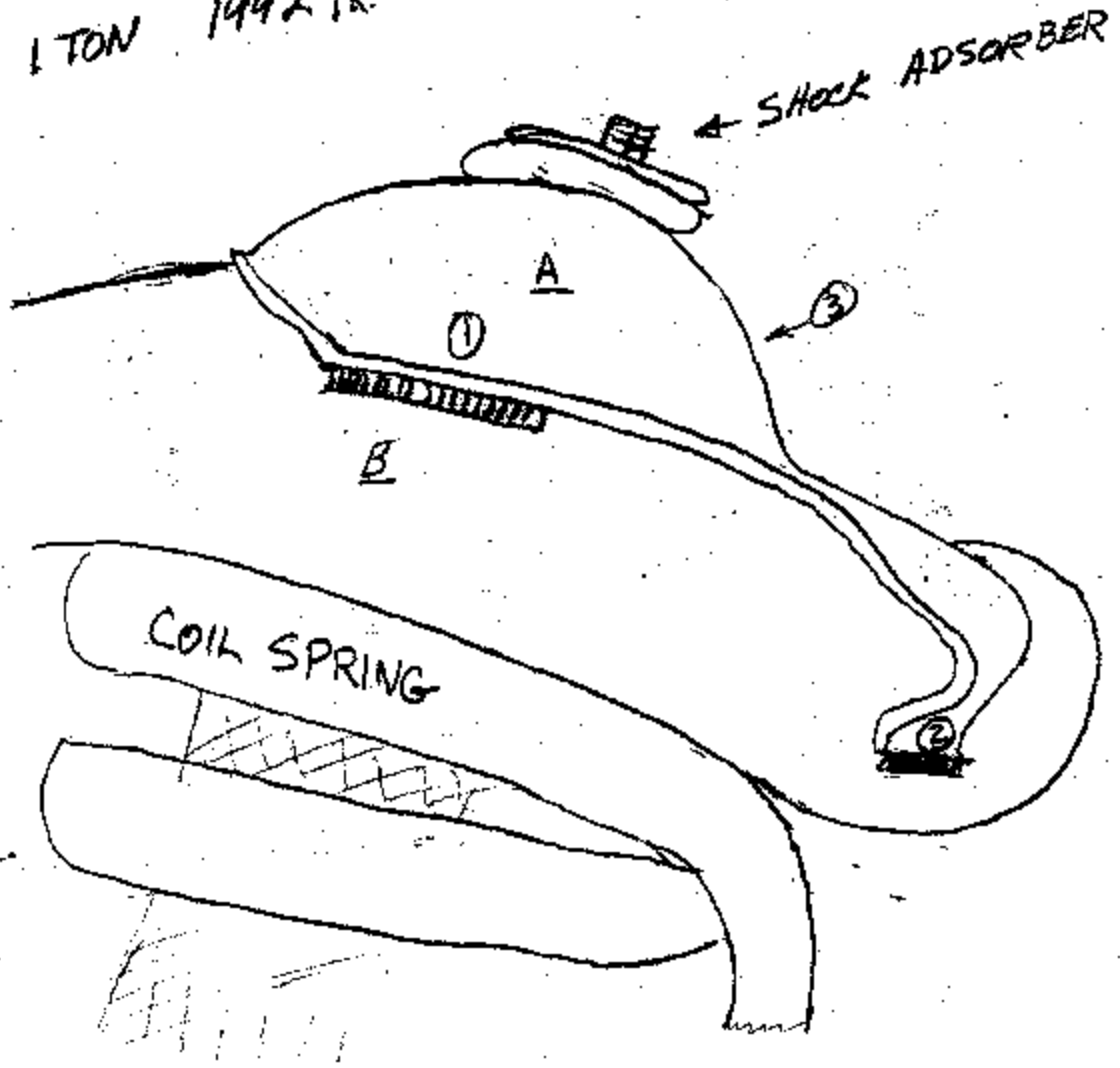
The front support beam outer edge welds are cracking in three areas. The left and right welds. Please look at the free hand sketch and frame drawing # DGT-13 MARK (L/R) side location.

- A. UPPER TOWER CAP WELDS ARE CRACKING
- B. MAIN SUPPORT CROSS MEMBER
- 1,2,3. WELD SUPPORTS LOCATIONS ARE CRACKING 80%

*Welds
L/R location of broken*
