| <p style="text-align: center;"><b>AUTO SAFETY HOTLINE</b><br/> <b>VEHICLE OWNER'S QUESTIONNAIRE</b></p> <p style="text-align: center;">NATIONWIDE 1-800-424-9393<br/> DC METRO AREA 202-366-0123</p> | | <p style="text-align: center;">FOR AGENCY USE ONLY</p> <div style="border: 1px solid black; padding: 5px;"> <p>RECEIVED<br/> 01 JAN 22 AM 1:11<br/> OFFICE<br/> DEFECTS INVESTIGATION</p> </div> <p style="text-align: right; font-size: 2em; font-weight: bold;">550547</p> | |
| VEHICLE IDENTIFICATION NO.<br>3PCNF539XXJA12048 | | VEHICLE MAKE<br>Fleetwood Motorhome<br>on 1999 Ford Super-Chassis | |
| VEHICLE MODEL<br>Flair 340 | | MODEL YEAR<br>1999 | |
| COMPONENT<br>Headlamps | PART NAME(S)<br>Low Beams | LOCATION<br><input checked="" type="checkbox"/> LEFT <input checked="" type="checkbox"/> RIGHT<br><input checked="" type="checkbox"/> FRONT <input type="checkbox"/> REAR | FAILED PART(S)<br><input checked="" type="checkbox"/> ORIGINAL <input type="checkbox"/> REPLACEMENT |

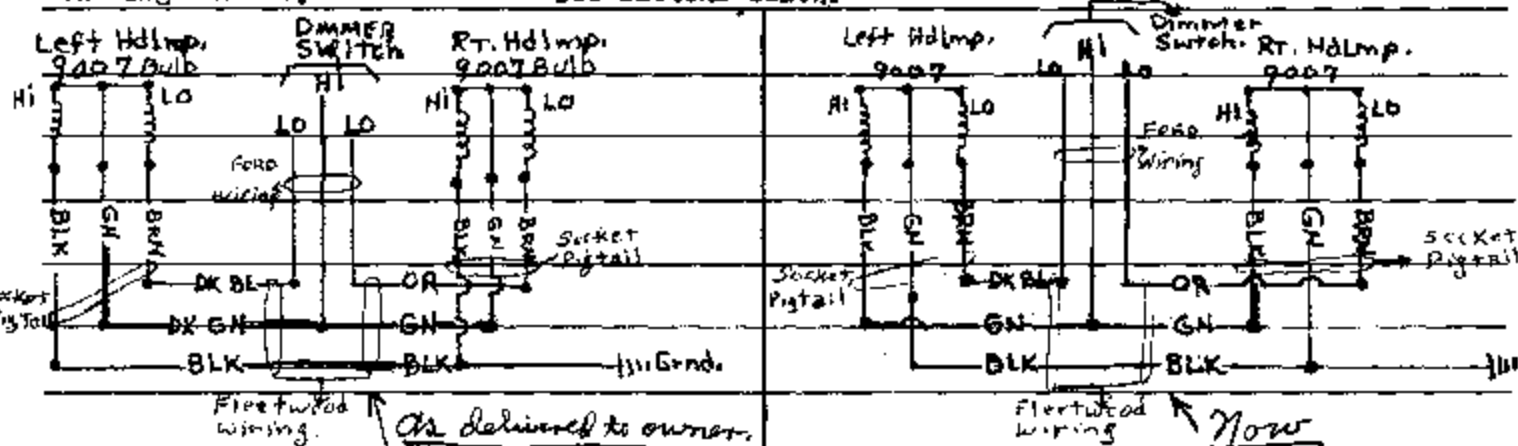
What I found was the headlamp sockets were not wired correctly for the bulb they are using.

The ground wire inside the 9007 bulb is common to the top end of both High beam & Low beam filaments.

Fleetwood spliced the ground wire feed to the High beam punching on the socket & spliced the

High beam feed wire to the Ground punching on the bulb socket. The Low beam voltage seeking

Ground had to go thru Lo & Hi beam filaments in series, greatly reducing the voltage-

causing the very dim low beams. See sketches below.

I swapped the High beam feed & the Ground feed at the socket pigtail to Fleetwood High beam & Ground feed, splices. Headlights are fine now. I am forwarding this to you in the interest of all the other owners. I can't believe mine was the only Meter Home that left the factory with a Low beam too dim to see the road.
