## Vehicle Owner's Questionnaire

TO REPORT VEHICLE SAFETY DEFECT

INTERNET: <http://www.nhtsa.dot.gov>RECEIVED  
Date Received  
00 JUL 10 AM 10:09  
OFFICE  
DEFECTS INVESTIGATION  
Reference No.  
552932

| Vehicle Ident. No. (VIN.)<br>(17 Digits)<br><u>4SLD3HR33XNS2475</u> | (Located at bottom of<br>windshield on driver's side) | Vehicle Make<br><u>Beaver</u> | Vehicle Model<br><u>Patriot</u> | Vehicle Year<br><u>1999</u> | Current Odometer Reading<br><u>13000</u> |

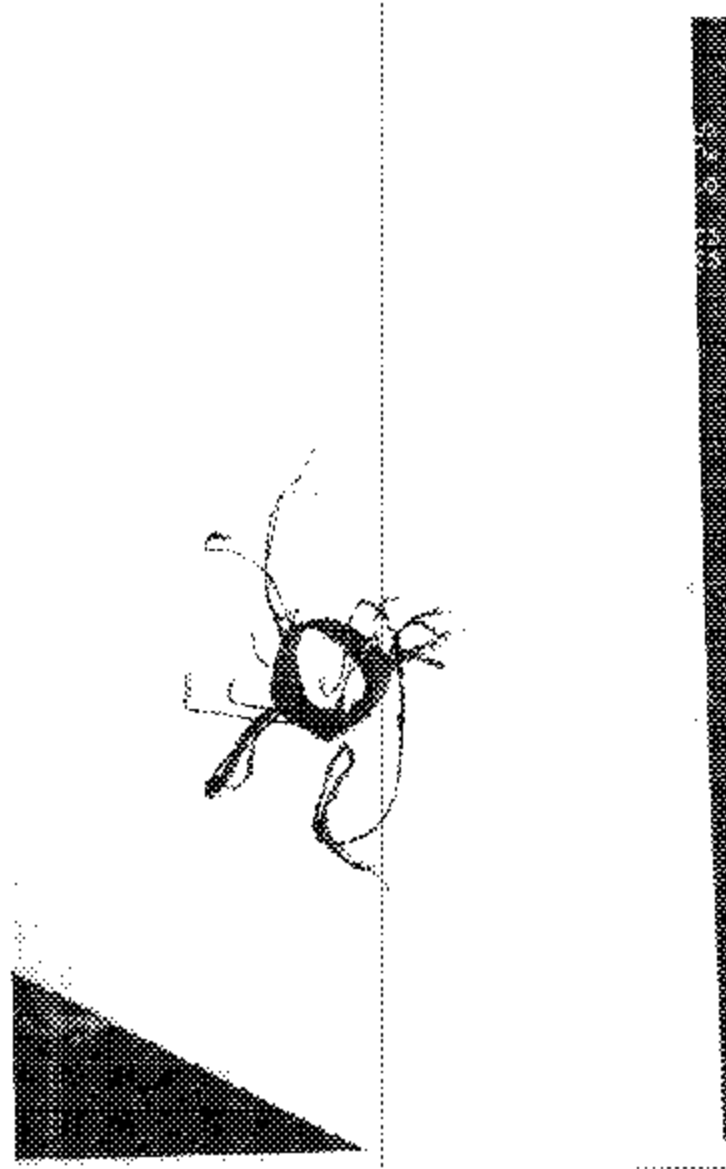
While driving approximately 65 mph in our Beaver 40 ft. motorhome the right front tire exploded.

Approximately eight 2x15 inch pieces of tire, pieces of the flooring and other debris came into the motorhome through a hole approximately two by three feet at the top of the wheel well. The smaller debris flew as high as five feet into the motorhome.

The treads of the tire were completely gone; only a strip of approx. 3 inches wide and the cross steel wires were still attached to the wheel.

As you can see from the pictures, part of the chassis, probably the bars to which the rubber flap inside the wheelwell was attached, are completely sheered off and have not been found.

While the tire is our concern, our main worry, in case this would happen again, is that the floor of the coach is not strong enough to withstand a tire blow-out.
