## Vehicle Owner's Questionnaire

Office of Defects Investigation

1999 CHEV. VENTURE

Re: LIABILITY FOR DESIGN OF SPARE TIRE STORAGE SYSTEM →

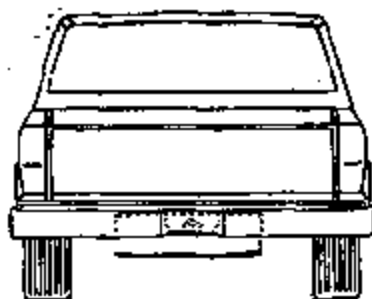
Push & Pull

Rotate Tire

Your owner's manual tells you to check tire inflation pressures at least once a month. Make sure that all tires are inflated to the correct pressures. This tire inflation check should include checking the inflation of the spare tire. (See "Tires" in the index to the owner's manual for more information). Try to push or pull and then rotate or turn the tire to be sure that it will not move (see diagram on next page). A spare tire that can be rotated or turned is not stored securely. Either add air to the spare tire or turn the hoist, whichever is appropriate.

At least twice a year when you are checking the inflation pressure for the spare tire, also check to make sure that it is stored securely. In addition, tires should be rotated every 10,000 to 13,000km (6,000 to 8,000 miles). See your owner's manual for additional information. Any time you notice unusual wear, rotate your tires as soon as possible and check wheel alignment. Also check for damaged tires or wheels. When you rotate your tires, check the spare tire by attempting to push or pull and then rotate or turn it to ensure it is stored securely and will not move. If the spare tire moves, secure it properly as indicated above.
