U.S. Department  
of TransportationNational Highway  
Traffic Safety  
Administration

## Vehicle Owner's Questionnaire (VOQ)

859166

1993-94 EXPLORER

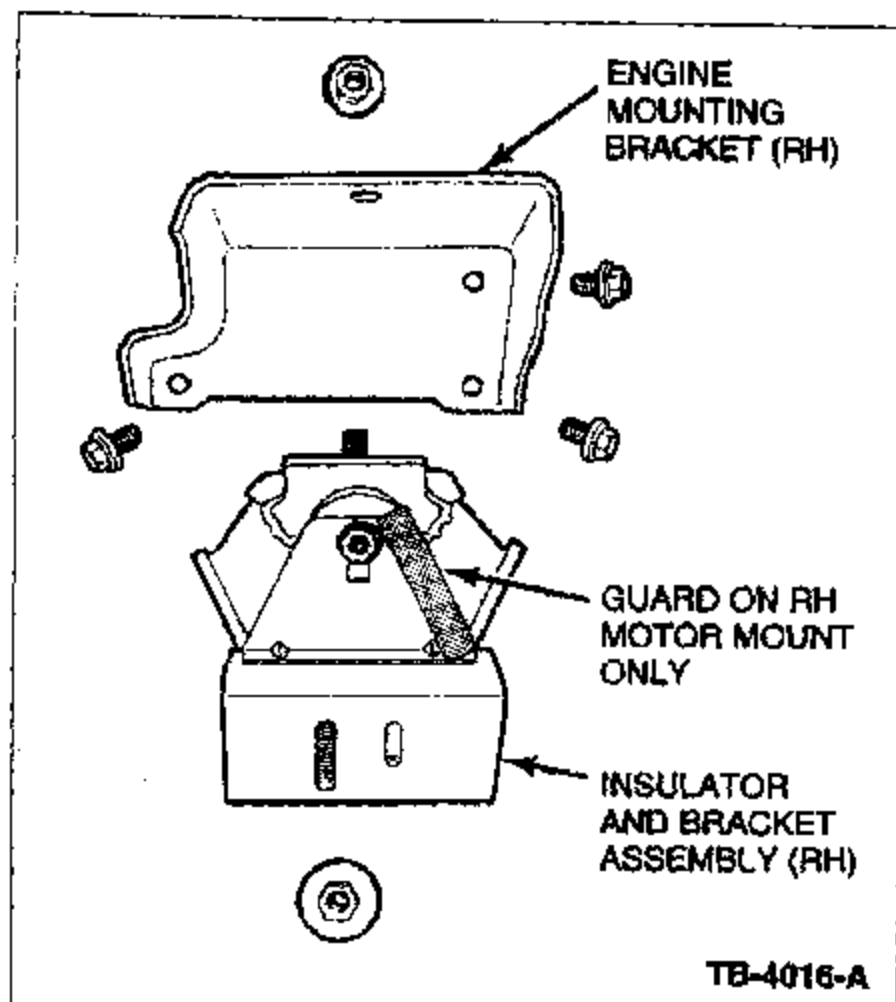
Figure 1 - Article 98-4-15

A vibration/shake may be felt in the seat and/or floor at speeds above 80 km/h (50 mph) and peaking near 105 km/h (65 mph) on some vehicles. This condition is not rpm dependent and occurs at all driving modes, i.e., acceleration, cruise and deceleration. An "aftershake" condition may also exist when driving over a bump at speeds less than 72 km/h (45 mph). This condition may improve with tire balancing or tire exchange, but may not be completely eliminated. This may be caused by the movement frequency of the engine aligning with the tire rotation frequency causing the vibration/shake.

Confirm the vibration/shake condition occurs in all driving modes, including neutral coast. Install new design LH and RH engine mounts and rear axle-to-frame lateral shock absorber kit. Refer to the Service Procedure for details.

Absorber Kit (F67Z-6K007-AA) (Figures 1, 2, and 3). Refer to the Instruction Sheets included with the kit for service details.
