Vehicle Owner's Questionnaire (VOQ)

Dear Sir,
Subject: Failed Drivers Seat Frame in 1995 Tahoe, FP-Number, 12472585, Frame 16.716

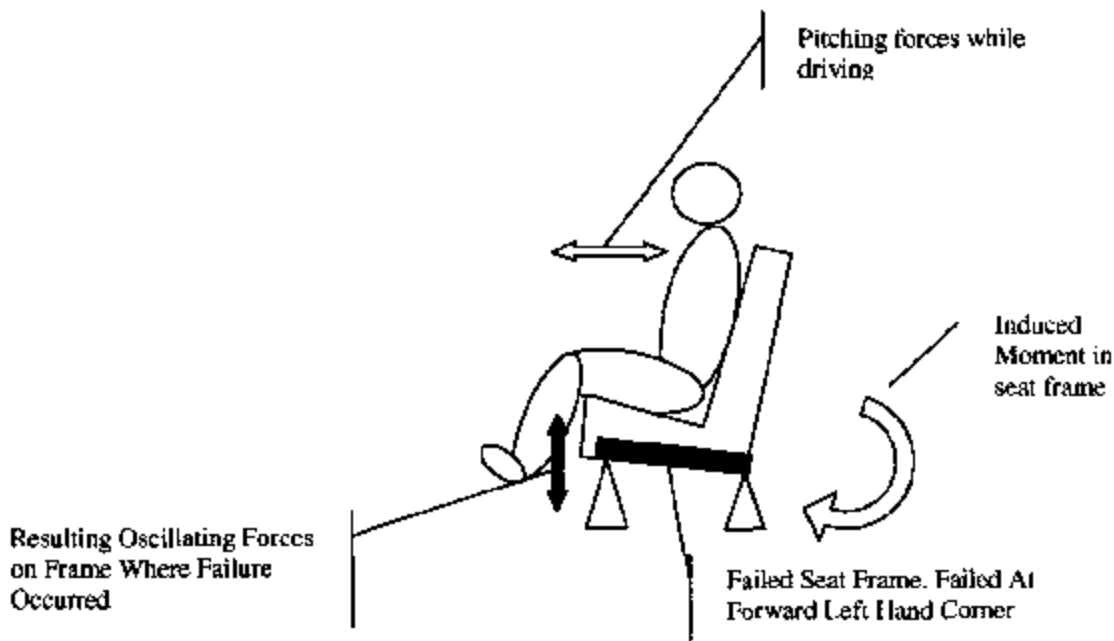
Figure 1. General description of forces and point of failure

It is reasonable to suggest that as the driver of the vehicle sits in the seat, the vehicle pitching occur at a frequency less than 10 Hz. This would indicate that the seat had fewer than 61,666 cycles of reversing load. See Figure 1 for illustration:

Assuming the load distribution is equally distributed between all four attachment points, the average loading would be 46.25 pounds. The metal stamping was measured at a thickness of 0.40 of an inch thick with the spot weld diameter of 0.375 inches. The backing plate is welded at 4 spots. Therefore the static working stresses should be on the order of 2,500 psi in the weld. The reversing stress to cause failure within 61.666 cycles is on the order of 20,000 psi. Knowing that the force at the seat attachment point is 46 pounds, this would indicate an acceleration of 7.6 g's, not exactly positive marketing data for operator comfort and vehicle smoothness. Clearly, there are other design flaws at work for this failure to occur.

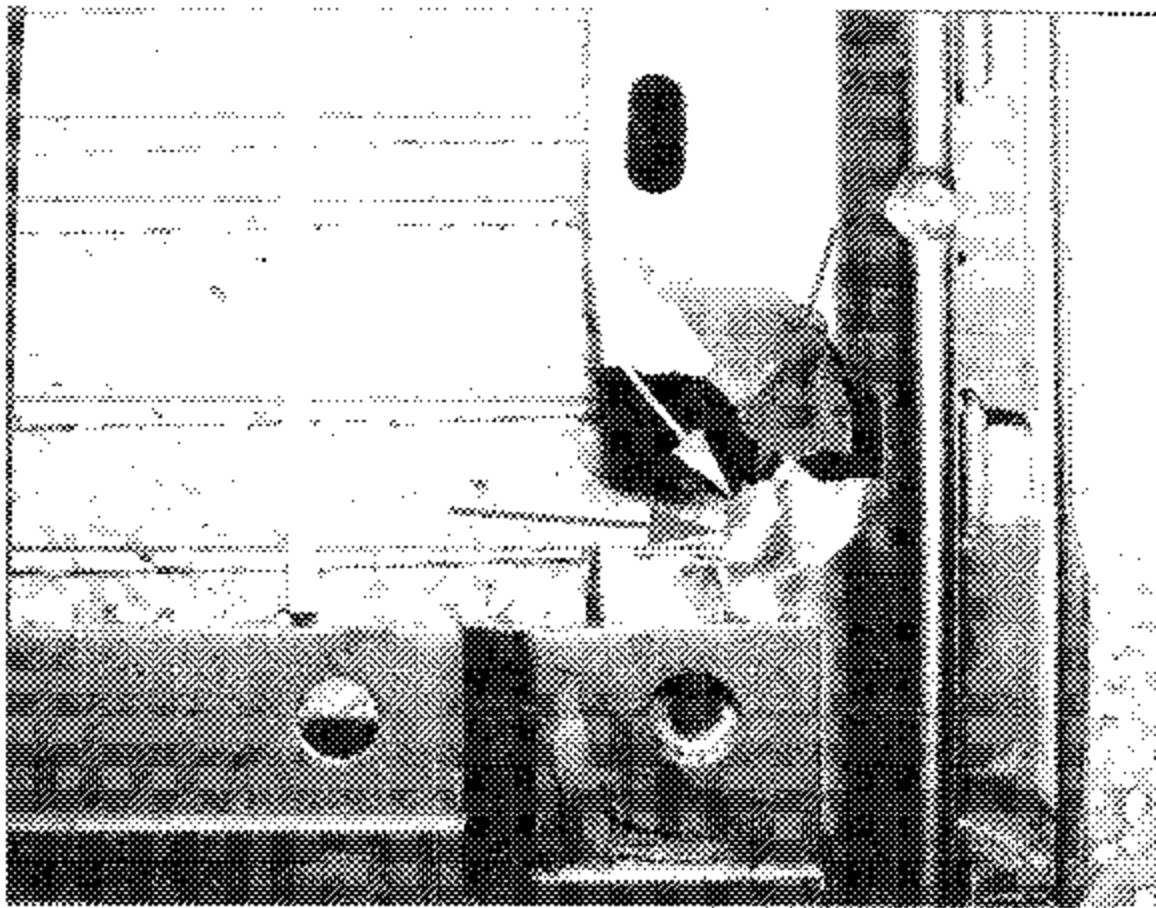
Figure 2. Frame Point of Failure.

Examination of the seat frame at the failure location clearly shows multiple cracks emanating from multiple stress discs in the stamped frame material. The metal stamping had a backing plate spot-welded to the frame. The frame had a stamped hole where a fastener could be run through to the backing plate. The backing plate was formed with a hole where threads would be formed upon insertion of a fastener. The sheet metal stamping also has multiple holes stamped into the surface where various components may be attached or bolt fasteners attached to the nut backing plates. The initial source of the cracking occurred at the hole punched through the sheet metal to form the hole where the fastener from the seat frame attached to the chassis to the seat itself. The yellow arrow highlights the remainder of the stamped hole in the following Figure 2. The red arrows show the initial crack that lead to the ultimate failure.

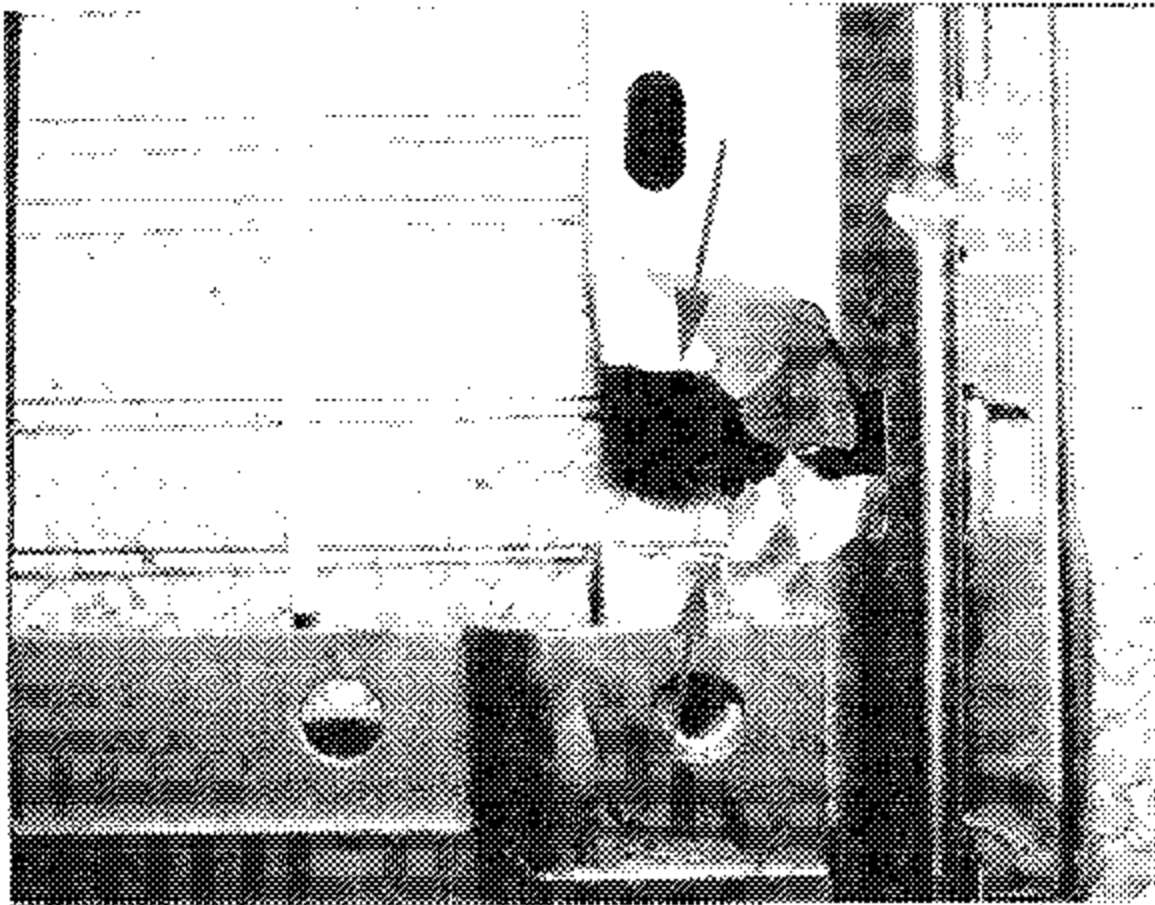
Figure 3 Secondary Cracks Leading to Ultimate Failure

Secondary failure points were located where the backing nut was spot welded to the stamped cross member. The blue arrows in Figure 3 points to two of four spot welds where the crack continued to propagate leading to the ultimate failure of the seat frame. Also visible in Figures 2 and 3 are the multiple cracks that developed during the point of initiation to failure. All of these cracks lead to a dramatic loss in strength of the frame, making for a potentially very dangerous situation for the driver and passengers of the vehicle.
