## NHTSA Investigation

## Toyota Response

## NHTSA Concerns (EA Resume)

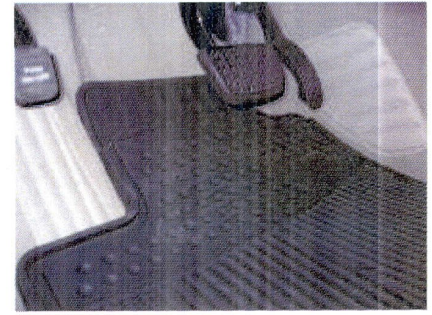
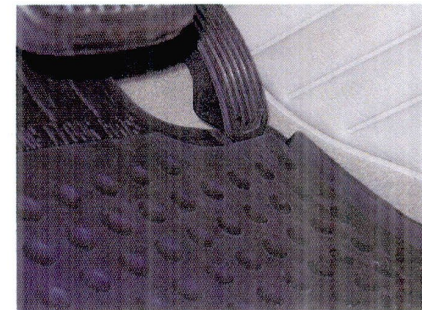
“ODI has observed that an unsecured Lexus accessory all weather floor mat can trap the throttle pedal in an open position resulting in significant unwanted acceleration.”

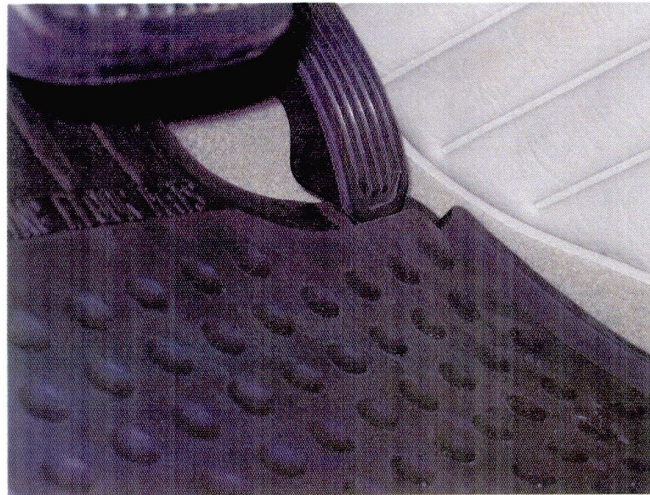
- What is the prevalent failure mode?
  - Double stacked AWM
  - AWM: Pedal trapped in ridge

**Note: AWM cannot interfere with accelerator pedal if properly secured with the retention clips**

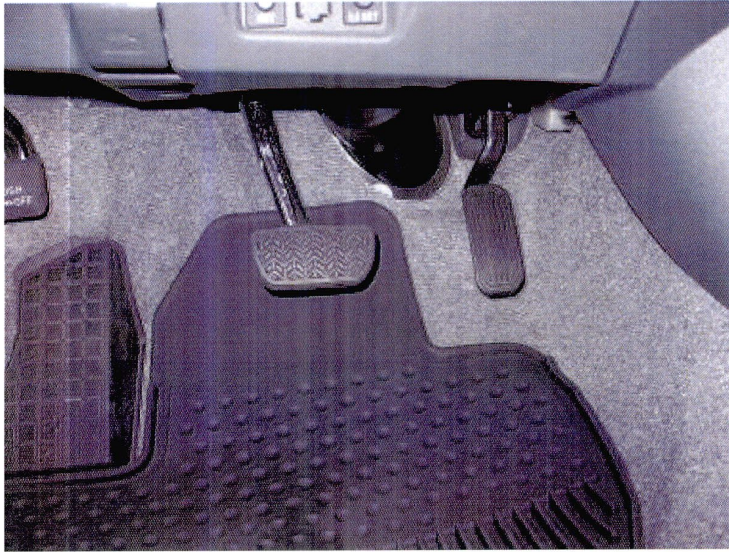
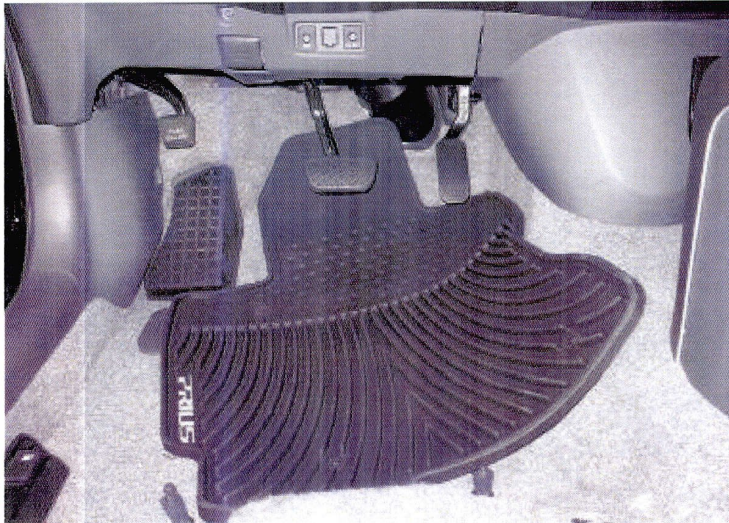
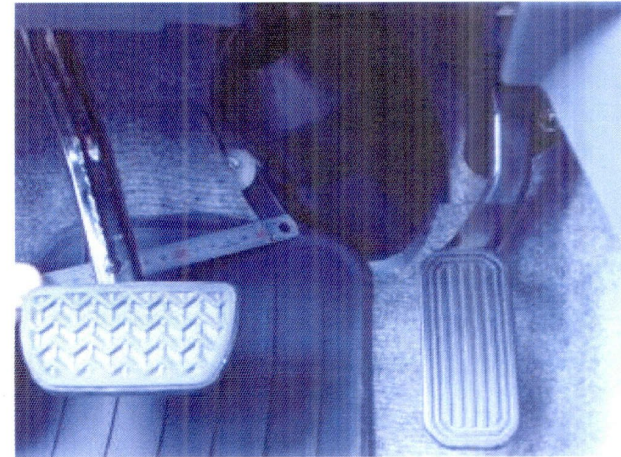
### Prius

- Leading edge of mat interferes with steering column cover
- Footrest obstructs forward movement of AWM
- Cannot experience same condition as ES350

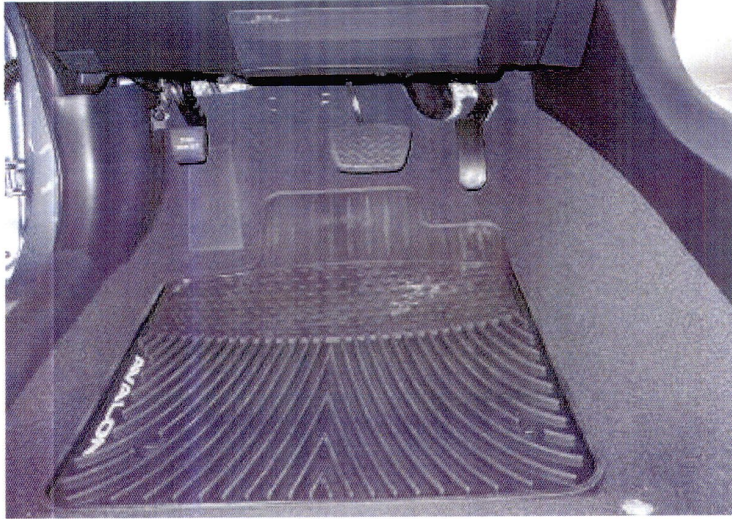
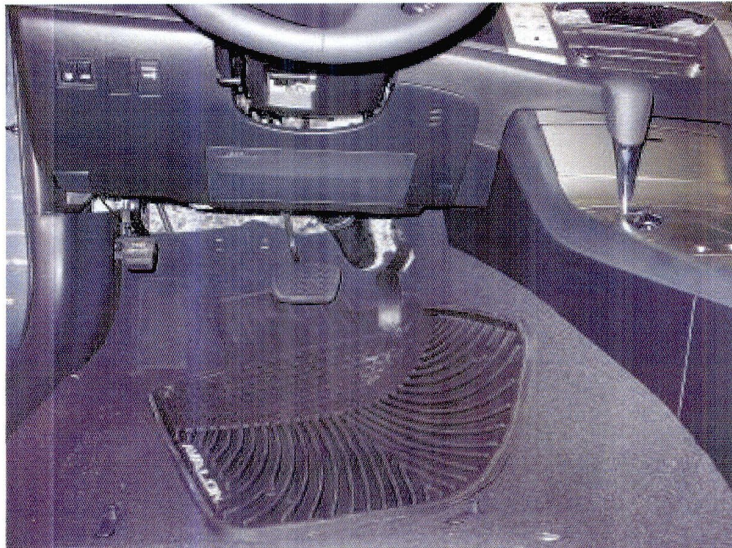
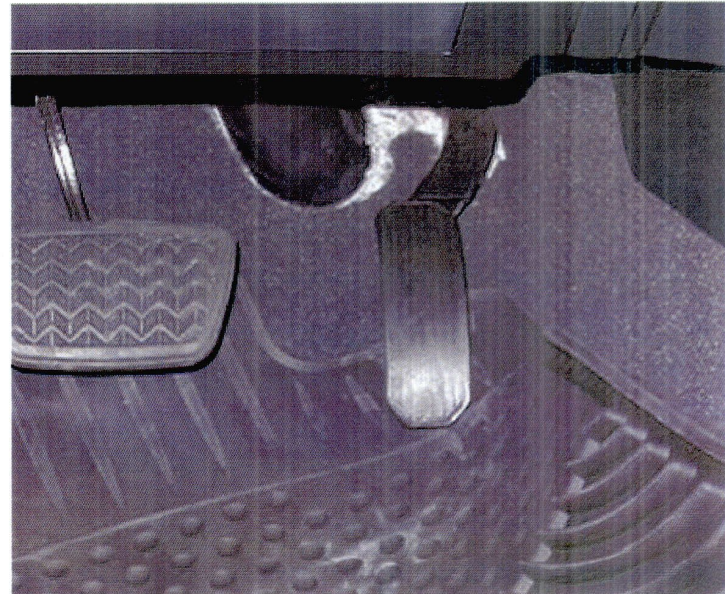
## Avalon

- Different ridge on AWM
- Footwell impedes forward movement of AWM
- Tunnel design reduces the possibility of occurrence

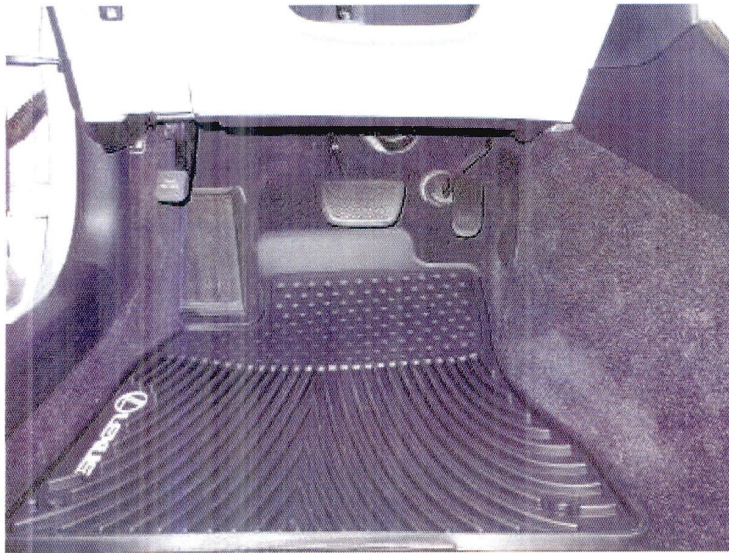
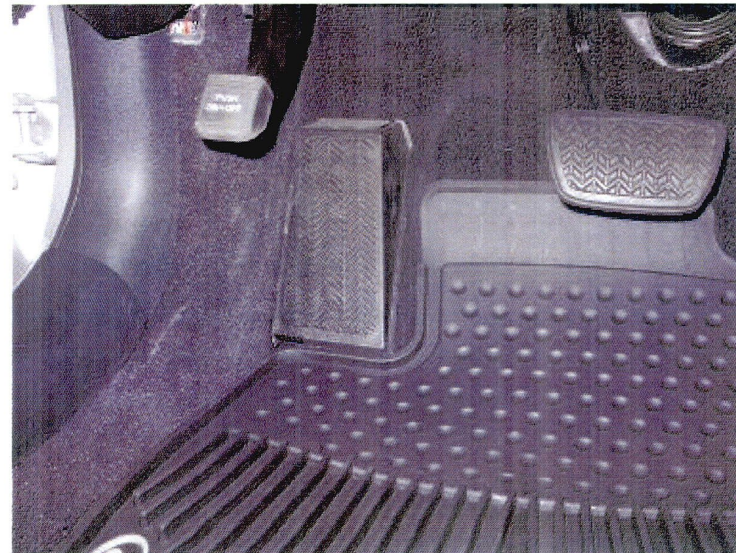
### IS250/350

- Footrest obstructs forward movement of AWM
- Cannot experience same condition as ES350

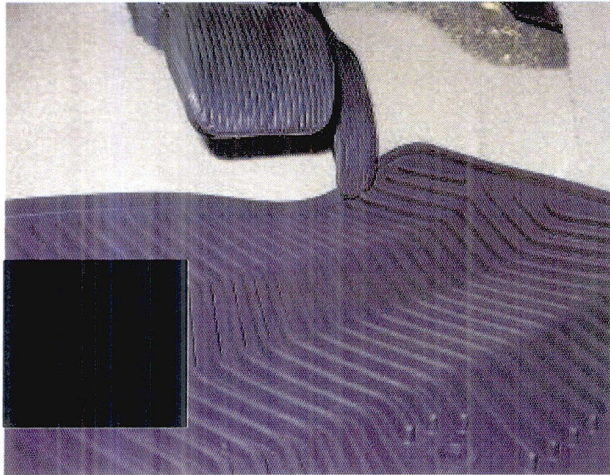
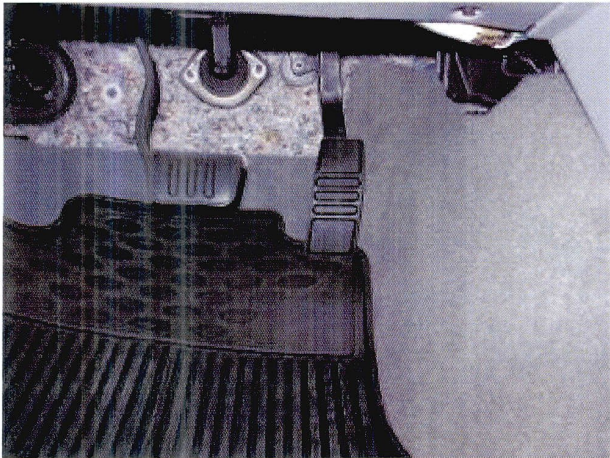
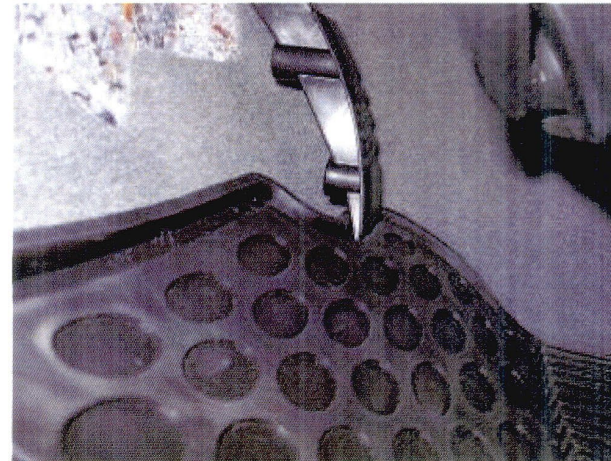
- Same AWM supplier
- OE Accessory
- Related VOQ's in NHTSA Database
