FIELD TECHNICAL REPORT

| TQCN DOC# FTR-80N129671 | Affiliate TMS | Dept. QA-Vehicle and | Source FTS | Location TMS-GST | Ref 43351-1 | Date 10/24/2007 |
| Problem Area PPO/DIO | Primary Model Tacoma | Model Year 2006 | Production Date 01-Aug-2006 | Odometer 7176 mi | VIN (confirm 17 characters): 5TEKU72N06Z [REDACTED] | |
| Condition Title FLOOR MAT ALL WEATHER - REF# 58525 | | | | | | |

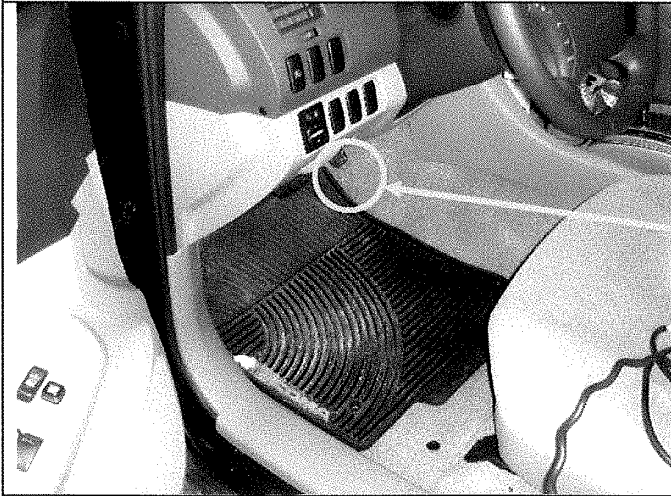
Left front all weather floor mat interferes with the proper operation of the accelerator pedal when the mat is not properly installed.

Improper installation of all- weather floor mat.

Photo showing location of the accelerator pedal interference with floor mat.

Cut flashing off of the rear portion of the mat and reinstalled into the vehicle with the retainer clips installed and the interference with the accelerator pedal was no longer evident.
