To: All Toyota Dealer Principals, Service Managers, Parts Managers

Subject: Safety Recall – 90L
Certain 2007 – 2010 Model Year Camry and Camry Hybrid Vehicles
Potential Floor Mat Interference with Accelerator Pedal (January, 2010)
Phase 1 – Vehicles Equipped with Accelerator Pedals manufactured by Denso Corporation

TECHNICAL INSTRUCTIONS
FOR
SAFETY RECALL 90L
DENSO ACCELERATOR PEDAL MODIFICATION
2007 – 2010 MODEL YEAR CAMRY

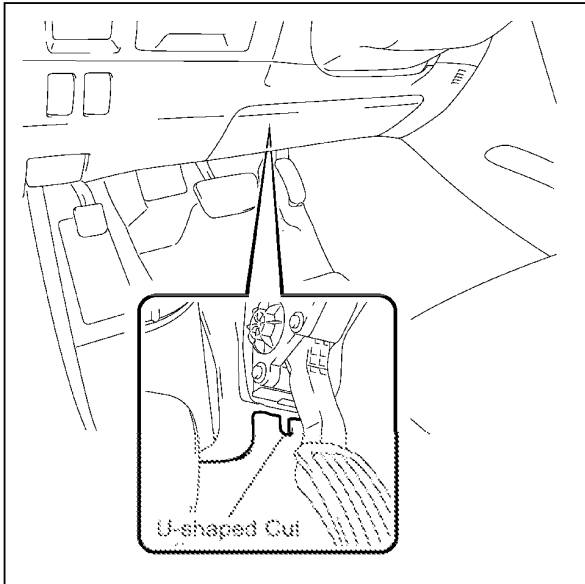
2. INSPECT THE FLOOR CARPET

- a) Verify if the floor carpet has a “U” shaped cut in the location shown.
