Wayne Hutchinson / TMS Toyota Customer Services
 Quality Compliance
 February 2, 2010
 Approved By: Bob Waltz

To: All Toyota Dealers
 From: Toyota Customer Services

**Safety Recall A0A - Vehicles Equipped with Accelerator Pedals Manufactured by CTS Corporation
 Accelerator Pedal Reinforcement Bar Installation**

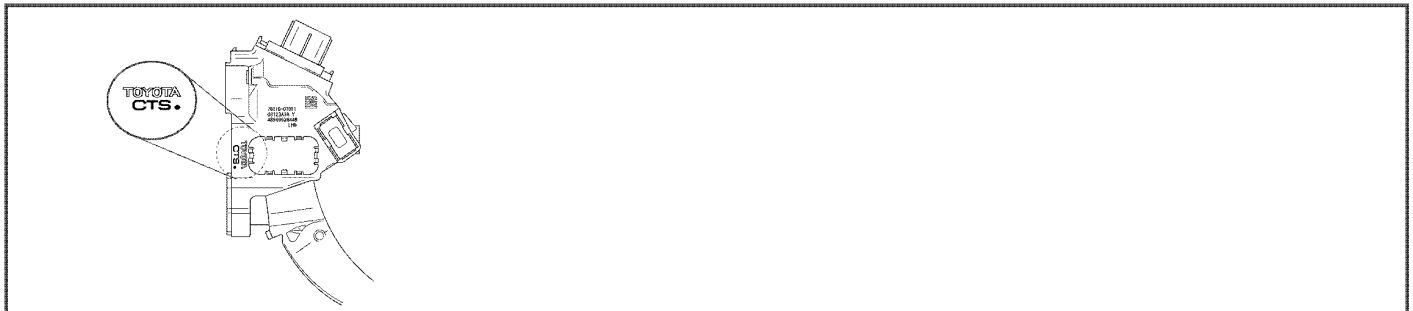
There is a possibility that certain accelerator pedal mechanisms may mechanically stick in a partially depressed position or return slowly to the idle position. Over time, the internal mechanisms in the accelerator pedal may become worn. As a result of this wear combined with certain operating and environmental conditions, friction in the mechanism may increase and intermittently result in the accelerator pedal being hard to depress and/or slow to return or, in the worst case, stick in a partially open position, increasing the risk of a crash.

Toyota dealers are requested to install a precision-cut steel reinforcement bar (“reinforcement bar”) that will increase the clearance in between the internal mechanisms in the pedal assembly. This increased clearance will reduce the friction caused by wear and environmental conditions and allow the pedal to operate smoothly for the life of the vehicle. The safety recall remedy will be performed at **no charge** to the vehicle owner.
