Wayne Hutchinson / TMS Toyota Customer Services
 Quality Compliance
 February 2, 2010
 Approved By: Bob Waltz

To: All Toyota Dealers
 From: Toyota Customer Services

**Safety Recall A0A - Vehicles Equipped with Accelerator Pedals Manufactured by CTS Corporation
 Accelerator Pedal Reinforcement Bar Installation
 *****URGENT*******

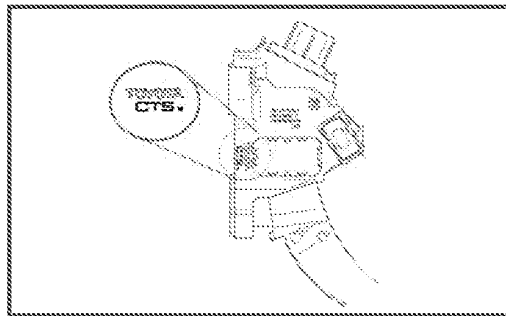
There is a possibility that certain accelerator pedal mechanisms may mechanically stick in a partially depressed position or return slowly to the idle position. Over time, the internal mechanisms in the accelerator pedal may become worn. As a result of this wear combined with certain operating and environmental conditions, friction in the mechanism may increase and intermittently result in the accelerator pedal being hard to depress and/or slow to return or, in the worst case, stick in a partially open position, increasing the risk of a crash.

Toyota dealers are requested to install a precision-cut steel reinforcement bar ("reinforcement bar") that will increase the clearance in between the internal mechanisms in the pedal assembly. This increased clearance will reduce the friction caused by wear and environmental conditions and allow the pedal to operate smoothly for the life of the vehicle. The safety recall remedy will be performed at **no charge** to the vehicle owner.
