TOYOTA CUSTOMER SERVICES

INTEROFFICE MEMORANDUM

Subject: Safety Recall (Special Service Campaign) – A0A
Accelerator Pedal Reinforcement Bar Campaign
Vehicles Equipped with Accelerator Pedals Manufactured by CTS Corporation

Subject: Safety Recall (Special Service Campaign) – A0A
Accelerator Pedal Modification Campaign
Vehicles Equipped with Accelerator Pedals Manufactured by CTS Corporation

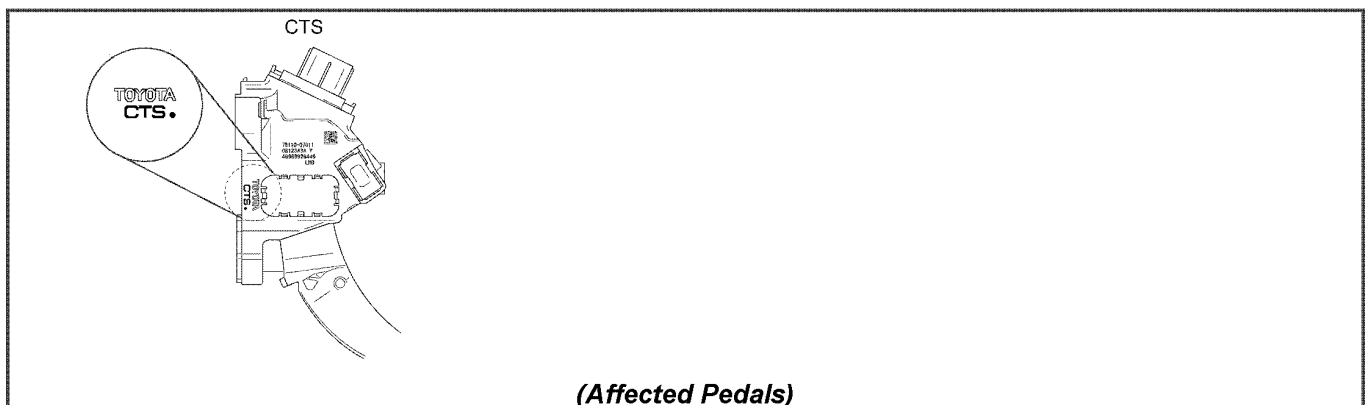
There is a possibility that certain accelerator pedal mechanisms may mechanically stick in a partially depressed position or return slowly to the idle position. Over time, the internal mechanisms in the accelerator pedal may become worn. As a result of this wear combined with certain operating and environmental conditions, friction in the mechanism may increase and intermittently result in the accelerator pedal being hard to depress and/or slow to return or, in the worst case, stick in a partially open position, increasing the risk of a crash.

- **The manufacturer name is embossed (CTS) on the upper sensor housing on the brake pedal side.**
- **This safety campaign addresses the potential for a CTS accelerator pedal to mechanically stick in a partially depressed position or return slowly to the idle position.**
- **This condition is separate from the (DIR) filed in early October, 2009, in reference to the potential for an incorrect or improperly installed floor mat to interfere with the accelerator pedal.**

Toyota dealers will be requested to install an accelerator pedal reinforcement bar (“reinforcement bar”) that will increase the clearance in-between the internal mechanisms in the pedal assembly. This increased clearance will reduce the friction caused by wear and environmental conditions and allow the pedal to operate smoothly for the life of the vehicle. The campaign remedy will be performed at **no charge** to the vehicle owner.

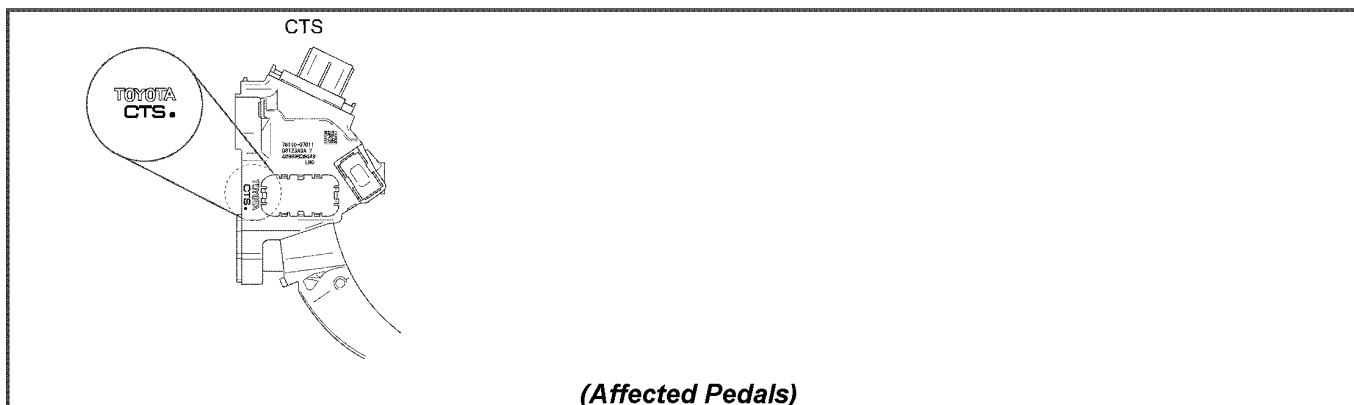
There is a possibility that certain accelerator pedal mechanisms may mechanically stick in a partially depressed position or return slowly to the idle position. Over time, the internal mechanisms in the accelerator pedal may become worn. As a result of this wear combined with certain operating and environmental conditions, friction in the mechanism may increase and intermittently result in the accelerator pedal being hard to depress and/or slow to return or, in the worst case, stick in a partially open position, increasing the risk of a crash.

- **The name of the manufacturer is printed (Denso) or embossed (CTS) on the upper sensor housing on the brake pedal side.**
- **This safety campaign addresses the potential for a CTS accelerator pedal to mechanically stick in a partially depressed position or return slowly to the idle position.**
- **This condition is separate from the (DIR) filed in early October, 2009, in reference to the potential for an incorrect or improperly installed floor mat to interfere with the accelerator pedal.**

Toyota dealers are requested to install an accelerator pedal reinforcement bar (“reinforcement bar”) that will increase the clearance in-between the internal mechanisms in the pedal assembly. This increased clearance will reduce the friction caused by wear and environmental conditions and allow the pedal to operate smoothly for the life of the vehicle. The campaign remedy will be performed at **no charge** to the vehicle owner.
