SAFETY COMPLIANCE TESTING FOR FMVSS NO. 104 WINDSHIELD WIPING AND WASHING SYSTEMS

TOYOTA MOTOR CORPORATION
2020 TOYOTA COROLLA LE, PASSENGER CAR
NHTSA NO. C20205105

FINAL REPORT

1. Report No. 104-GTL-20-001	2. Government Accession No.	3. Recipient's Catalog No.
4. Title and Subtitle Final Report of FMVSS 104 Compliance Testing of a 2020 TOYOTA COROLLA PASSENGER CAR NHTSA No. C20205105	5. Report Date January 6, 2020	6. Performing Organ. Code GTL

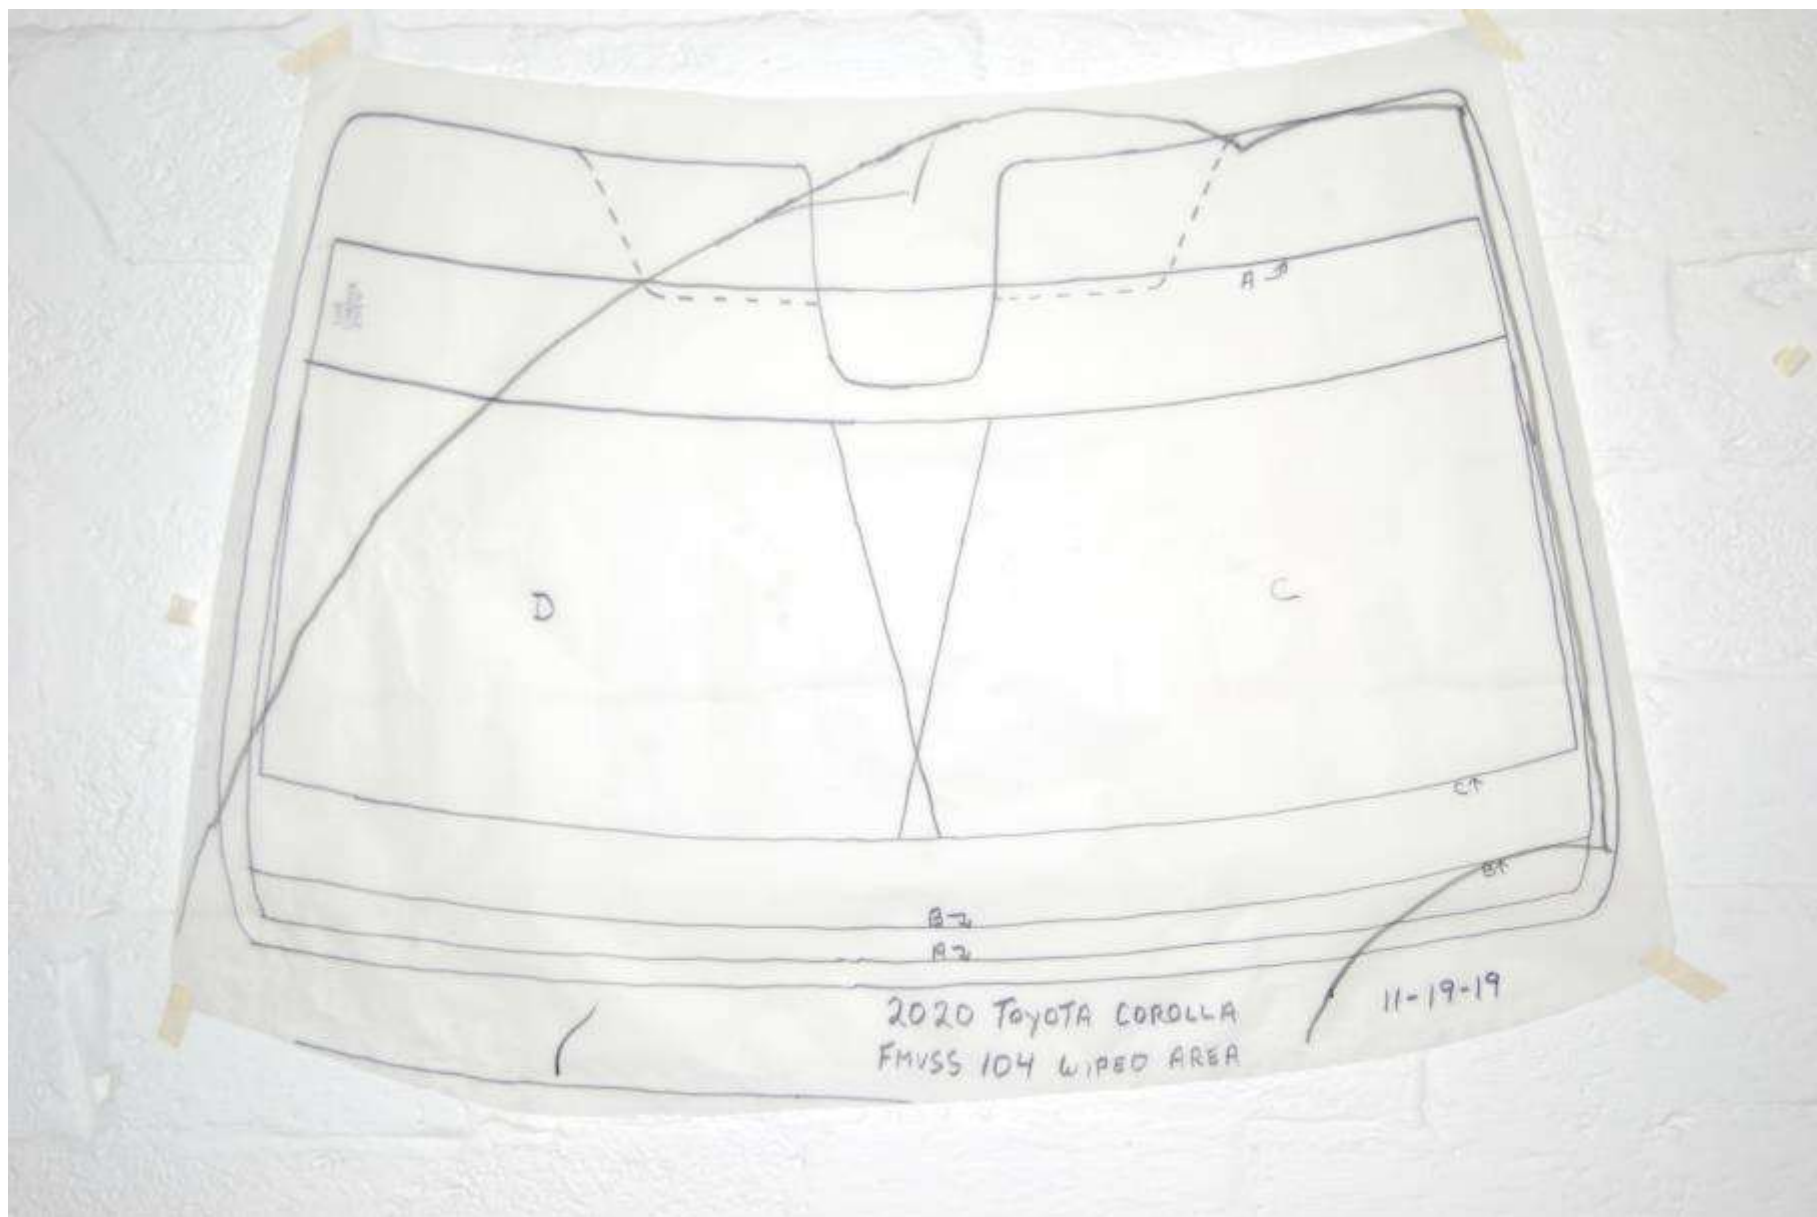
FIGURE 5.10
WIPED AREA TEST PATTERN

PERCENT WIPED				
WINDSHIELD AREA	ACTUAL	REQUIRED	PASS	FAIL
A	92.5%	80%	X	
B	95.7%	94%	X	
C	100%	99%	X

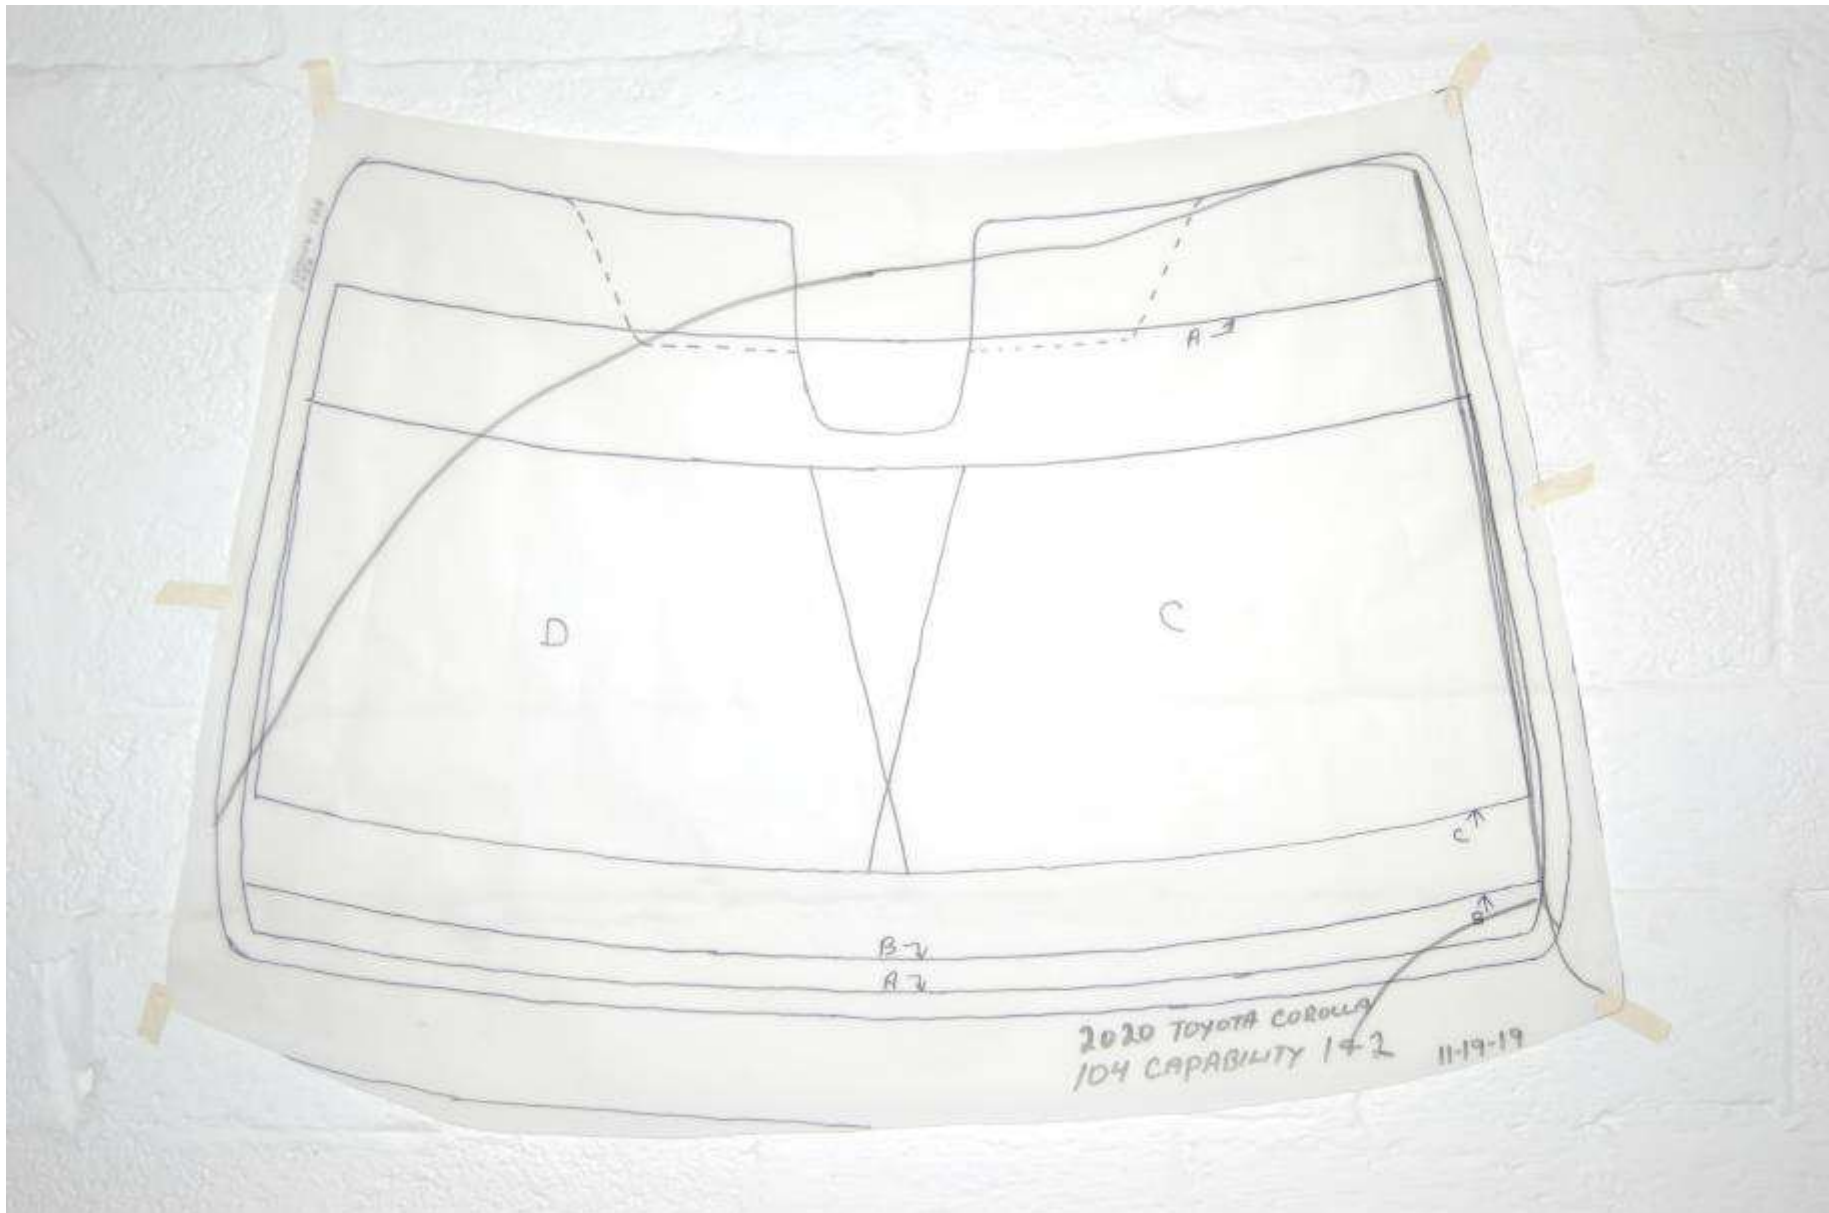
FIGURE 5.15
 CAPABILITY TEST #1 AND #2 PATTERN

Vellum patterns from capability Test #1 and Test #2 were identical.

CLEARED AREA PERCENTAGES						
WINDSHIELD AREA	TEST 1	TEST 2	AVG	REQ'D*	PASS	FAIL
A	93.0	93.0	93.0	75%	X	
B	95.8	95.8	95.8	75%	X	
C	100	100	100	75%	X
