**Mitsubishi Motors North America, Inc.**

April 13, 2010

# VEHICLE SAFETY/POLLUTION RECALL CAMPAIGN IN JAPAN

| CAMPAIGN No. | 2499 | DATE | April 8, 2010 |

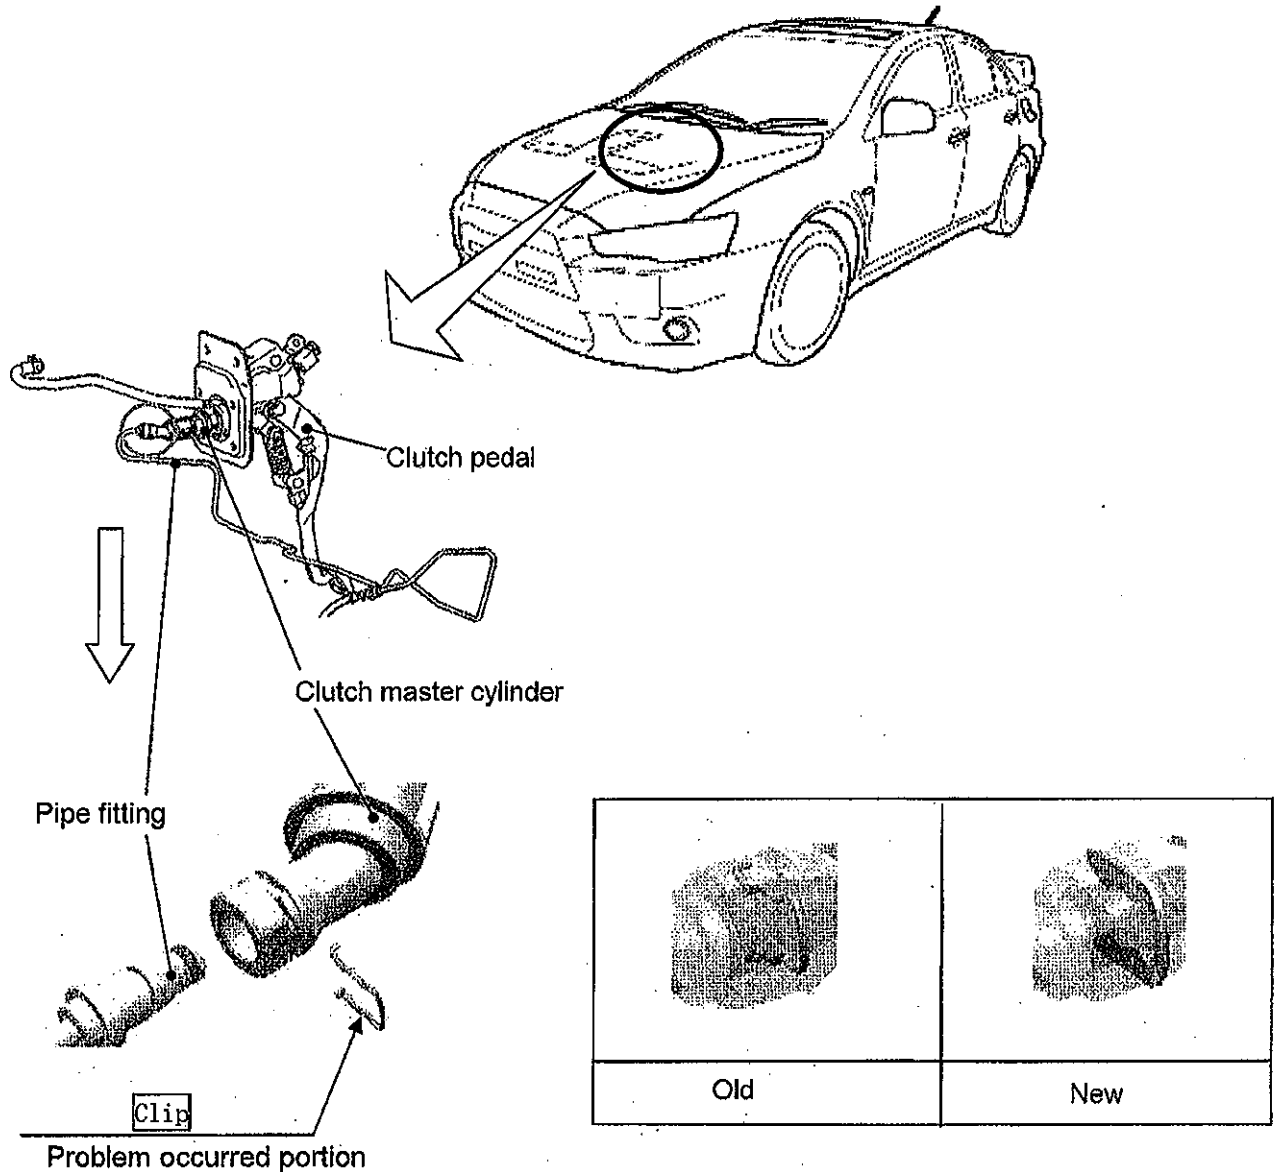
## Detail of Modification

( Since the strength of the clip affixing the oil pressure pipe to the clutch master cylinder is insufficient, the subject clip may get damaged due to the oil pressure in the clutch operation. Due to this condition, the subject pipe may come off resulting in oil leak so that driver can not operate the clutch. )

Note: In the above drawing, the part in the frame  is the replaced one.

Replace clip with countermeasure one

Identification: Apply paint mark (white or yellow) on the pipe fitting for clutch (near Clutch master cylinder).
